September 25, 2013

7468-1

City of Santa Barbara Parks and Recreation Commission
City Hall
P.O. Box 1990
Santa Barbara, CA 93102**Subject: Tree Removal and Preservation/Protection - 3714-3744 State Street,
Santa Barbara, CA**

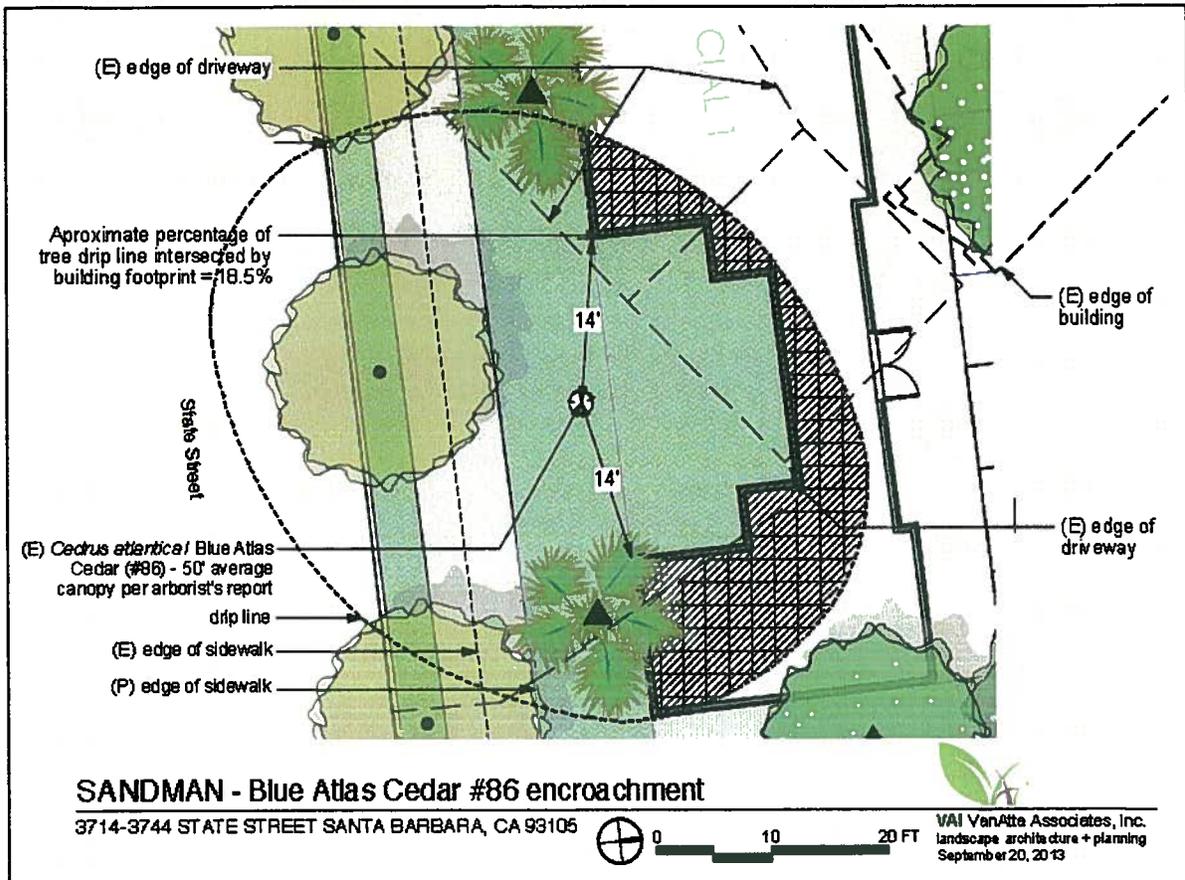
Figure I. Canopy Extents and Planned Construction

As previously stated, tree #86 is considered to be in “good” health and “fair” to “good” structural condition. As such, Dudek and the project applicant agree that this Blue Atlas Cedar is a quality tree that is of value to both the City of Santa Barbara and the property. The Street Tree Advisory Committee requested that the applicant investigate a potential redesign of the adjacent building to reduce the potential impacts to the Cedar. The Applicant did redesign this building to provide an atrium entry and an inverted “U” shape which emphasizes and features the retention of the Cedar. To supplement the City of Santa Barbara’s Street Tree Advisory Committee’s recommendation for redesign, Dudek believes that this tree can be protected in place within the

constraints of the currently proposed development footprint through a series of enhanced tree protection measures. The existing covered patio is located within a few feet of the tree and it will be deconstructed using sensitive methods and with tree protection measures to minimize impacts, as described below. The proposed building at this location will not be closer than roughly 14 feet to the tree and has been designed to largely avoid any soil disturbances adjacent the tree canopy (Figure 1). However, the foundation for the building will be built under roughly 18.5% of the tree's dripline. This does not mean that 18.5% of the tree's roots will be impacted, as foundations will require excavations of up to 24 inches deep and a few feet wide, but tree roots in this area may be more widespread and deeper, especially the structural supporting roots. Similarly, City-required sidewalk and planter areas will be constructed on the street side of the tree, under the tree's canopy. This work will require surface disturbances and irrigation related trenching, which will be minimized as much as possible.

- 6) **Deconstruction within the Dripline** – No new construction will occur within 13 feet of the trunk on the side(s) of the tree adjacent to the proposed building following the removal of the adjacent structure. Furthermore, new construction which will occur within 5 feet of the tree’s dripline on the remaining sides of the tree shall be minimized to the extent practical and shall be performed under the guidance of an ISA Certified Arborist at all times.. Prior to commencing deconstruction of the adjacent building, a 4-foot high, orange-webbing, polypropylene barricade fence with tree protection signs shall be erected around the preserved cedar tree prior to the start of deconstruction activities. The fence will be placed at the edge of the work activity zone. If the above conditions result in the fence being closer than 4 feet to the tree trunk, the trunk should be protected with strapped-on planking to a height of 8 feet (or to the limits of the lower branching) in addition to the reduced fencing. Once deconstruction is completed, the fencing will be re-positioned outward as far as possible to the edge of the construction zone.
