CITY OF SANTA BARBARA

# Street Tree Infrastructure Conditions Project

2014

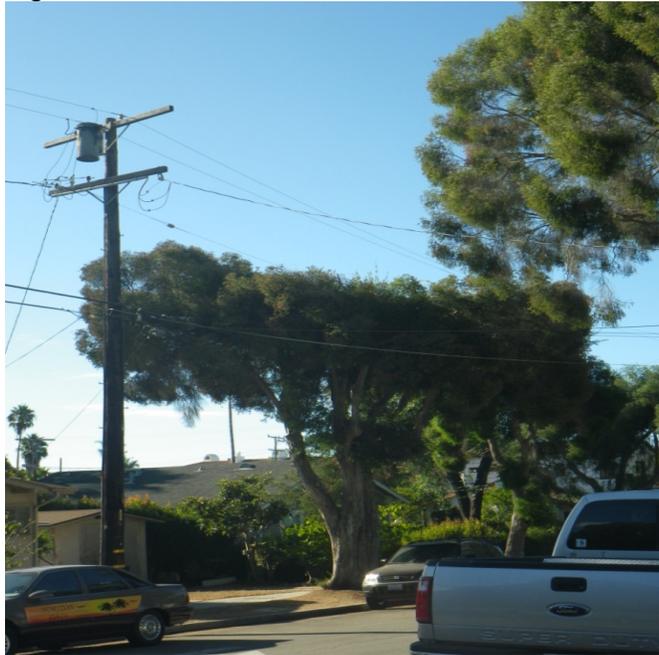
Topped

- None – No visible pruning conducted to the tree
  - Topped- the entire top of tree is reduce to a uniform height
  - Side Notch - a portion of the tree is reduce by a heading cut creating an asymmetric appearance to the tree profile

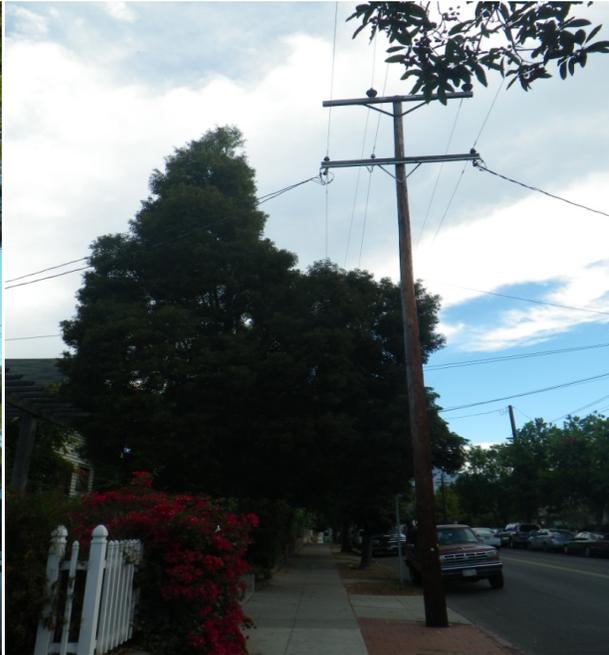
Side Notch

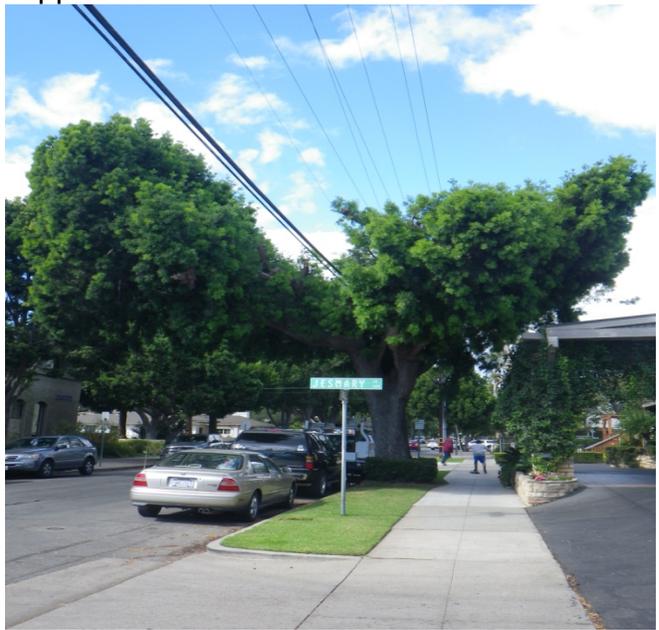
V- Notch

- Side Trim – branch removal of one side of the tree creating an uneven appearance of weight distribution of the tree
  - V-notch - branch removal down the center of the tree creating a deep V shape depression

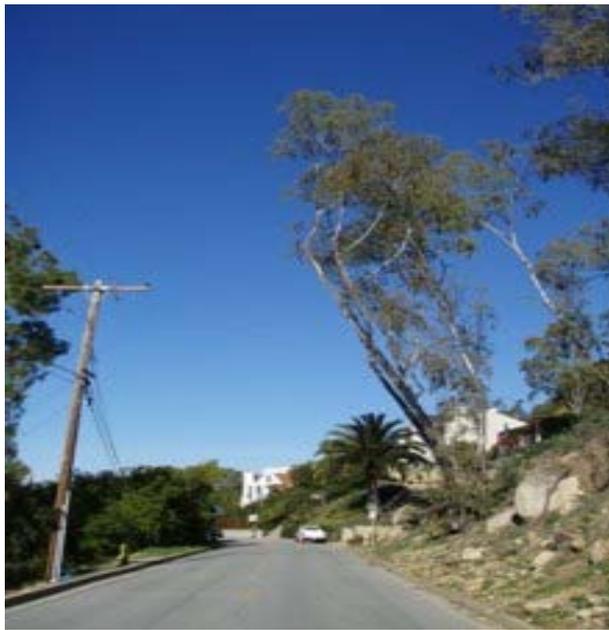
Side Trim

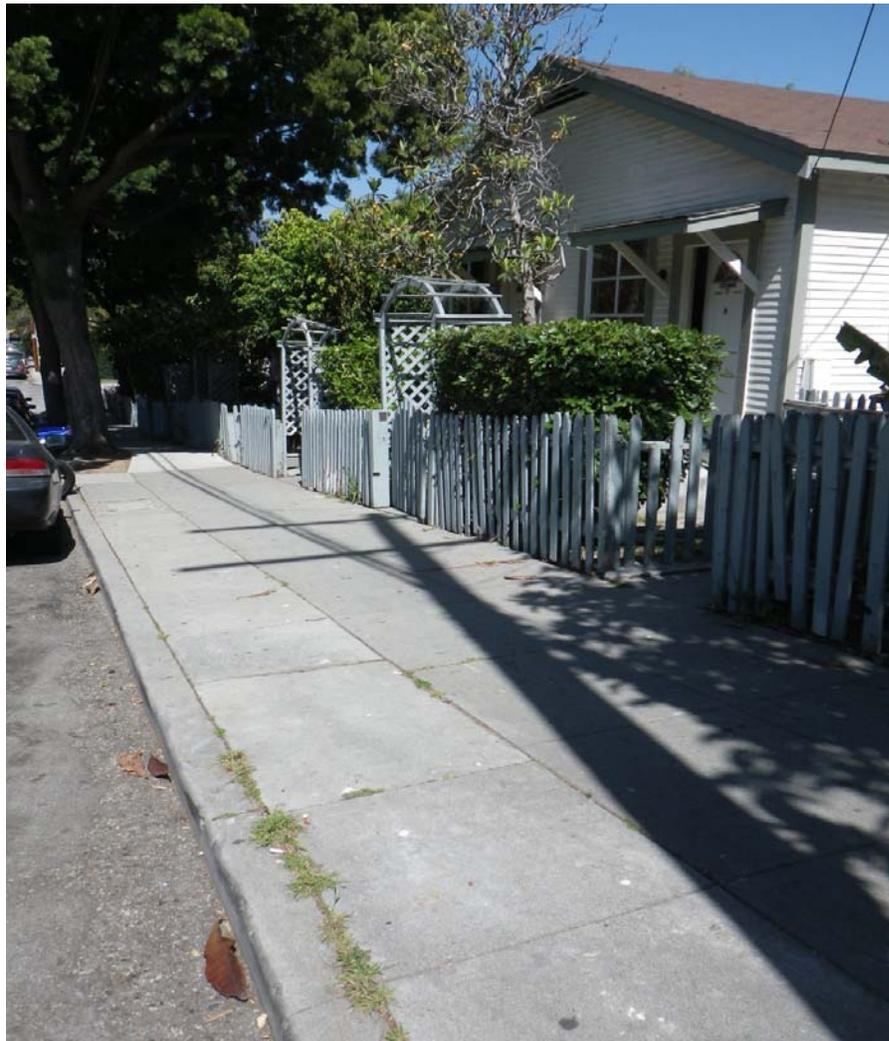
Figure 2: 522 East Canon Perdido St

- Landscaping
  - Rock/Gravel
8. **Parkway Size** – A numeric measurement in feet of length and width of parkway strip.
  9. **Growspace Size** – A numeric measurement in feet of length and width or diameter of available planting space within parkway strip.
    - a. If current site is in a suitable planting location, but grow space is obstructed by parkway substrate, measurement of 0x0 was recorded as growspace size. Figure 2 shows a suitable site for planting but there is no growspace available due to cemented parkway.

- In some cases a long stretch of parkway has been cemented over, but if removed, would provide ample growing space for a tree to live. The survey identified 22 vacant sites throughout the city that have a cement parkway and no growspace. In addition, there are two vacant tree sites found in the Eastside neighborhood with a parkway of cement and a growspace of 2x2 feet. This small growspace also provides an opportunity for enhanced growing conditions if opened up.
