Historic and Specimen Tree Drought Action Plan

August 14, 2014

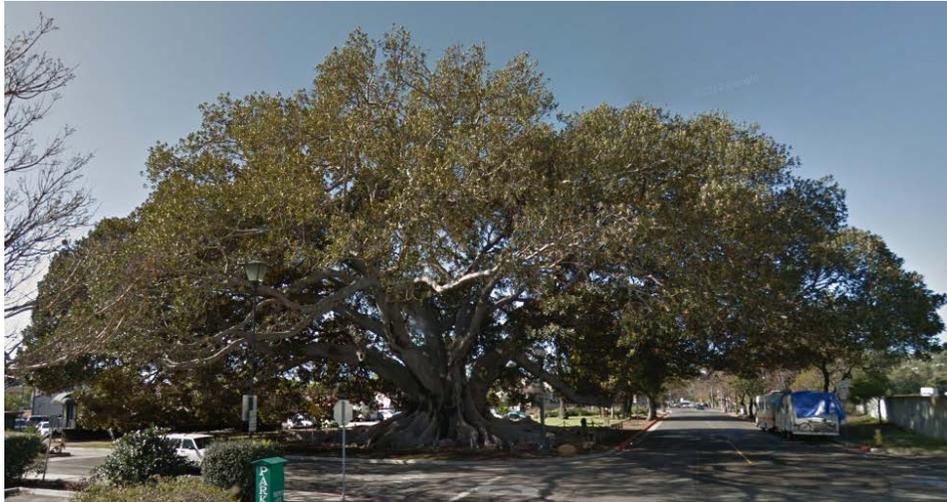
1. Moreton Bay Fig Tree (*Ficus macrophylla*) Corner of Chapala St. at Montecito St. – City owned.

Current Conditions: The City Arborist has been monitoring the condition of this tree bi-monthly by visual inspection and has taken monthly soil moisture samples since 2008 due to the presence of Phytophthora Root Rot. The disease has caused a thin canopy, reduced leaf size, and dieback at the ends of branches. These symptoms occur most prevalently in the top and eastern portions while the lower canopy and the western portions exhibit good health.

Management of the disease includes disease suppressing soil injections and management of water. Soil injections were implemented in February, May and August of 2013 in partnership with Bartlett Tree Care Experts. The soil injection treatment appears to have arrested this decline. Inspections of the tree indicate that the tree is thinning at a reduced rate, new foliage has come back larger than in previous years and root inspections indicate new feeder roots free of the disease.

Irrigation decisions are based on the moisture level of the soil. The City Arborist checks moisture levels monthly to determine when the irrigation is needed.

Constraints: Much of the root system of this tree is located under Chapala Street and Montecito Street. During construction of the 101 freeway an irrigation system was installed under Chapala and Montecito Streets to provide the tree roots with a source of water. While the irrigation system is functioning well, the roadways limit access to check soil moisture levels and inspect roots for the disease.

Action: Water will be administered based on the needs of the tree while not creating an environment that contributes to the disease. Between the months of July 2013 and June 2014, an average of 17,800 gallons of irrigation was applied per month. In addition, as part of the Lower Mission Creek Flood Control Project, the City of Santa

Barbara Public Works Department will be providing improvements around this tree in the fall of 2014. Improvements include extending the chain and post barrier and installing mulch out to the drip line. These combined measures are expected to provide benefits to the tree through decreased evaporation and reduced soil compaction from foot traffic.

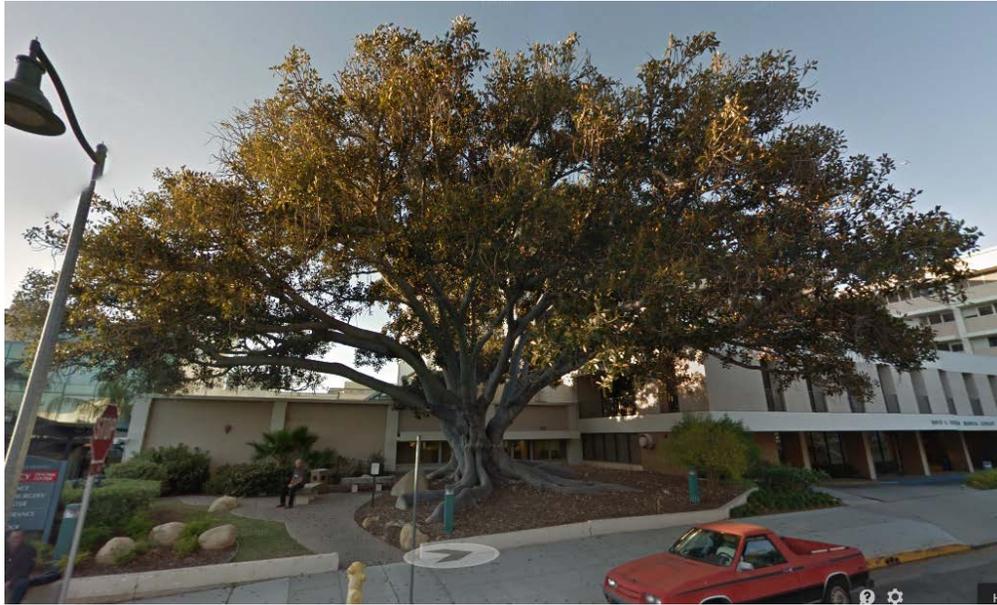
**2. Moreton Bay Fig Tree (*Ficus macrophylla*)
320 West Pueblo Street – Private Property, Cottage Hospital**

Current Conditions: This tree is located in an irrigated planter on the property of Cottage Hospital. The tree's current health condition is good.

Constraints: Space exists for deep watering and proper tree care. No known constraints exist.

Action: Parks and Recreation staff will meet with Cottage Hospital maintenance staff to provide tree preservation information and help establish appropriate tree care. City staff will work to ensure that they understand preservation requirements as specified in Santa Barbara Municipal Code Chapters 15.24 and 28.00, can identify signs of the tree stress and or disease, and develop appropriate irrigation practices.

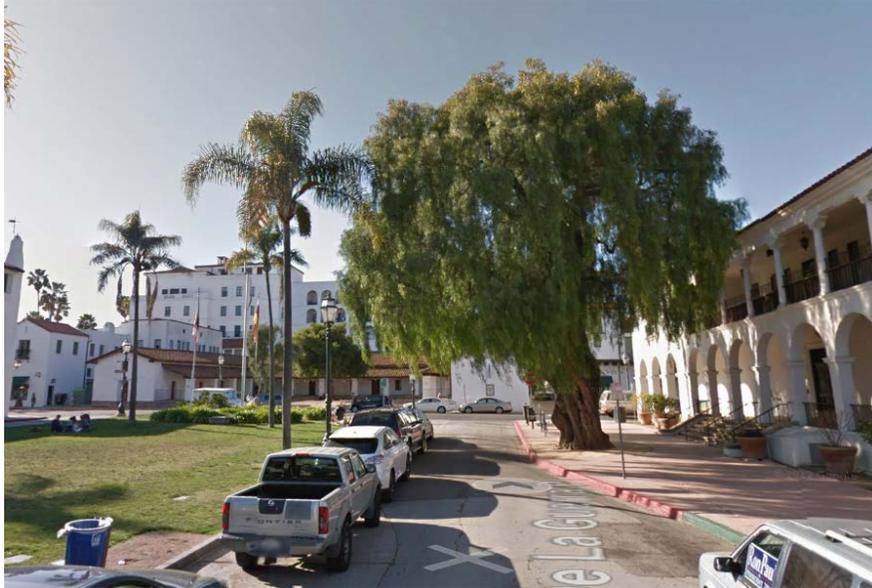
**3. City Hall Pepper (*Schinus molle*)
De La Guerra Plaza entrance to City Hall – City owned**

Current Conditions: This tree is currently not showing signs of water stress and is in good condition.

Constraints: This tree is located in an oblong planter that cannot be significantly enlarged due to accessibility constraints. Much of the absorbing roots exist under the surrounding hardscape, making watering difficult.

Action: Staff will monitor its health on a bi-monthly basis. Deep probe watering will be utilized if the tree begins to show signs of drought stress in the planters nearby as well as in the adjacent lawn.

In order to provide more water to the roots of this tree the following opportunities could be pursued: removal of pavement adjacent to the tree at locations near the drip line of the tree canopy to provide access ports for watering; and installing permeable pavers or other type of permeable surfaces surrounding the tree and/or within the De La Guerra Plaza roadway.

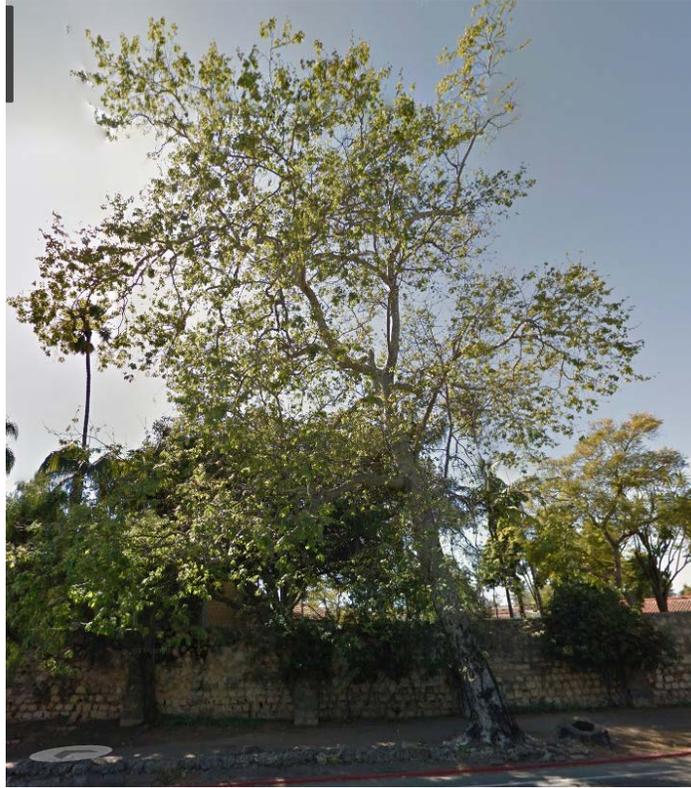
4. Cota Sycamores (*Platanus racemosa*)
Mission Santa Barbara at Los Olivos St. & Alameda Padre Serra (APS) –
City owned

Current Conditions: These two trees exist in a dirt parkway that varies in width from 3 to 9 feet. One of the two trees was removed down to a stump in 2004 due to hazards it presented to the public. The stump has sprouted and is still alive. The large tree is in healthy condition and not currently showing signs of water stress. Though it is leaning slightly, it is not endangering public safety.

Constraints: Most of the absorbing roots for these trees exist outside areas the City can access.

Action: Staff will monitor the tree's health on a bi-monthly basis. Staff will provide water in the parkways as deemed necessary, provide mulch where room exists within the parkway, and work with Old Mission Santa Barbara to provide information on how they can assist with irrigation on their property if it becomes necessary.

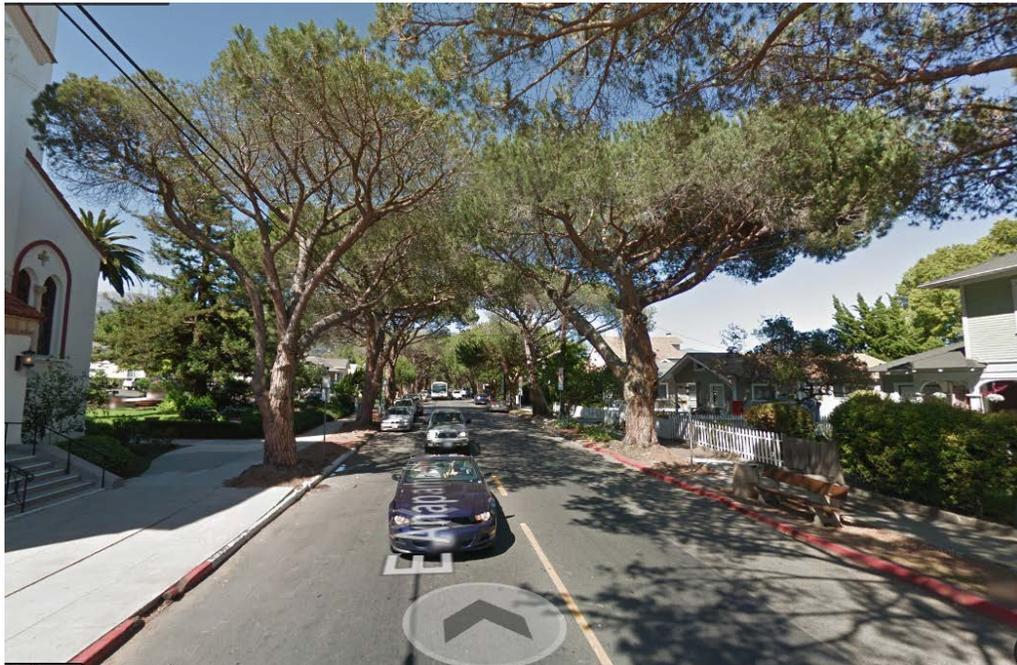
5. Doremus Stone Pines (*Pinus pinea*)
300-800 Blocks E. Anapamu St. – 79 original trees – City owned

Current Conditions: The historic Stone Pines include many of the trees spanning the 300 to 800 blocks of East Anapamu Street. Three trees died in recent years and were replaced with new trees. Based on a recent inspection of the 300 – 800 blocks, four trees are currently dead having succumb to pest infestation and are awaiting removal, 12 are in poor health, 24 are in fair health, 26 are in good health, and 19 are in excellent health (See attached Health Conditions Map). Tree health varies due to the growing conditions in which they are located, root pruning practices that have been conducted on them in the past, effects of the drought as well as attacks by insects. These trees have the potential to succumb to beetle infestations if vigor becomes too low for the tree to ward off the pest. Staff has monitored their health on a bi-monthly basis since 2013 by visual assessment and watered these trees on various occasions since 2008. To date, staff has applied a total of 5,778 gallons of water within the parkways between the trees.

Constraints: The trees were planted in two batches in 1908, and from 1919 – 1921, when Anapamu Street was a dirt roadway and did not include improved sidewalks. Since then, the street and parkway hardscape was installed constraining the growing space of these trees and decreasing the trees access to water and air. They now exist within parkways that range in width between 3 - 6 ½ feet. Several sites exist where the planter space is small and confined by hardscape on all sides. Because of this, there is a history of root pruning for hardscape and underground utility repairs. In addition,

some tree roots have grown above grade and fill the parkway space, making deep probe watering difficult. Most of the absorbing roots for these trees exist outside areas the City can access.

Although these trees can suffer from beetle infestations, the treatment techniques may not be utilized due to the potential affect on overall tree health. Treatment for beetle infestation includes an injection of pesticide into the trees cambium layer, killing it for a distance around the injection site. The injection may cause enough dieback so as to cause further decline or possible death.

Action: The Department's initial step will include removing dead trees to avoid spreading the pest infestation to nearby trees. Trees that are in poor health will receive water. Providing water to these trees requires extensive resources. During the recent water application (5,778 gallons) it took 2 staff, 60 hours, the water truck and water trailer to provide water to 71 trees. Additional resources will be needed to maintain a monthly watering schedule. It is recommended that these trees receive monthly watering applications for best results. Bi-monthly assessments will be conducted to monitor tree health along this corridor, provide mulch where space exists, as well as explore opportunities to remove hardscape. The Department will also implement a door-to-door outreach campaign to solicit neighbor participation in tree watering. The outreach will include an information mailer, door hangers, and one-on-one meetings.

In order to provide more water to the roots of these trees the following options/opportunities may be pursued: removal of pavement and/or bricks adjacent to locations near the drip line of the tree canopy (attached Health Conditions Map illustrates locations where opening the parkway is available); installing mulch where parkways can retain it; exploring the feasibility of installing permeable pavers or other type of permeable surface along the side walk and/or street; and expanding planters at strategic locations to reduce root pruning and hardscape conflicts.

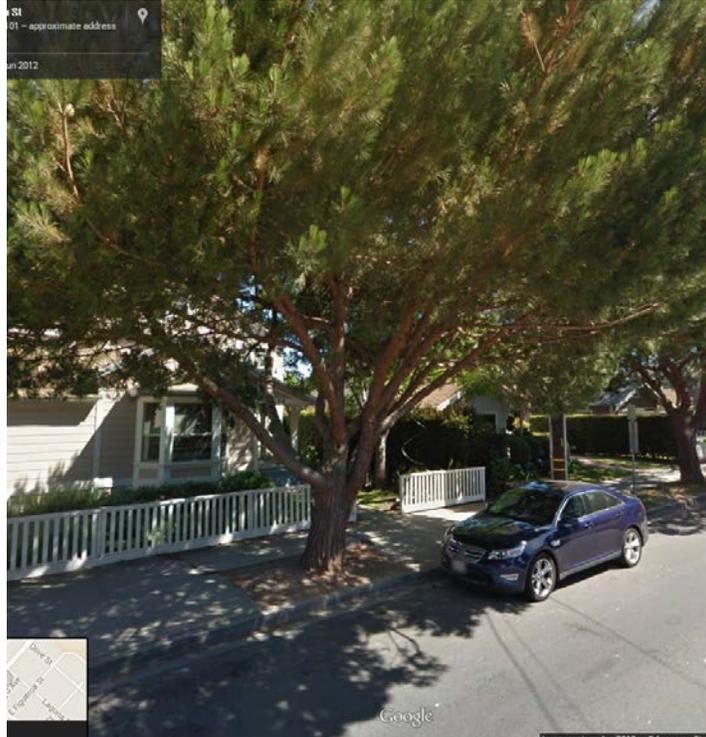
318 East Anapamu showing confined growing space. Opportunities to remove the surrounding cement at this location may improve root access to water.

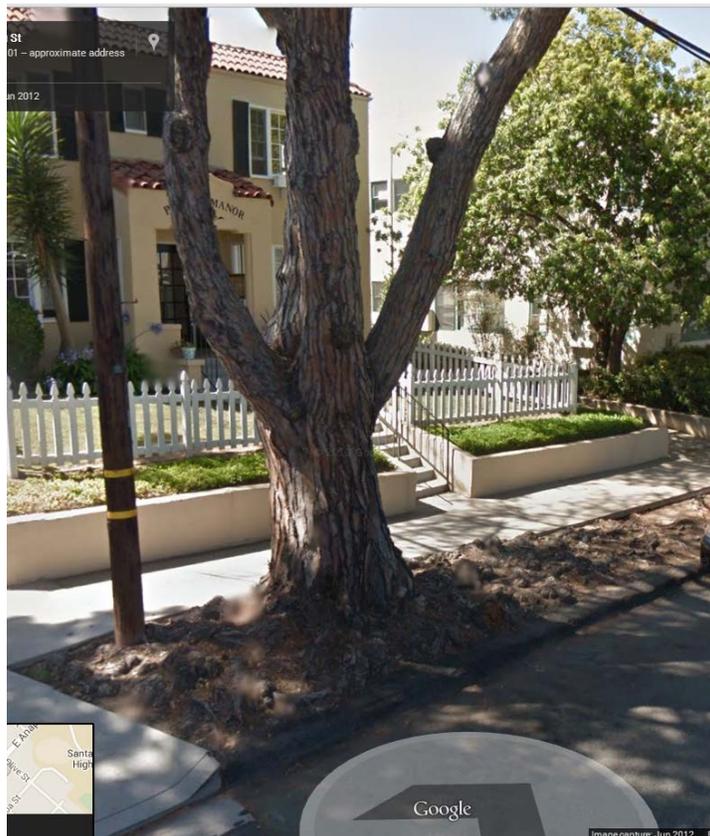
425 E Anapamu showing root structure and potential difficulty watering within parkway.

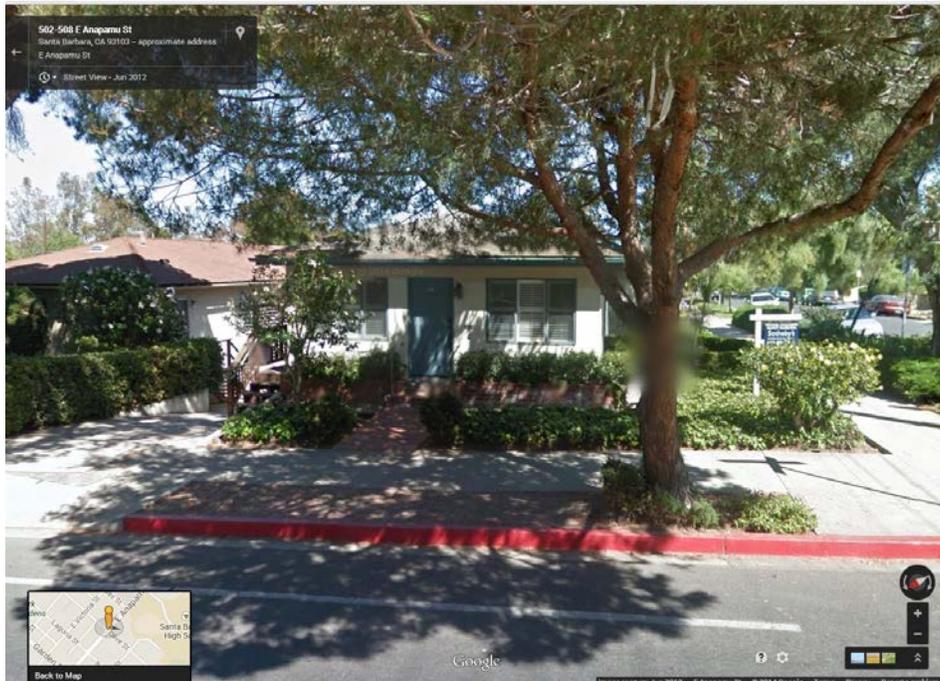
Corner of E Anapamu and Olive Street showing parkway filled in with bricks.

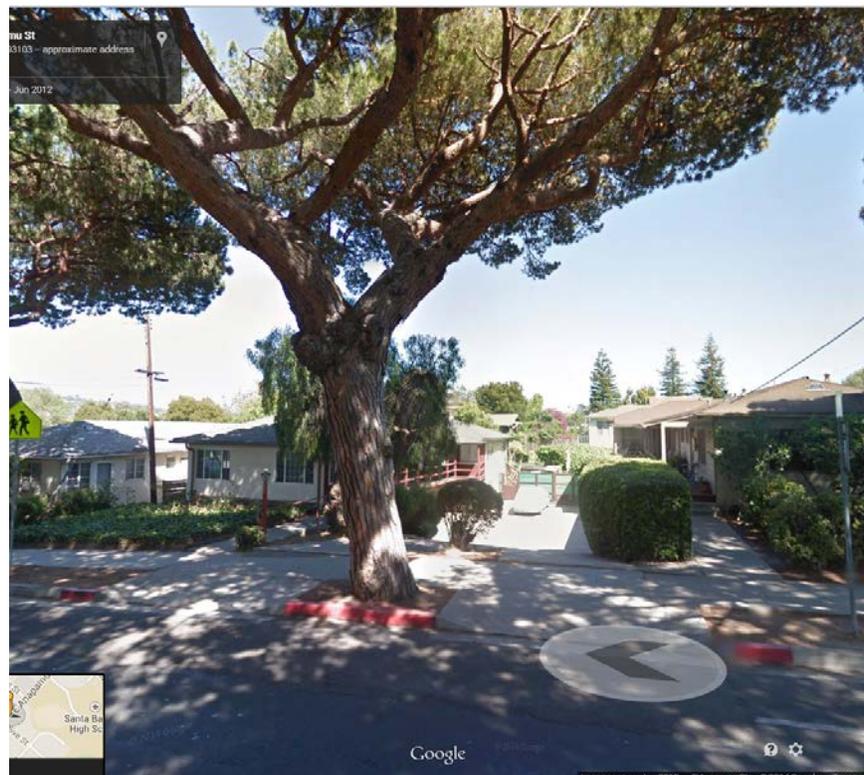
500 Block- Picture showing small planter space between two driveways

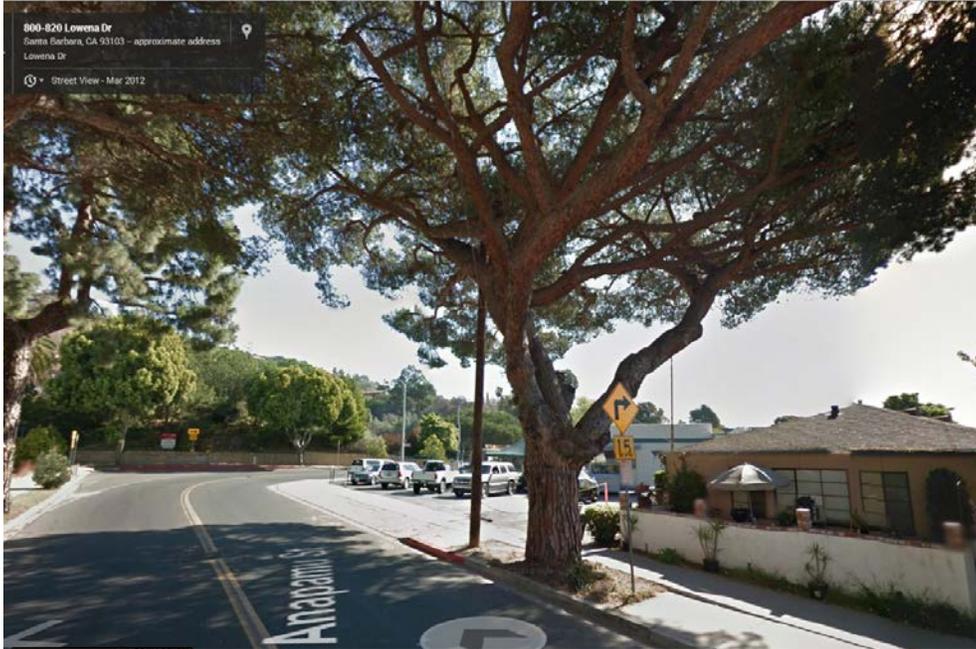
800 Block- Several small grow spaces exist within the 700-800 block section making watering difficult.

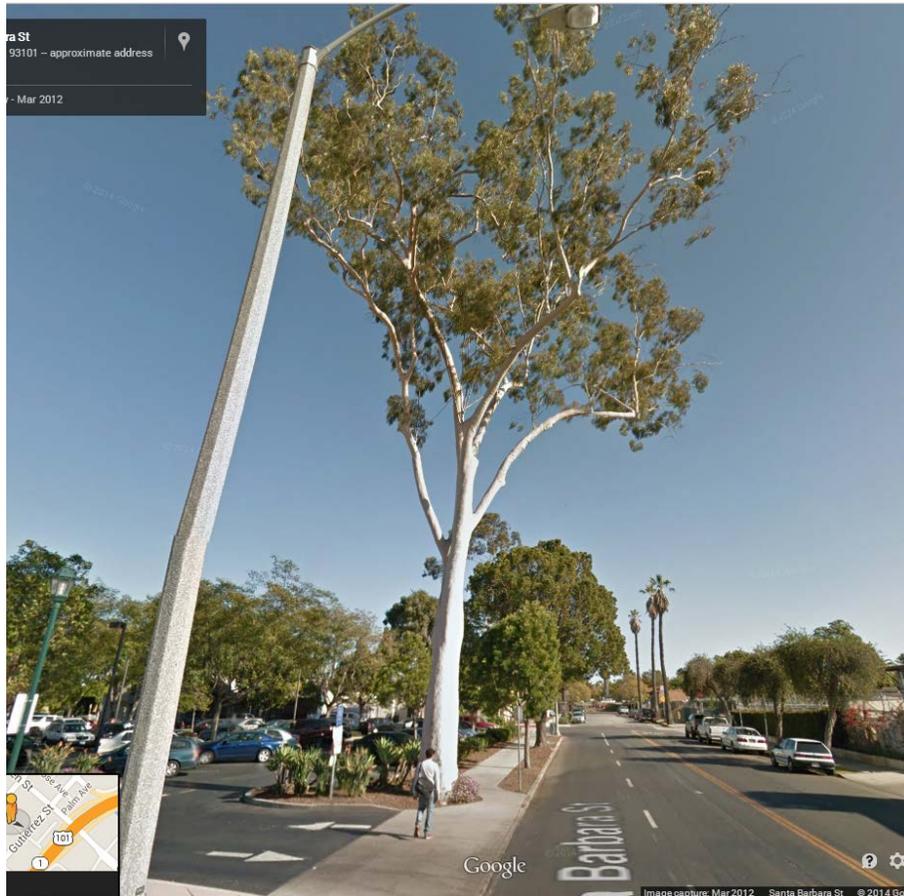
6. “Fernald Eucalyptus” (*Corymbia citriodora*)
400 Blk. Santa Barbara St. (Smart & Final entrance) – City owned

Current Conditions: This tree exists partially within the road right-of-way along Santa Barbara Street. It is adjacent to a driveway entrance in an extended planter that is privately owned. The tree’s current health is good but the tree could become susceptible to pests should vigor become low.

Constraints: Even though much of the absorbing root structure is under hardscape, opportunities exist to water the tree within the privately owned planter and an adjacent parkway.

Action: Staff will monitor tree health on a bi-monthly basis. Staff will provide water in the parkways plus work with the land owner to access the private planter space if it becomes necessary.

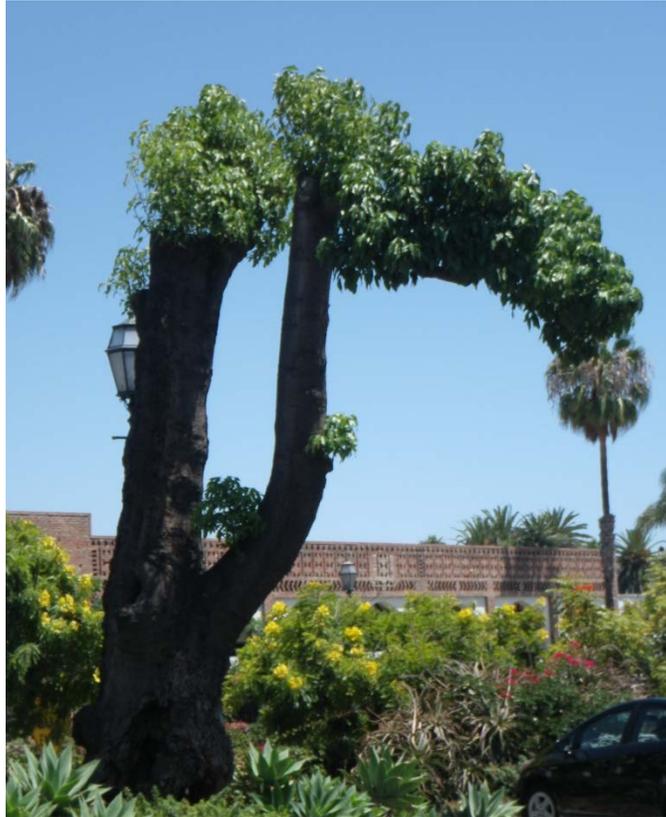
7. Franceschi Flame Tree (*Brachychiton acerifolium x populneum*)
11-15 W. Gutierrez St. – City Parking Lot 12 – City owned

Current Conditions: This tree exists in a planter within City Parking Lot 12. The tree has had a number of health issues related to a white rot decay to its trunk that cannot be treated. As a result of this white rot, the trunk has decayed to the point that the tree supports itself on sections of live wood in a fashion resembling four stilts. In 2013, City staff developed a treatment and propagation plan as a last attempt to save the tree while also reducing risk to the public safety from the tree falling over. The tree, formerly reaching 50 feet in height, has been reduced to about 15 feet with the intent of promoting new vegetative growth that can be trained into a new, smaller tree. Should the white rot show signs of worsening, thus weakening the tree further, then removal may be necessary. The tree has sprouted new growth and is showing signs of stability since the 2013 pruning.

Constraints: In response to the drought, the landscape irrigation in Parking Lot 12 has been turned off. Water has to be supplied manually to this tree within the available planter area.

Action: Parks staff monitors the tree's health on a bi-monthly basis and provides water as necessary. Staff will also continue to implement the Flame Tree treatment and propagation plan. Part of the plan calls for propagation of viable branchlets through grafting by Bruce Van Dyke. If successful, once the drought is over, at least one will be planted in the parking lot planters where space is currently available. When safety

hazards dictate that the Franceschi Flame Tree must be removed, an additional one will be planted in that location. Staff has inspected the grafted stock and indicates that several are performing well.

Opportunities may exist to install permeable pavers or other permeable surface material within the parking lot.

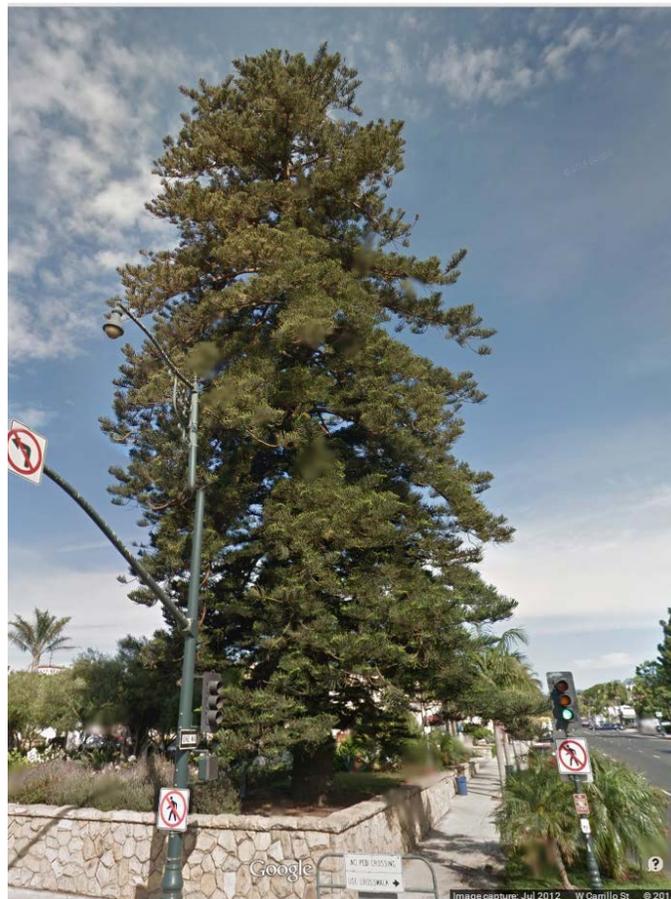
**8. “Tree of Light” (*Araucaria heterophylla*)
100 W. Carrillo St. (NW corner of Chapala St. at Carrillo St - Ralphs Market)
Privately owned**

Current Conditions: This tree exists within a private parking lot surrounded by hardscapes. The tree’s current health is good and it is not showing signs of stress.

Constraints: This tree is privately owned and maintained with most of the absorbing root structure under hardscape.

Action: Staff will provide tree care information to the owner and their grounds maintenance contractor to ensure they understand preservation requirements as

specified in Chapters 15.24 and 28, can identify signs of tree stress and or disease, and develop appropriate irrigation practices.

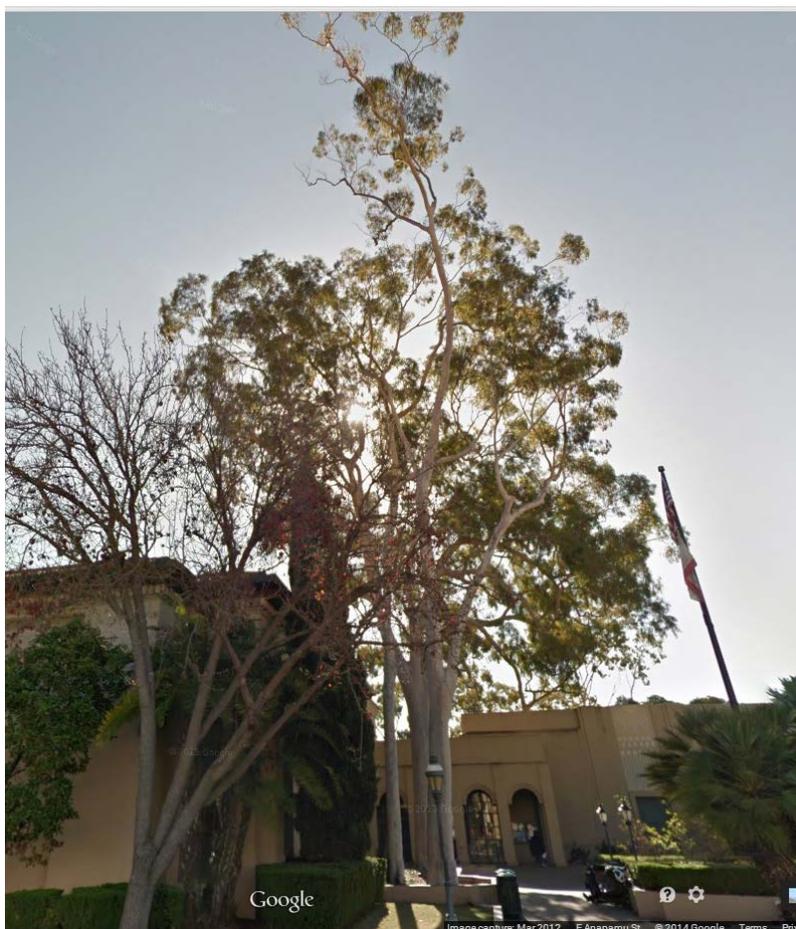
**9. Main Library Lemon Scented Eucalyptus (*Corymbia citriodora*)
40 E Anapamu Street– 5 Trees – City owned**

Current Conditions: Three of these trees exist within a planter in front of the Main Library entrance. The other two are adjacent to the rear entrance and are completely surrounded by bricks and other hardscapes. Tree health is good for all five trees.

Constraints: Trees are located in small planters with the majority of the absorbing root structure located under hardscape.

Action: Staff will monitor their health on a bi-monthly basis and provide water where space is available as it becomes needed.

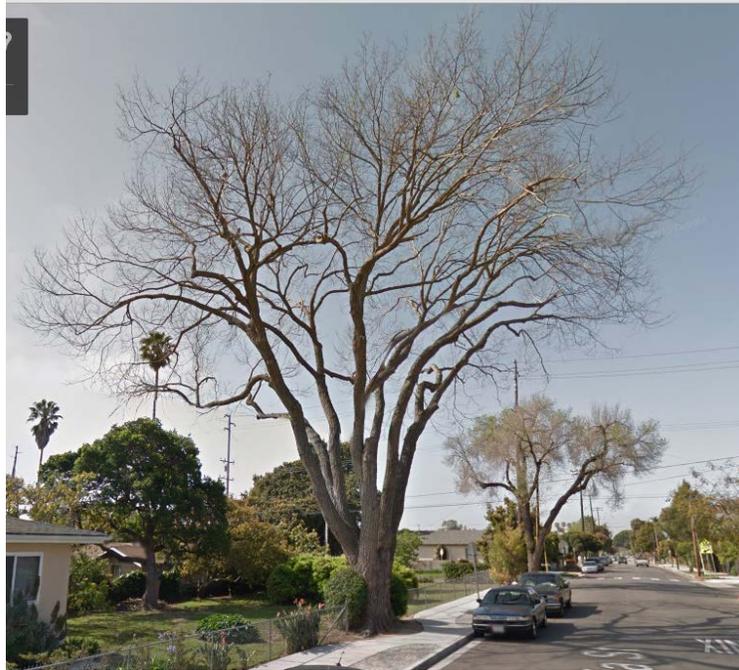
1. American Elm (*Ulmus americana*)

Current Conditions: This tree is owned and maintained by the City but exists partially on private property. Elms are native to the eastern North America and wetter climates. Given this, the tree's health is good but showing its age (yr).

Constraints: The parkway along this section has been filled with hardscape making the only area available to provide water on private property.

Action: This tree will be monitored bi-monthly to determine the level of care necessary for the tree. Staff will work with the private land owner to see if deep probe watering on their property is available.

Opportunities may exist to provide tree roots with more access to water by removing the brick hardscape that has been installed in the parkway or installing permeable pavers or other permeable surface material within the side walk and/or street.

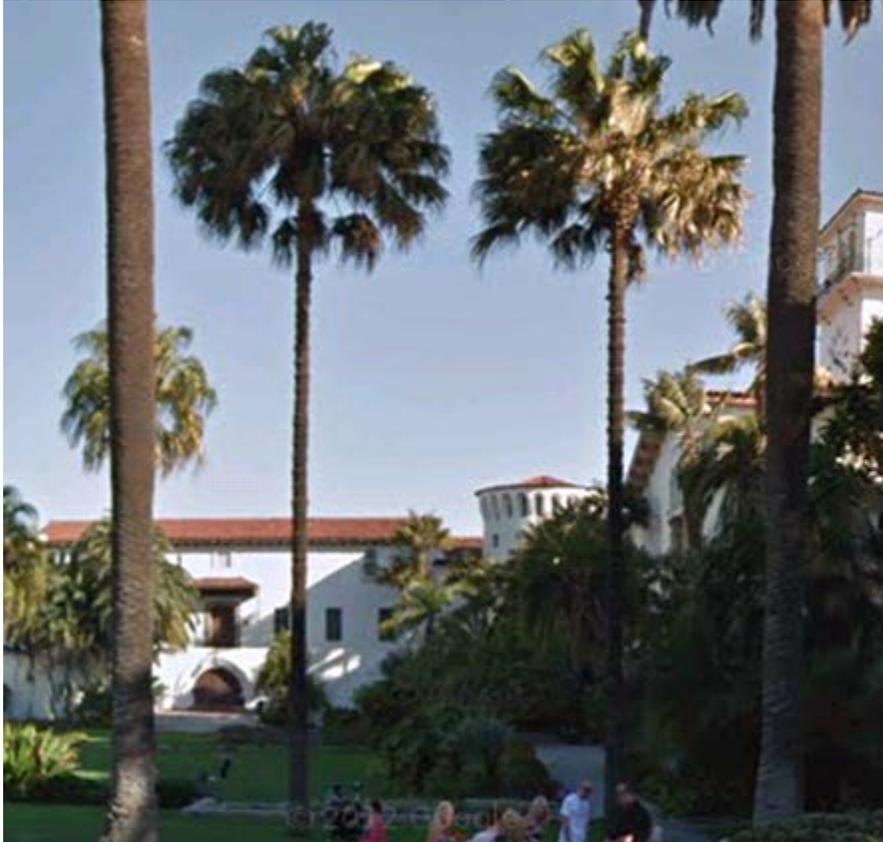
**2. Two Australian Fan Palms (*Livistona australis*)
131 E. Anapamu St., front setback -- County owned**

Current Conditions: These trees exist within the landscaped areas of the Santa Barbara County Courthouse grounds in the great courtyard near Anapamu Street and are maintained by the Santa Barbara County Parks staff. Their current condition is good.

Constraints: Ample space is available to provide water and overall tree care.

Action: Parks and Recreation staff will meet with County Parks maintenance staff to provide tree care information. ensure that they understand preservation requirements as specified in Santa Barbara Municipal Code Chapters 15. 24 and 28.00, can identify signs of the tree stress and or disease, and develop appropriate irrigation practices.

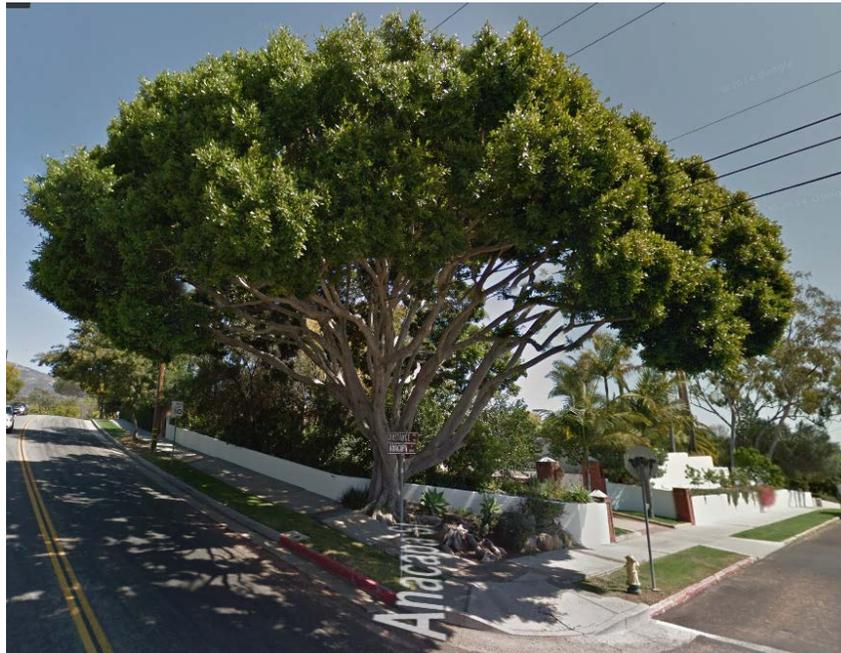
**3. Indian Laurel Fig (*Ficus microcarpa var. nitida*)
100 E. Constance Ave. (SE corner Constance at Anacapa St.) – Privately
owned, City maintained**

Current Conditions: This tree exists within an approximate 200 square foot planter between the public sidewalk and a wall. A planter exists under the canopy on the other side of the wall and in private property that the tree roots can access for water. The current condition of this tree is good.

Constraints: The majority of the tree's absorbing roots are under the public street or within the adjacent private property making watering by the City difficult. Although water can be applied within the parkway, it is limited.

Action: Staff will monitor the health of this tree on a bi-monthly basis and provide water within the parkway. Staff will work with land owners to solicit their participation in tree watering as well as to see if access to their property is available for watering.
