March 2015

City of Santa Barbara
Parks and Recreation Department
STREET TREE REMOVAL APPLICATION

Project Name: Laguna Lot Permeable Paver Project

The Sansum Clinic plans to relandscape the 215 Pesetas Lane campus to optimize sustainability and enhance aesthetics. Seven Aleppo Pines (*Pinus halepensis*) in the east Pesetas Lane **parkway** and five Red Gum Eucalyptus (*Eucalyptus sideroxylon*) in the southeast parking lot were identified as removal candidates based on their Hazard Potential and overall poor condition. Arbor Services, Inc. was contracted by Sansum Clinic to assess the twelve subject trees, in addition to an Aleppo Pine that recently failed on campus. The assignment was to determine overall tree condition, hazard potential and long-term viability as related to the proposed development objectives. Leigh Christman, Certified Tree Risk Assessor/Certified Arborist conducted the visual evaluations on January 15 and 16, 2015. It was concluded that the subject trees were in fair to poor condition with High Risk Rating. Even with arboricultural intervention, the safety, health and the aesthetic value of the trees could not be significantly improved. Further decline is anti

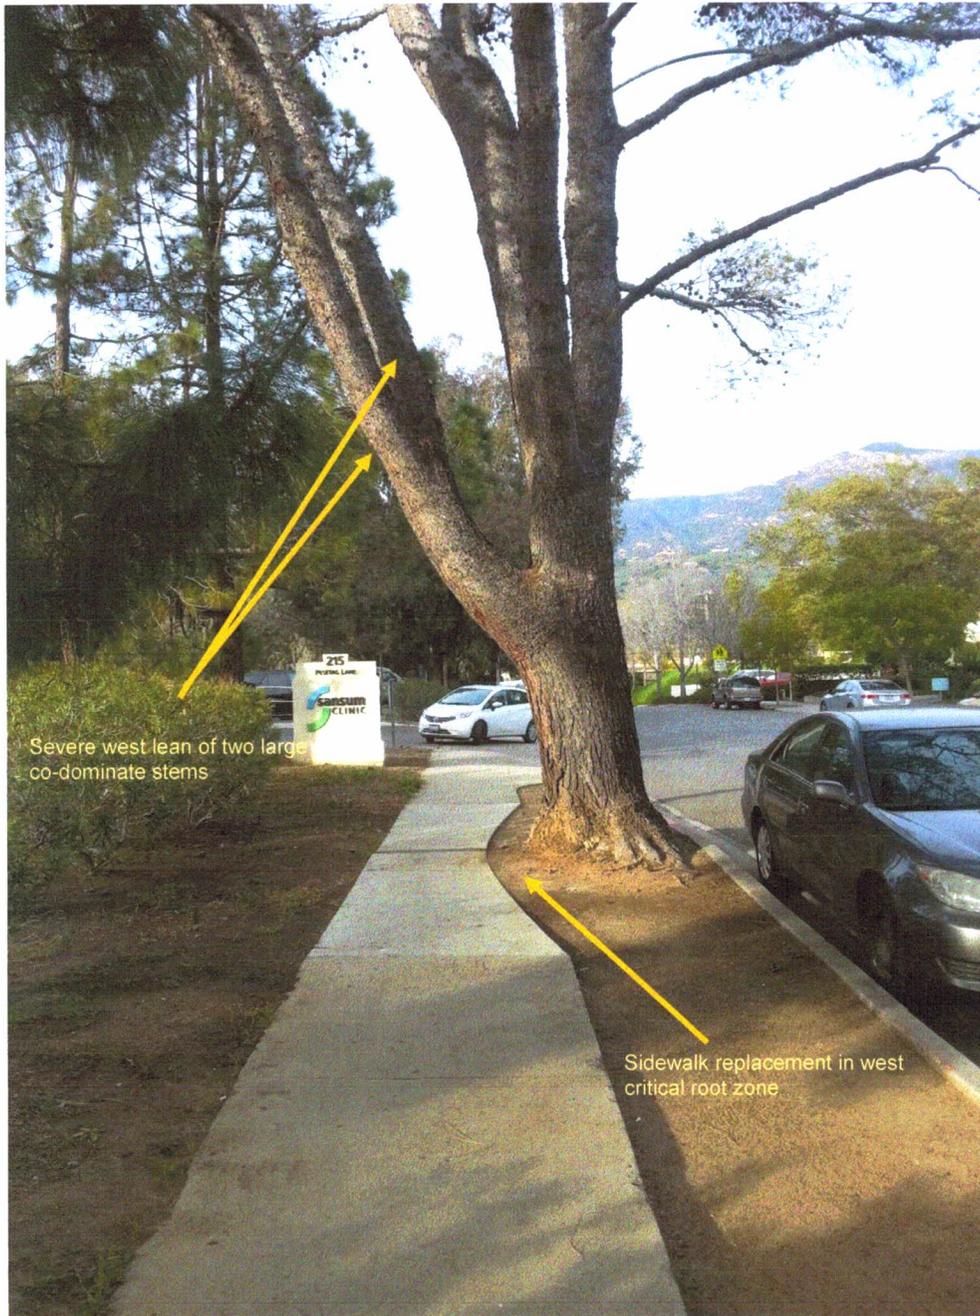
Aleppo Pine #1 has had recent sidewalk replacement within the west side of its **root crown**. The sidewalk has been bowed outward along the west main trunk to possibly accommodate the root crown and/or major roots. There is paving and landscaping within the CRZ. Ninety Percent of the rootzone is under pavement and landscaping. Exposed soil areas are compact and bare. It has multiple main trunks and an **asymmetrical canopy**. The **foliage** is sparse with significant dieback. The consequences of failure is high.

Figure 3: Aleppo Pine #1 located within parkway at 215 Pesetas Lane, Santa Barbara (Christman, 2015)

In the interest of long-term safety as first priority, **the removal of the seven Aleppo Pines and five Eucalyptus is recommended.** Their replacement not only resets the hazard rating to zero, but allows for the proactive, rather than reactive use of financial resources. The rebalancing of the Age Class to favor long-lived, drought tolerant and low risk trees is in Sansum Clinic and the public's best interest. The replacement of the Pines with the designated street tree for Pesetas Lane, the *Jacaranda mimosifolia* in 24 inch boxed trees in spacing to match those already established on the east side of the street will create a more balanced thoroughfare. The overhanging purple blooms of the mature Jacarandas on either side of W. Mission Street (Figure 11 and 12) are an example of how this investment would enhance the neighborhood. The Jacaranda species is more suited for the smaller parkway, thus its designation and more manageable for City Crews to maintain.

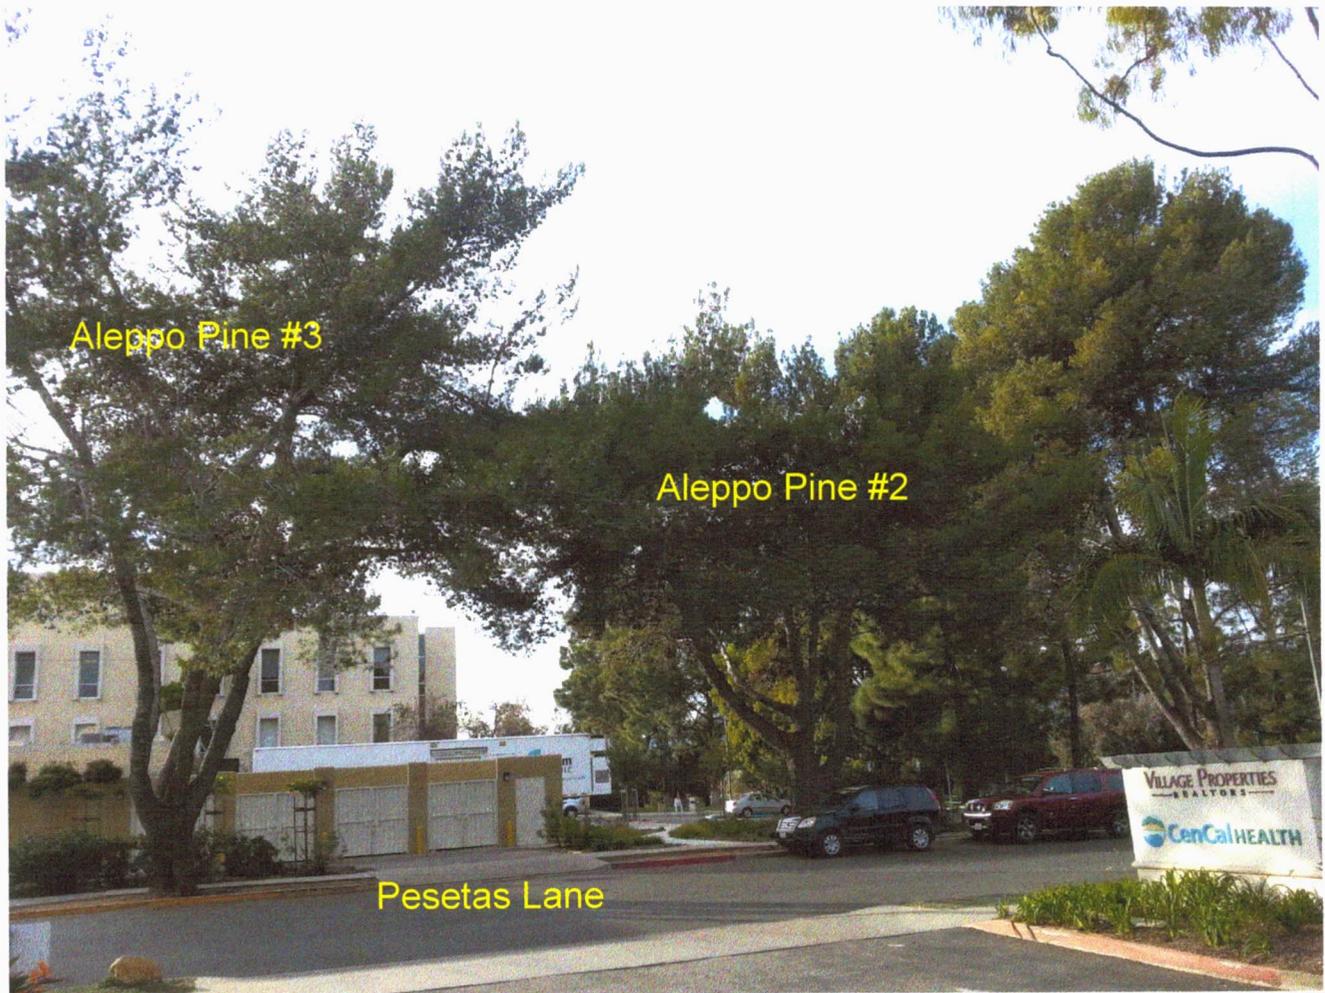
The sidewalk has been recently replaced on the west side of the main trunk. The soil exposed in the parkway is compacted and bare. Aleppo Pine #2's has interior and exterior branch dieback. Visual defects include heavy branch ends, and **lion's tailed** main branches. Consequences of failure are high.

Figure 4: The east view of Aleppo Pine #3 and Aleppo Pine #2 in parkway. They both overhanging the Sansum Clinic driveway and Pesetas Lane (Christman, 2015).

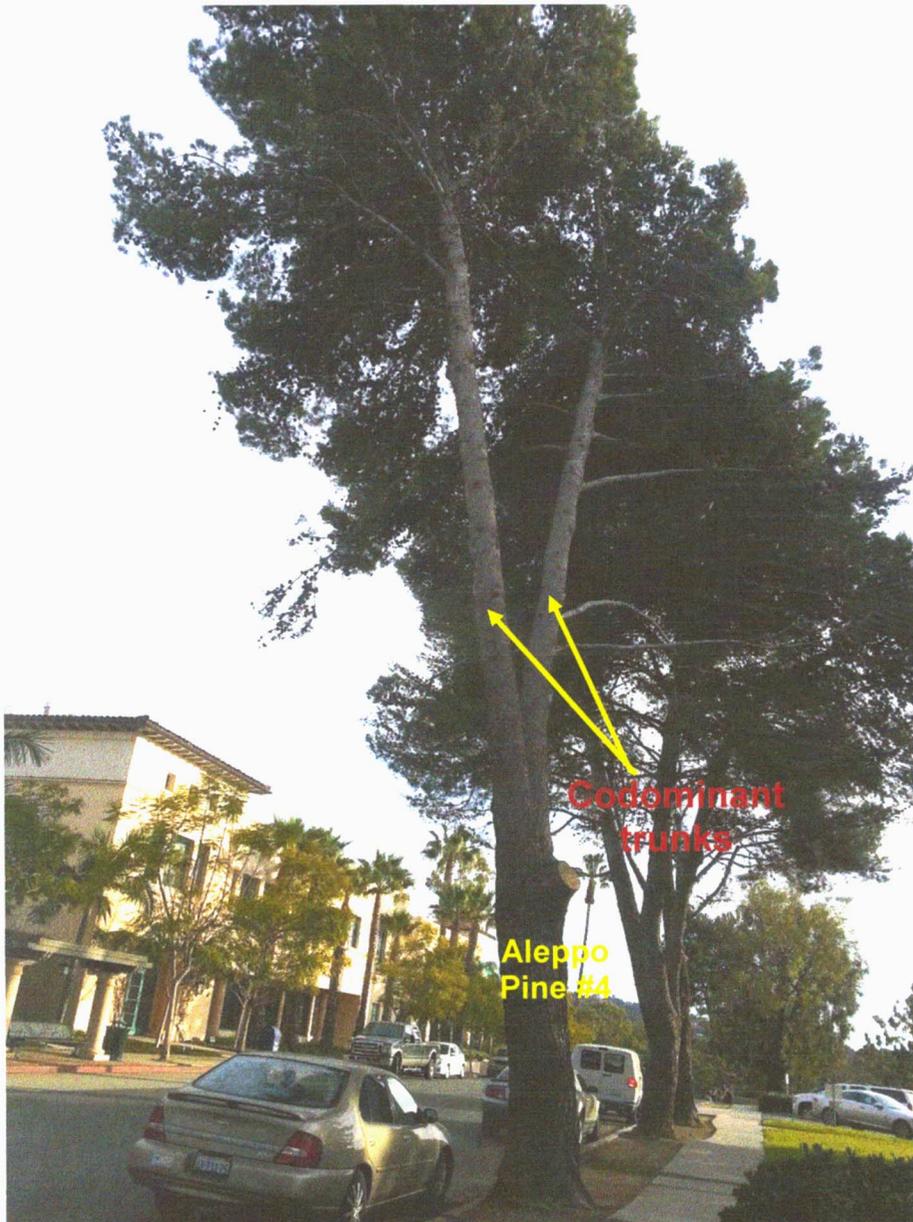
Ninety percent of the CRZ consists of lawn and pavement. All exposed soil is compact and bare. Recent site disturbance includes the failure of an Aleppo Pine 20 feet to the north. The subject pine has a major asymmetrical canopy and leans east. Co-dominate stems of equal size occur at approximately 15 above ground level. Approximately 90% of the north and east side of Aleppo Pine's canopy has been removed and/or failed leaving two southeast leaning trunks. Consequences of failure are high.

Figure 5: North view of Aleppo Pine #4 in Pesetas Lane parkway. The Pine has two large co-dominant trunks, a low Live Crown Ratio and poor symmetry (Christman, 2015).

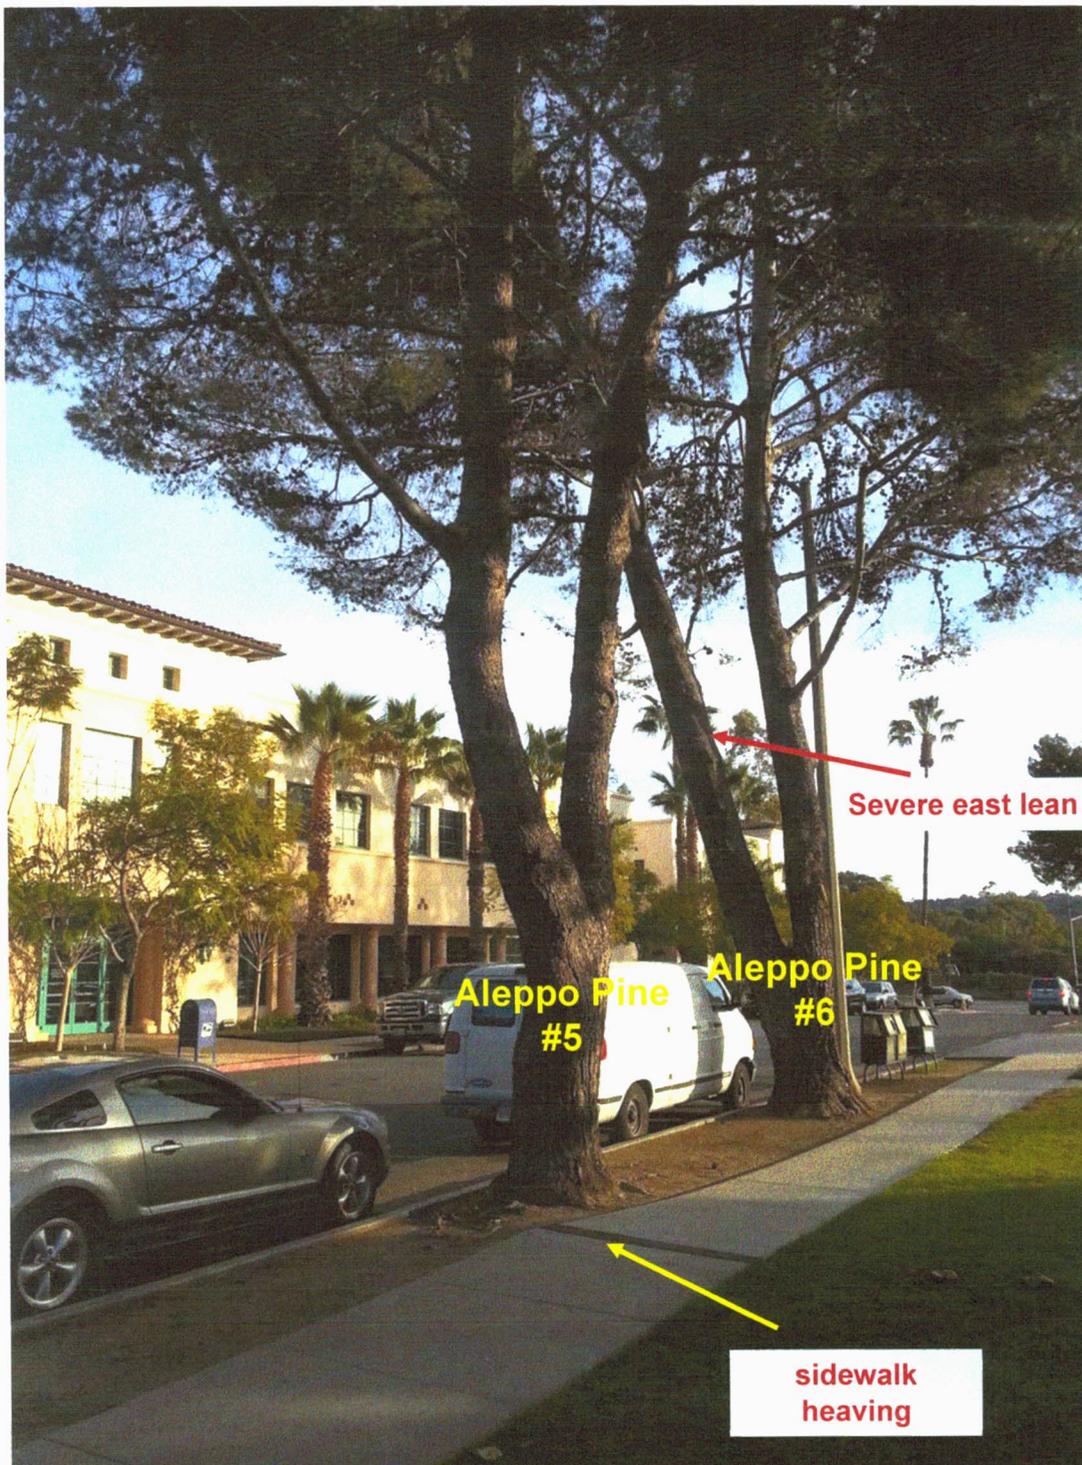
Aleppo Pine #5 has co-dominant stems that lean west toward the clinic and east over the roadway and sidewalk. Visual defects include heavy branch end weight and a low **live crown ratio (LCR)**, major dead interior foliage and an asymmetric canopy. It has a heavy pine cone crop.

As with the other subject pines, it is in a narrow public parkway with bare compacted soil. Sidewalk heaving to the west and a cracking curb was noted. **Fruiting bodies** of possible decay organisms were also growing west of the subject tree's root crown. Consequences of failure are high.

Aleppo Pine #6 is 15 feet south of Aleppo Pine #5 within the same parkway planter. It has a co-dominate trunk with the southernmost branch leaning severely east over Pesetas Lane. Branch ends are heavy and there is extensive interior canopy dieback. Foliage color is yellow-green with the west canopy being the sparsest. Trauma within the CRZ includes the replacement of the sidewalk to the west. Five roots approximately 6 inches in diameter appear to have been removed from the west root crown. Consequences of failure are high.

Figure 6: Northwest view of Aleppo Pine #5 and #6 in Pesetas Lane parkway. Pine #5 has codominant trunks and heaving sidewalk. Pine #6 also has codominant trunks with one leaning towards street. (Christman, 2015).

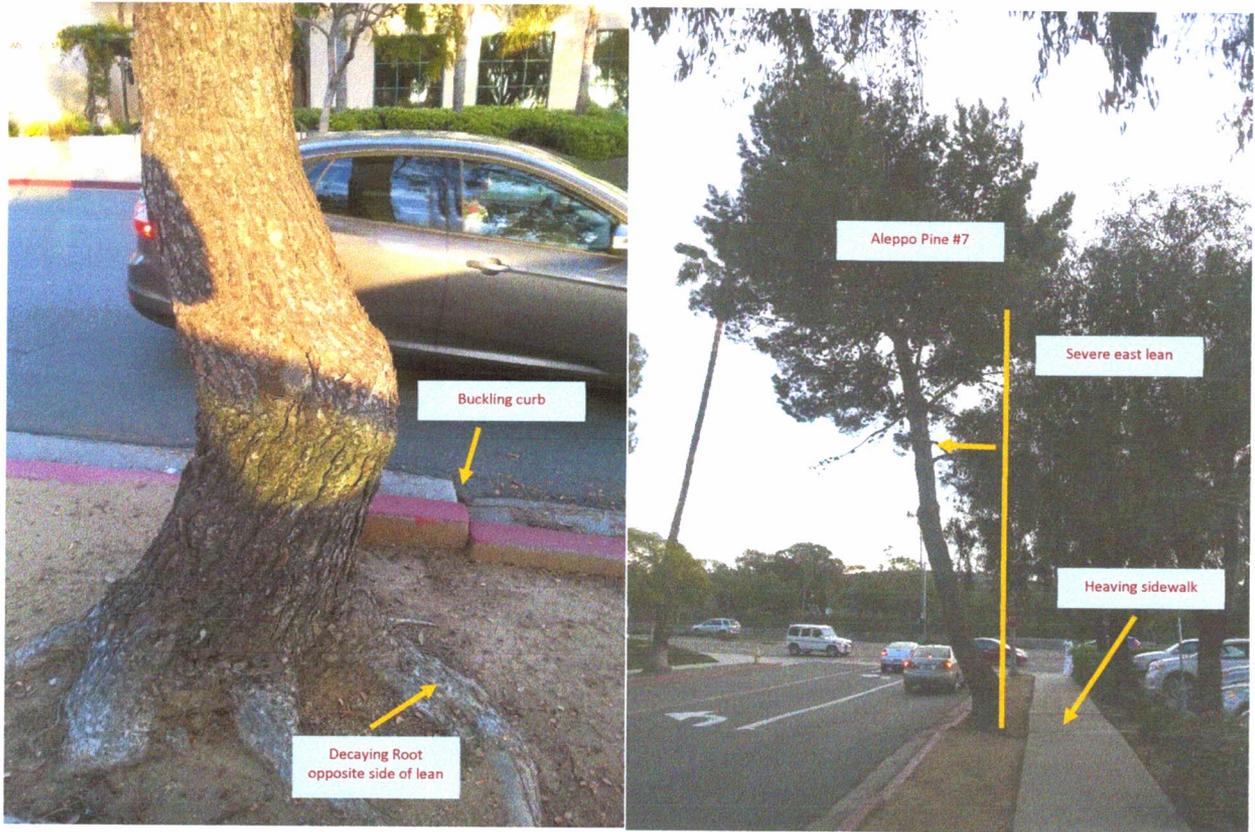
The southernmost subject Pine has several defects of concern. It has major asymmetry and a severe eastern lean over the roadway and fire lane. Aleppo Pine #7's trunk has a **reverse taper**, fiber buckling and dog-leg/elbow occurring at approximately 3 feet above ground level where two wounds are being **compartmentalized**. There is no recent callous development. Ninety percent of the foliage is in the upper canopy. There is **flagging** and extensive interior dieback. Ninety percent of the CRZ is under pavement and competing vegetation. The sidewalk and curb are heaving. The parkway soil is bare and compact.

Figure 7: Aleppo Pine #7 located on the south end of Pesetas Lane has a severe eastern lean and trunk bulge close to ground level. Curb heaving is evident. It has a low Live Crown Ratio (Christman, 2015).

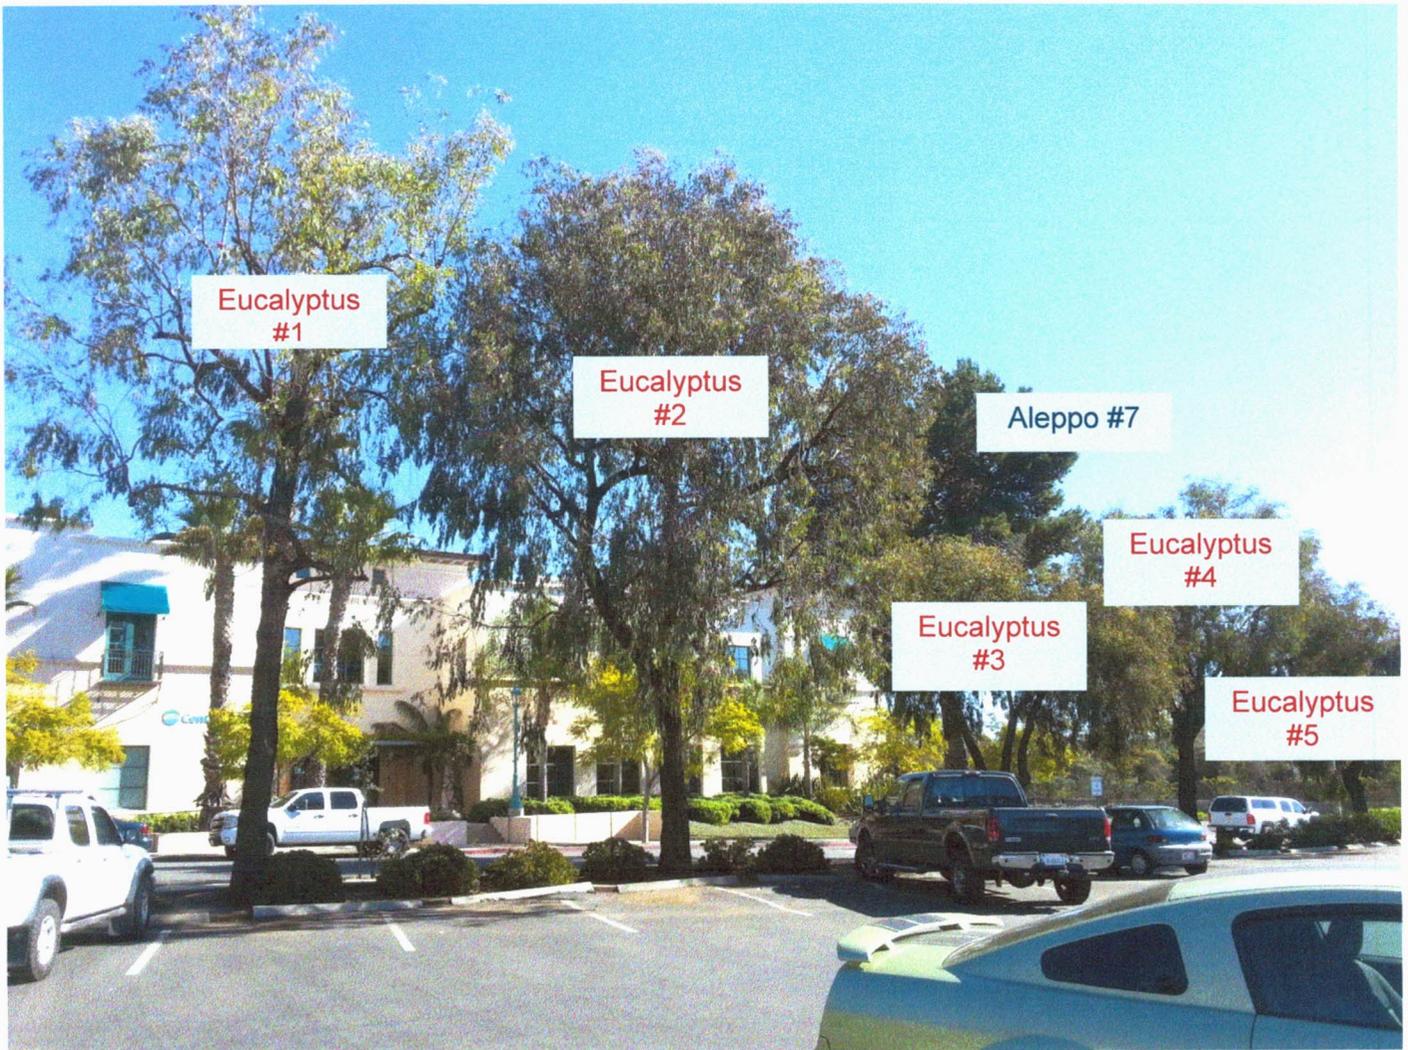
The five subject Eucalyptus run parallel to Pesetas Lane in the southeast campus of Sansum Clinic property. They are within the setback at the edge of the parking lot. Ninety percent or greater of their CRZ's are under pavement. There is visual evidence of asphalt cracking and heaving. Exposed areas consist of landscape plants and bare soil. They provide shade to several east pointing parking spaces.

Figure 8: western view of Eucalyptus #1, #2, #3, #4, #5 within the Pesetas Lane setback, overhanging Sansum Clinic parking lot. Aleppo Pine #7 located within the parkway is in the foreground. Eucalyptus #1 has a sparse canopy. Eucalyptus #3, #4 & #5 are stunted (Christman, 2115).

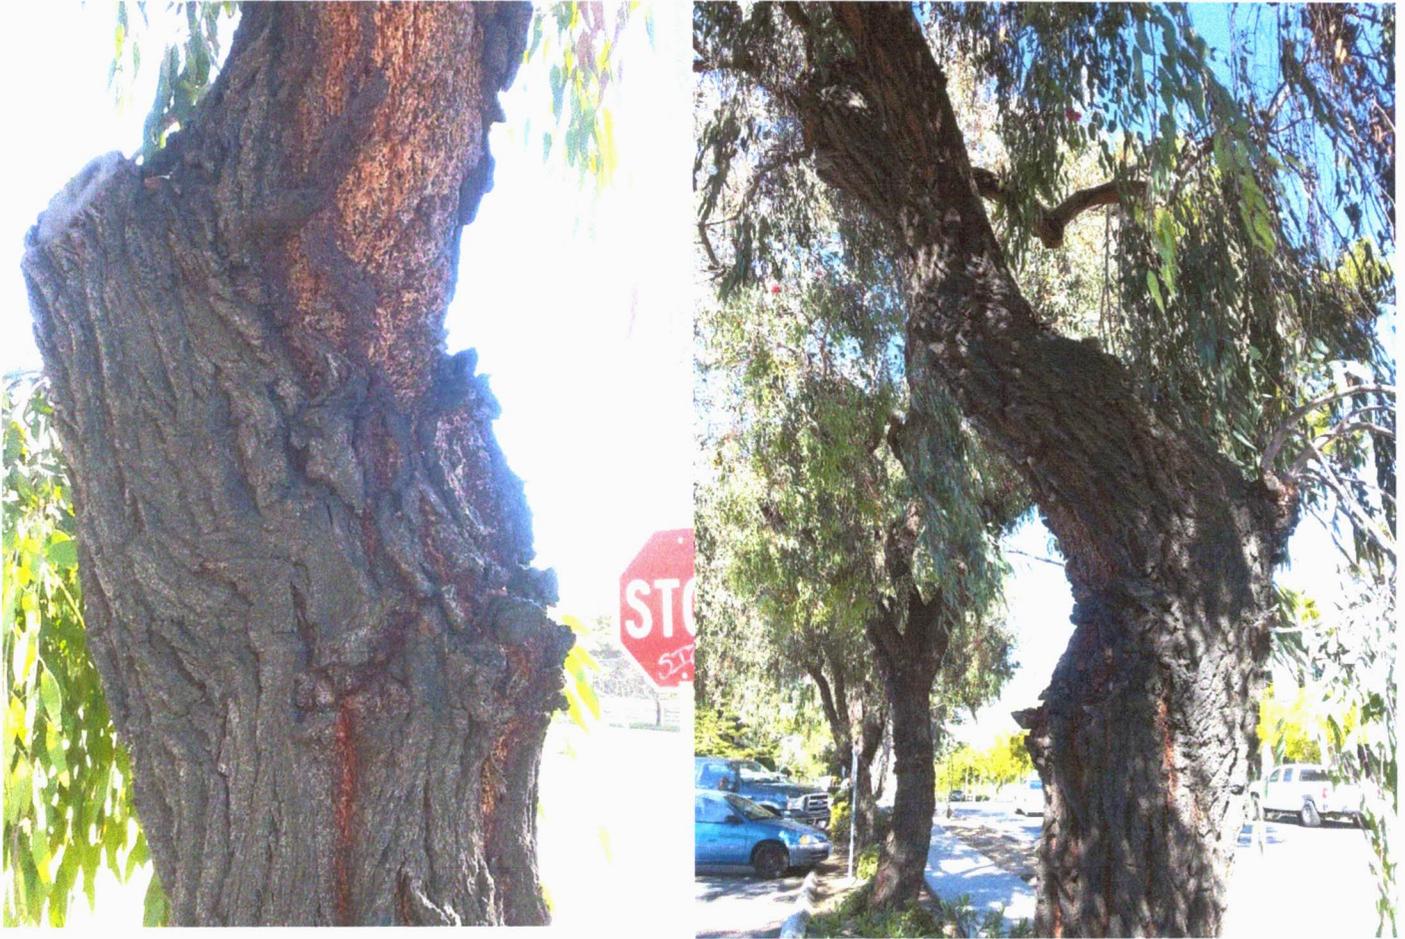
Overall, the Eucalyptus is stunted with significant dieback in the upper north canopy. It is asymmetrical and leans over the parking lot. The trunk is twisted. It has a co-dominant stem 15 feet above ground level. There are wounds, stubs, and a reverse taper in the lower seven feet of the trunk. Dense oleander surrounds the tree. Consequences of failure are high.

The subject Eucalyptus are in poor overall condition with a high Hazard Rating. They have numerous structural defects including trunk defects, sparse canopies and reverse tapered trunks. Eucalyptus #5 (Figure 9), for example has possible internal decay and is structurally asymmetrical. The Red Gum Eucalyptus, a fast growing species is known for shedding limbs even under calm weather conditions. It is the assessor's experience that they are not ideally suited for parkways and parking lots with frequent/constantly occupied Target Zones.

Figure 9: Structural trunk defects and oozing of Eucalyptus #5 located in southeast Pesetas Lane setback (Christman, 2015).

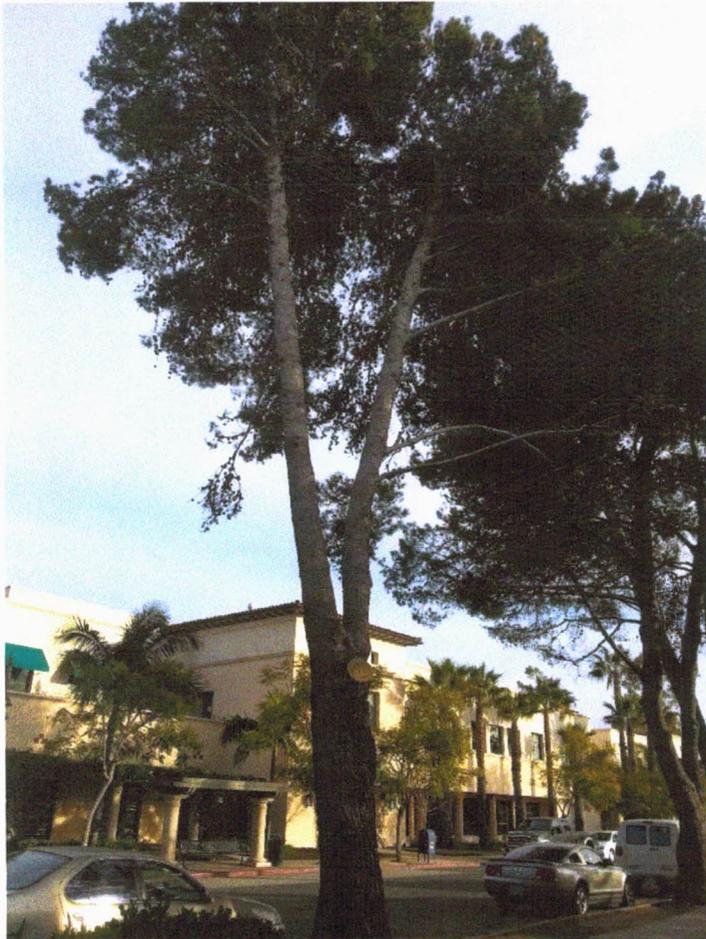
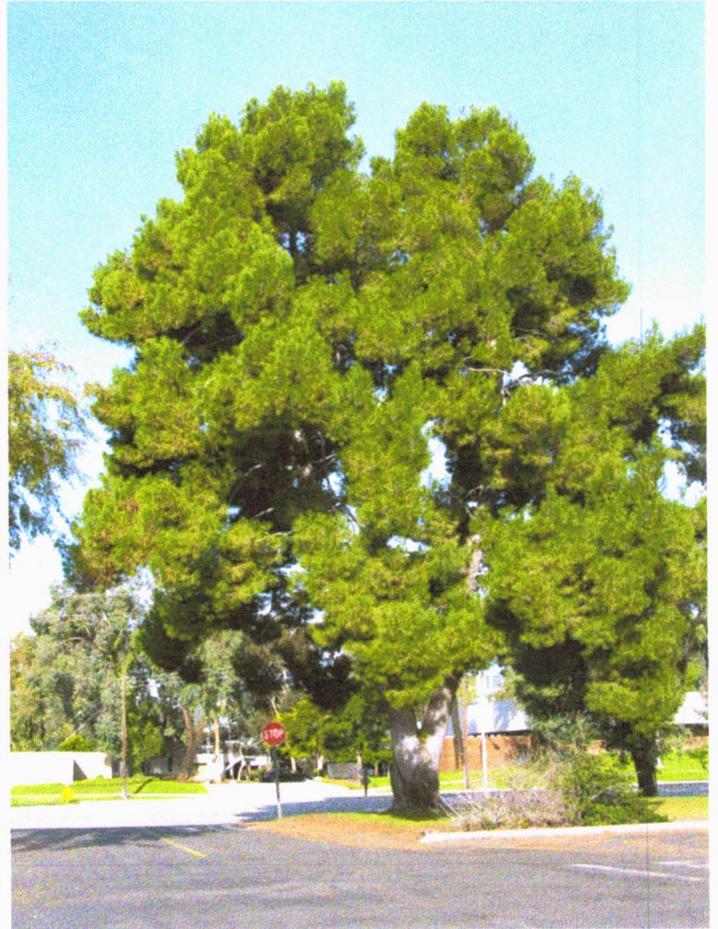
The low LCR's seen in the subject pines also cannot be reversed or corrected. As depicted in Figure 10, the evergreen pines cannot regenerate lower canopy growth. The LCR, a ratio of live crown to overall tree height determines a tree's ability to distribute stress from force. Trees with low LCR have a relatively higher failure rate in high wind events, according to Matheny & Clark (1994). This could have been one factor contributing to the failure of the fallen Aleppo Pine inspected at the time of this report.

Compared to a healthy Aleppo Pine of the same age range, as seen in Figure 10, the foliar density of the subject trees is notably diminished with a high percentage of deadwood. Canopy dieback in all of the trees is indicative of 1) root zone damage/restriction and/or 2) drought stress. As noted in the Observations, root pruning and surface root removal within the CRZ's was highly probable when the sidewalk as replaced on Pesetas Lane. Large root loss is detrimental to tree anchorage, stability and carbohydrate storage. Fine root loss impacts nutrient and water uptake. The narrow planters and high percentage of hardscape within the Aleppo Pine root zones are restrictive for optimum root growth. These factors combined with the current drought will continue to impair Pine vitality.

Figure 10: Aleppo Pine # 4 has a low live crown ratio with most of the branch weight on the ends. The Aleppo Pine in right hand photo (courtesy CalPoly, San Luis Obispo Urban Ecosystems Institute) has a live crown ratio of nearly 100%.

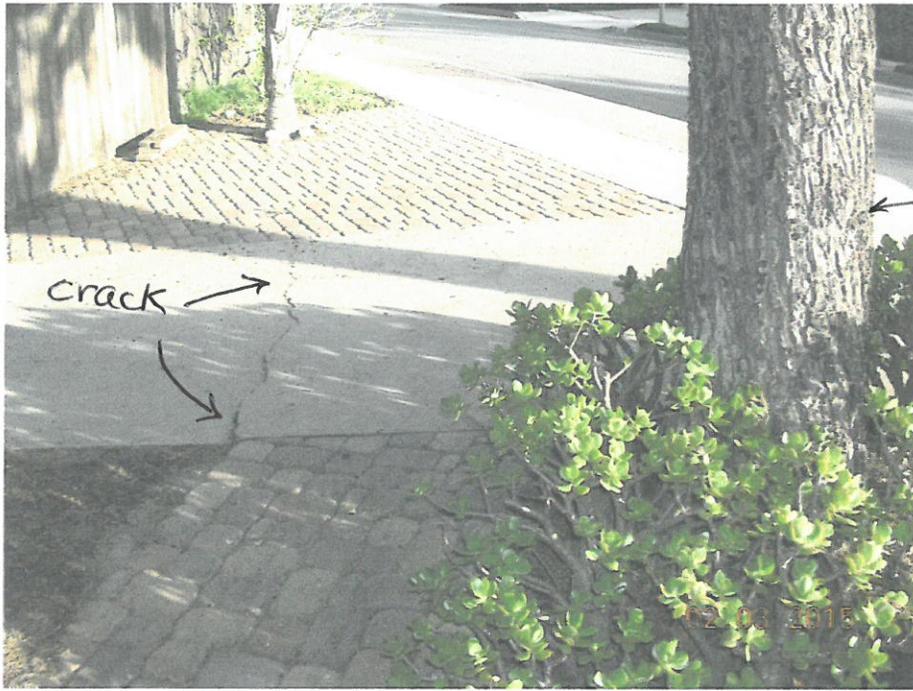
crack →

tree to be removed if permit is issued

Tree roots are lifting and cracking driveway, and growing under house, blocking bathroom drain and requiring frequent (almost monthly) repeated routing of drain.
