# Santa Barbara Airport

August 24, 2023

Conditions and Further Use Analysis Study for the General Western Aero Hangars,  
Buildings 248 & 249.

LMA Architects

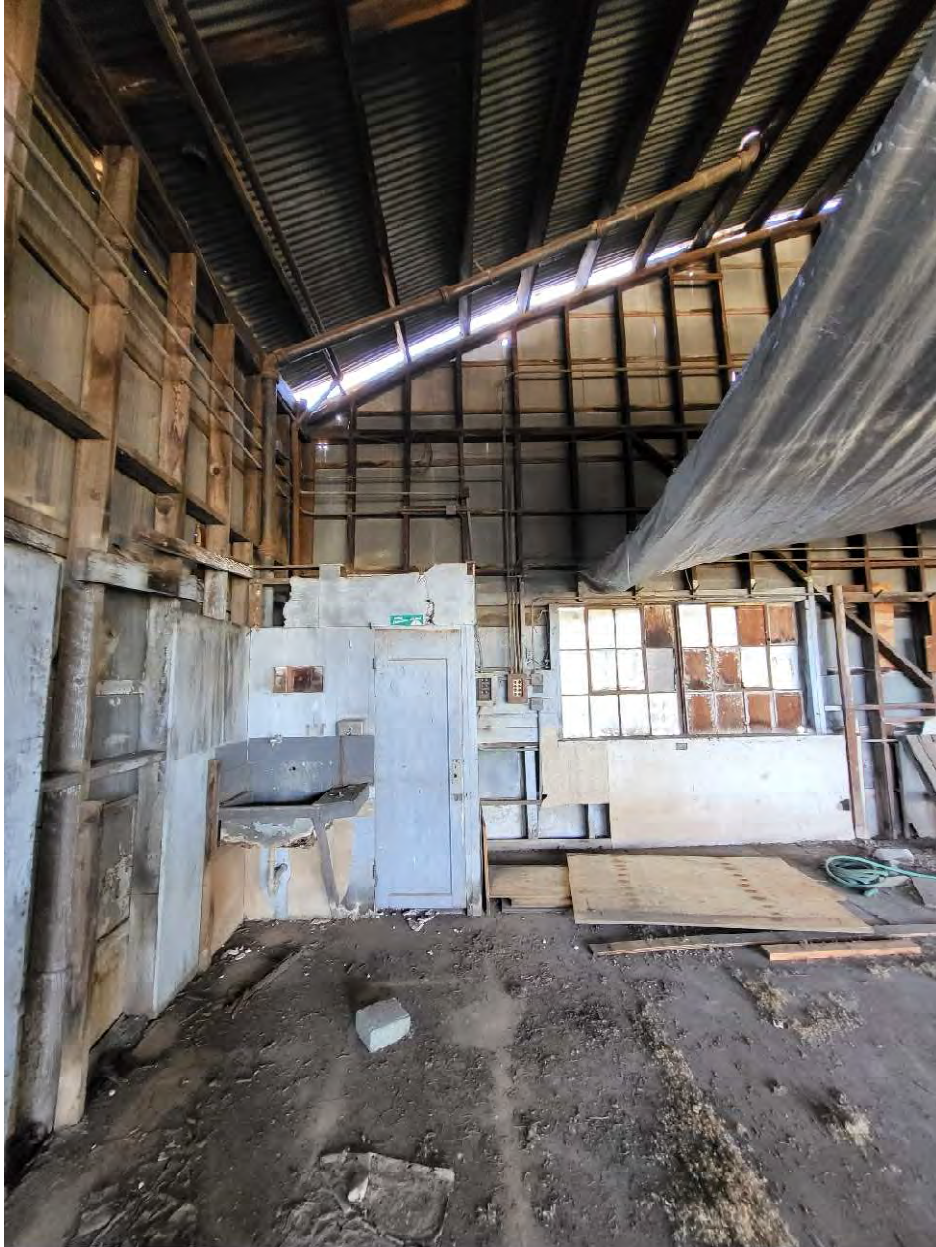
In 2022 Praxis Engineering observed that Building 248 is in poor structural condition. It sits on a downward slope within the San Pedro Creek floodway, and the exterior walls are subject to water exposure. The current finished floor height is below the existing Base Flood Elevation (BFE), resulting in deterioration at the base of the walls and sill plates. The southwest section of the roof has failed along the 80-foot wood trusses. The west side of the roof is damaged from deflection (Praxis Engineering 2022:4).

**BUILDING 248 – ROOF CONNECTION DISPLACEMENT**

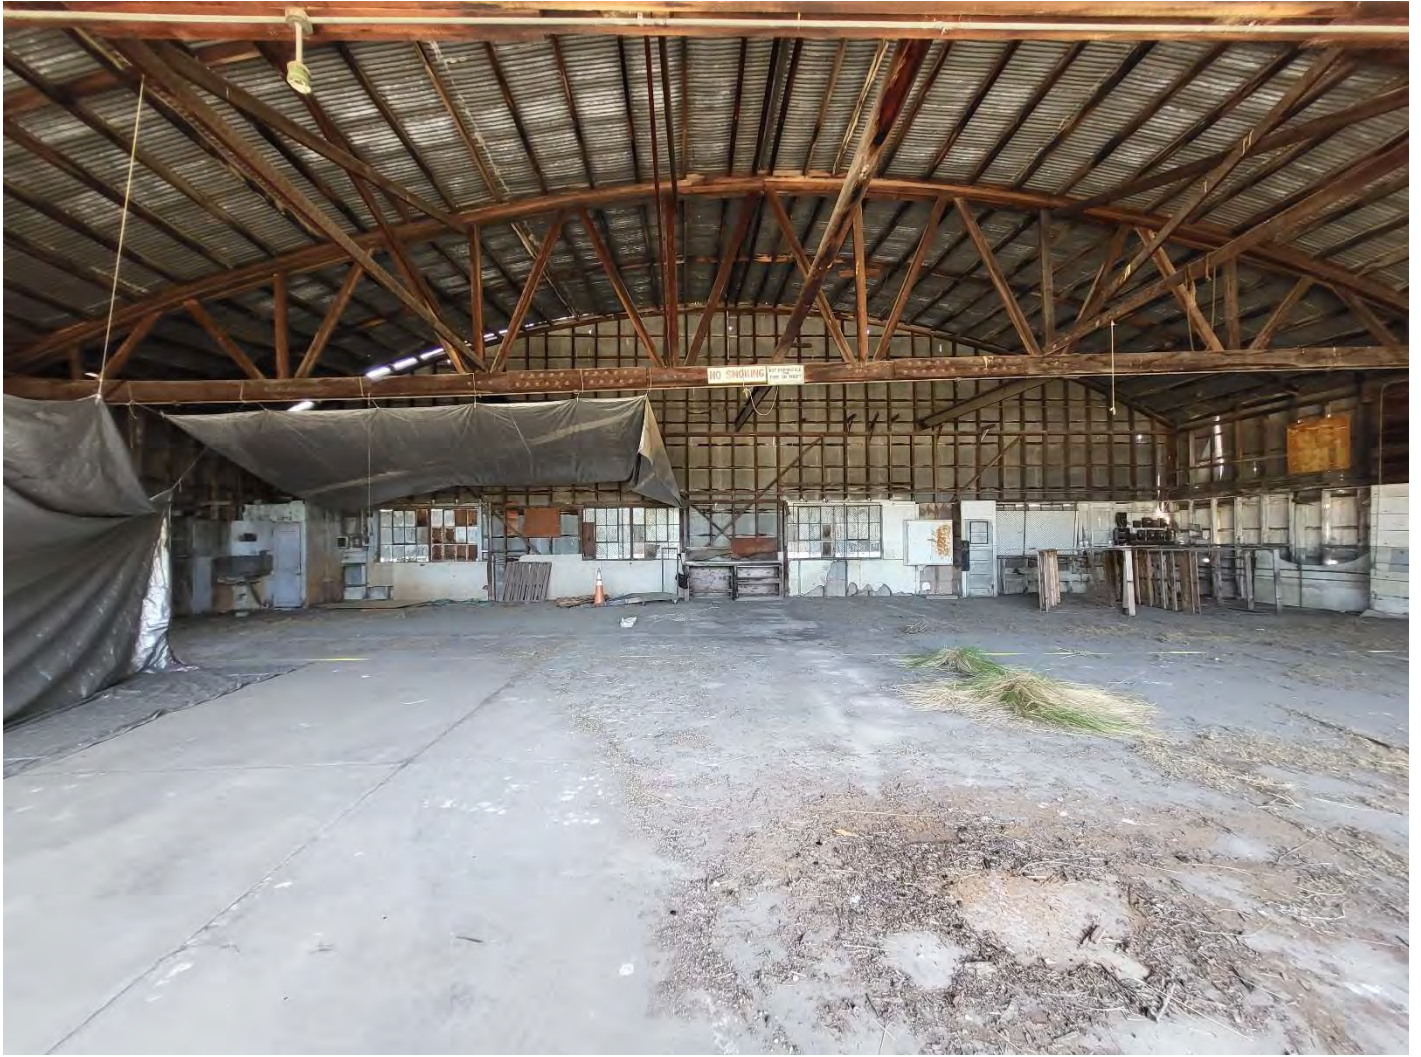
**BUILDING 248 – BOWSTRING TRUSS**

All roof rafters, walls, metal sheathing, and associated connections will need to be removed and either reinstalled following repair or replaced following the reset of the trusses. A reset is required as the two primary roof trusses can no longer support the applied loads. For stability of the trusses, additional members should be sistered on or vertical supports should be added (Praxis Engineering 2022:4).

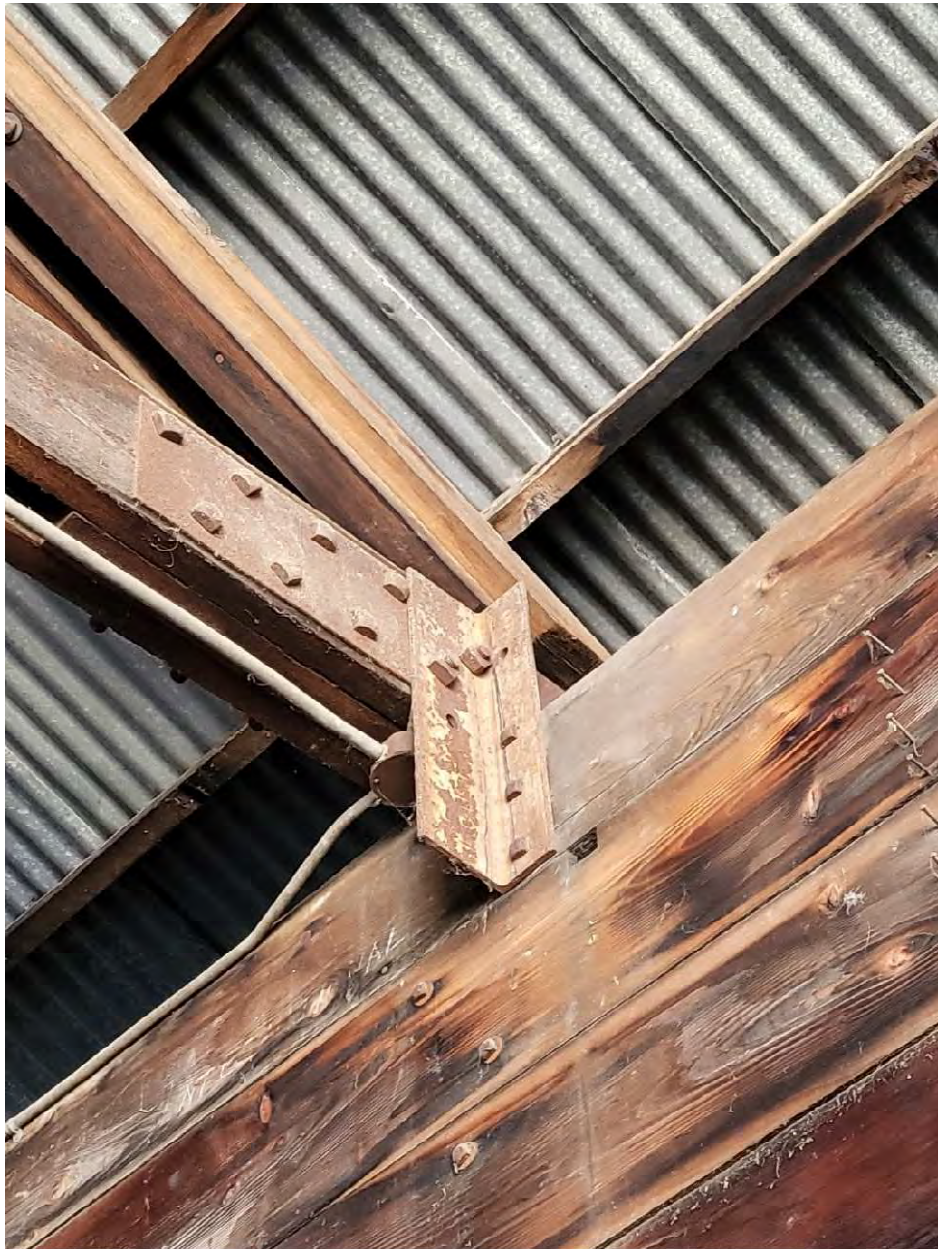
**BUILDING 248 – BOWSTRING TRUSS EASTERLY CONNECTION**

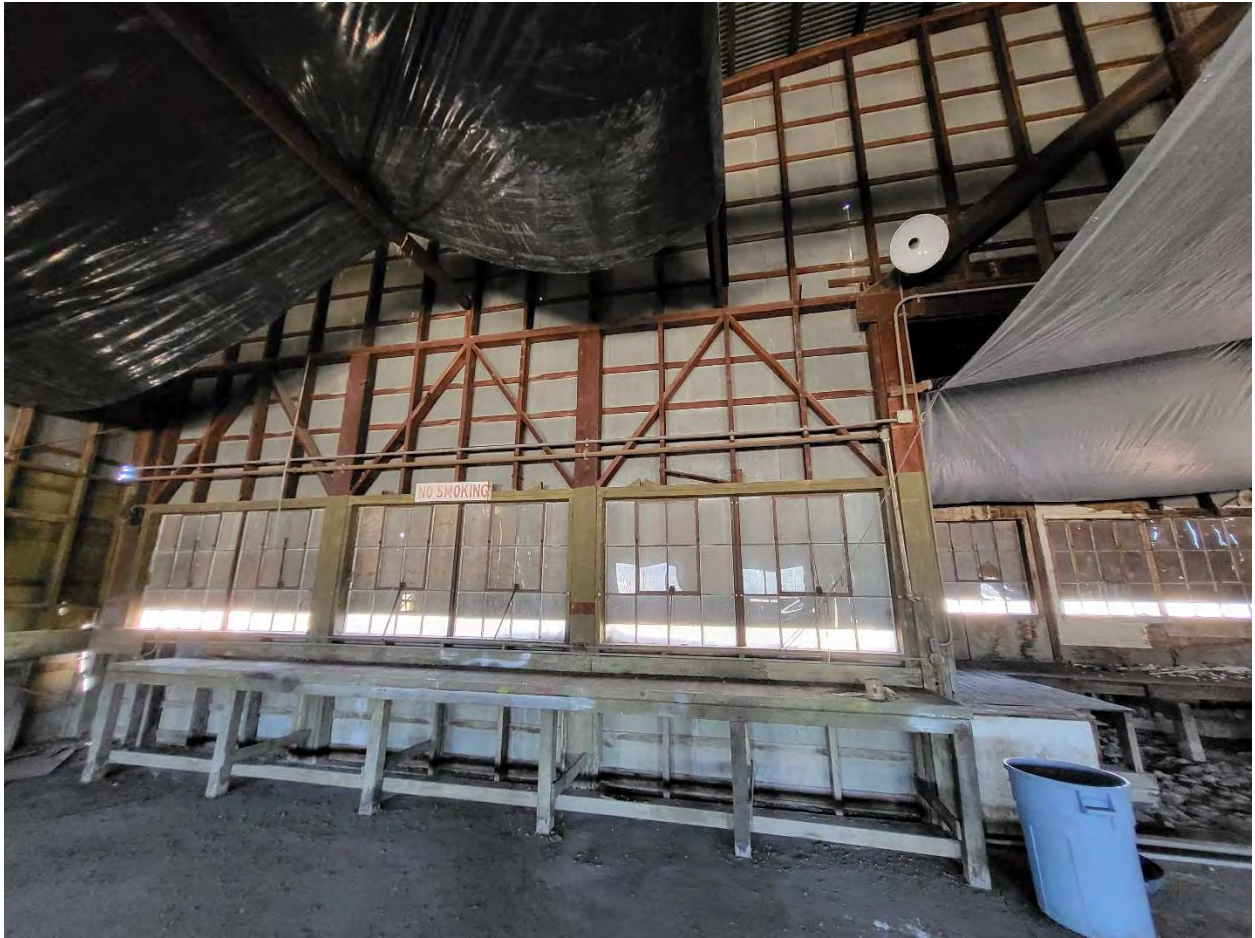
**BUILDING 249 – LET IN WOOD BRACES**

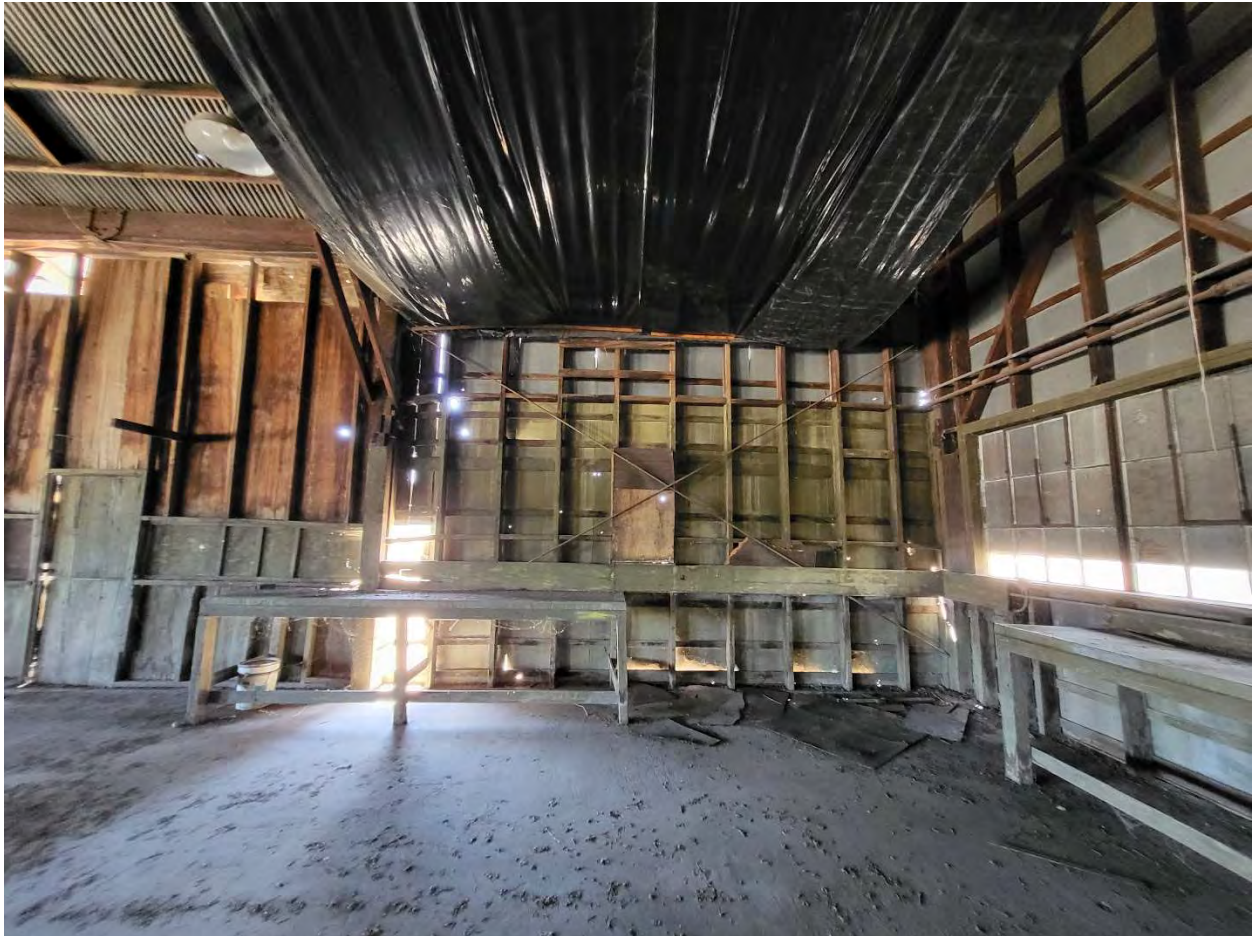
Building 249 is in fair structural condition. It is also on a downward-sloping site within the San Pedro Creek floodway, and the exterior walls are subject to water exposure. However, the lower portion of the northerly wall has a concrete flood wall that protects the hangar from deterioration, failures, and fatigue caused by water exposure as seen at Building 248 (Praxis Engineering 2022:7). The walls on the gabled ends require bracing with added members to span between the braces. Praxis Engineering recommends using a beam parallel to the wall anchored to the wall with braces or horizontal rod braces (Praxis Engineering 2022:8).

**BUILDING 249 – ROD DIAGONAL BRACES**
