OAK TREE ASSESSMENT AND PROTECTION PLAN FOR 34 EAST PADRE ST.

December 12, 2013

SUMMARY

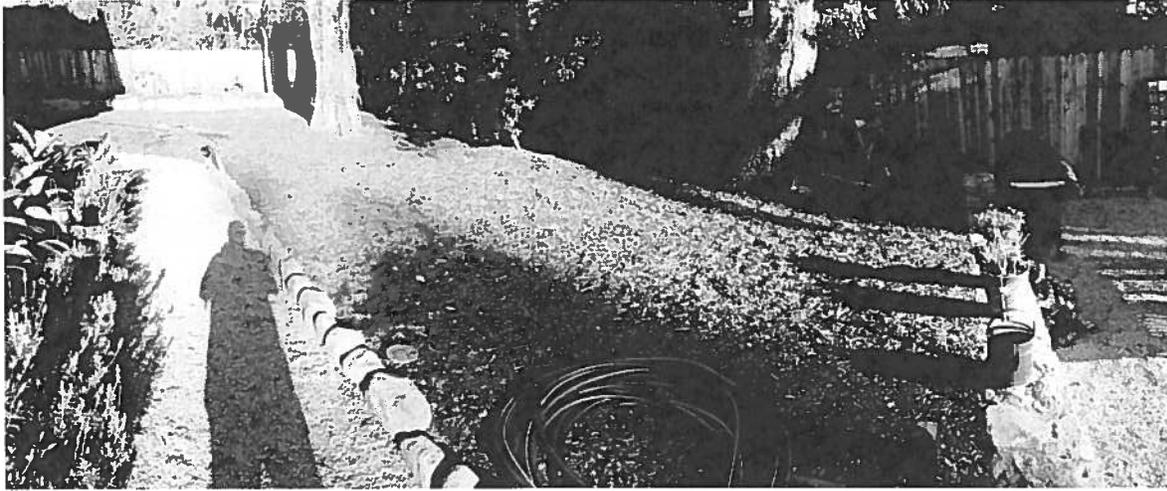
Above: A view of the ground below the oaks.
Below: The exploratory trench that was excavated.

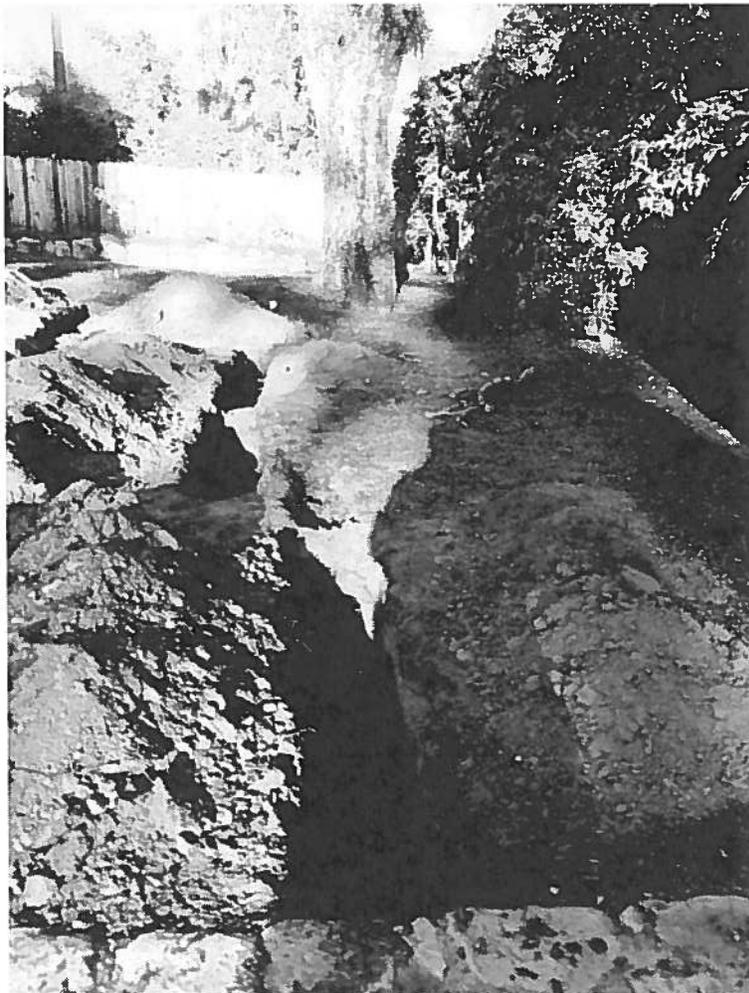
I found there to be roots from the oak, the adjacent pittosporum, and from a dead tree that once was growing in that area. The oak roots were primarily small in size, less than 1/8" in diameter, although there were several that were in the 1/2" - 1/4" range. There were many dead roots from the dead tree also in the trench. At the bottom of the trench the tops of more roots could be seen. The trench has since been backfilled.

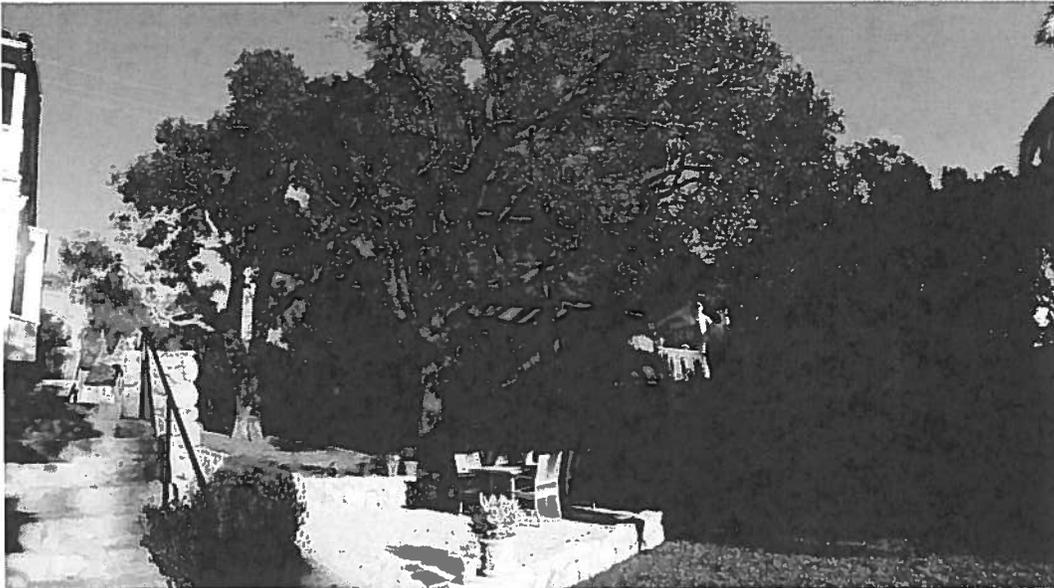
Above: View of both oaks. Although the closer tree (western oak) looks bigger, it is smaller than the back eastern oak.

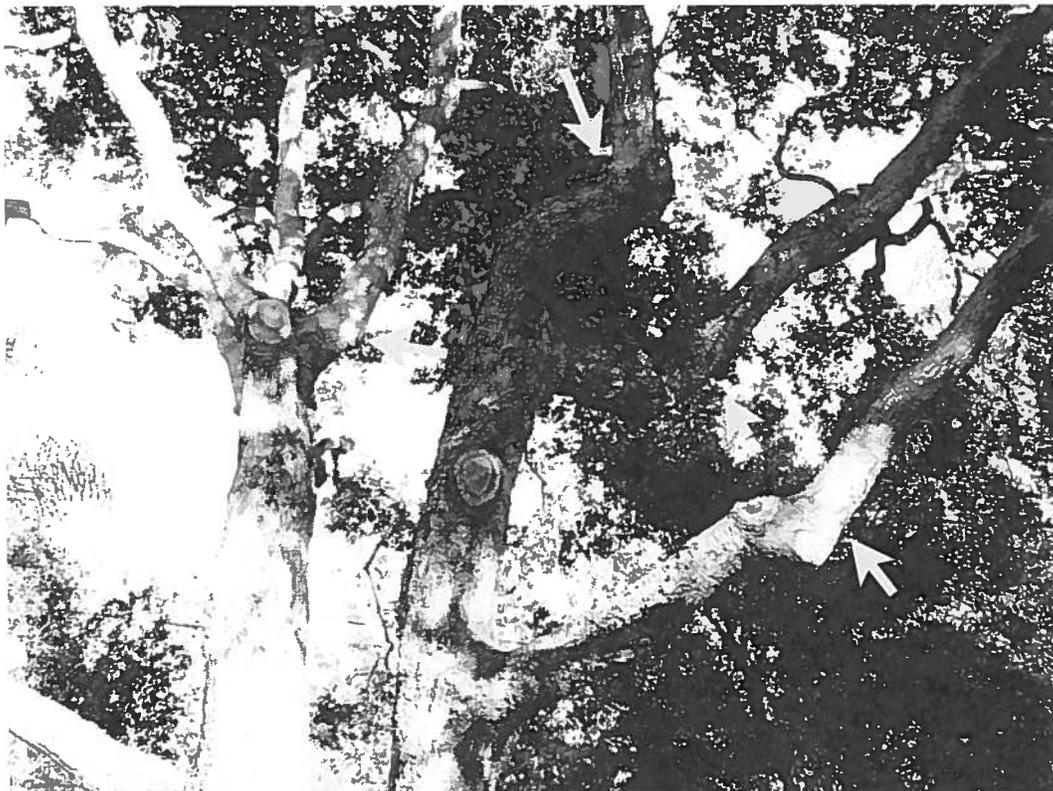
Below: Oak #1. Arrows point to the location where this tree was topped long ago. It is easier to see the differences in bark texture and age when on-site. It would be reasonable to assume that there are some internal pockets of decay.

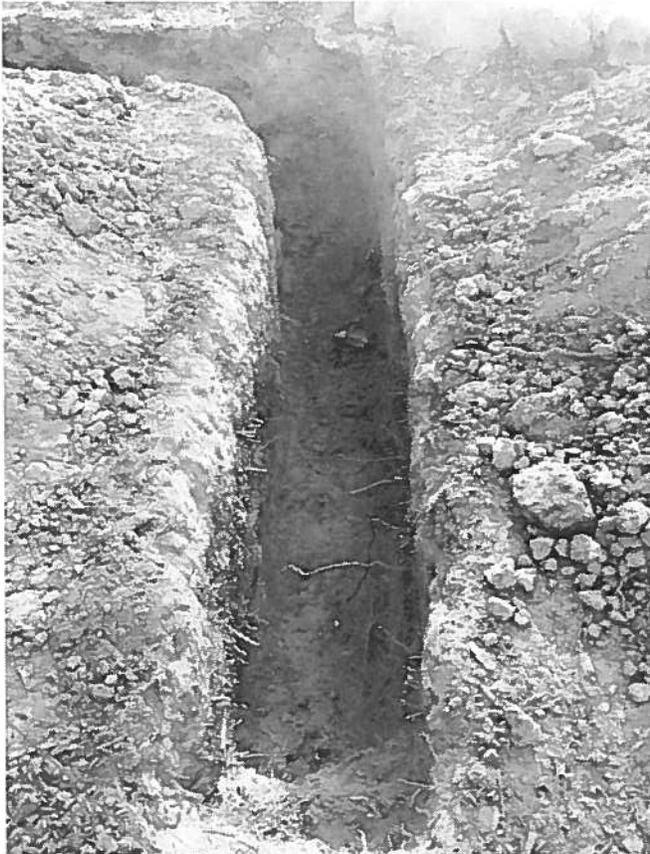
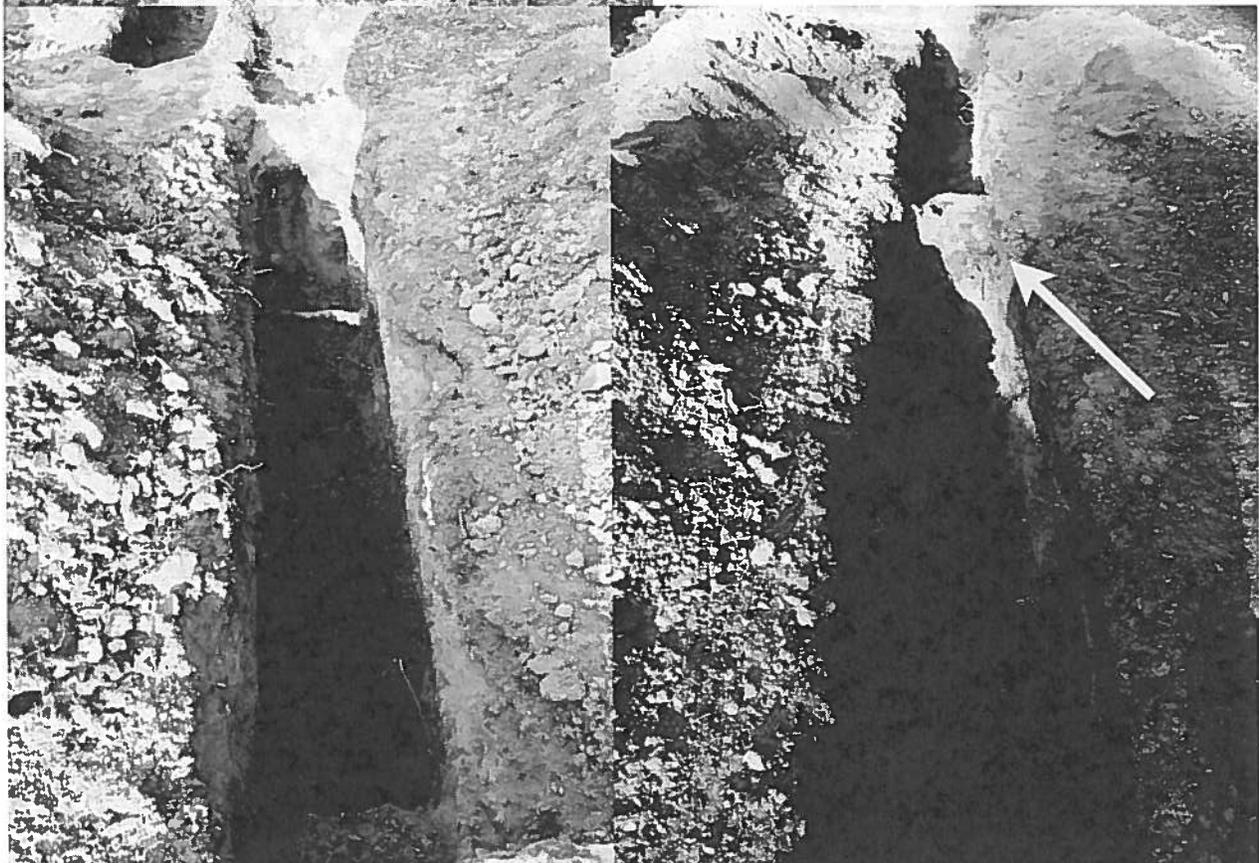
Upper left: A view of the trench looking east. Some small young roots can be observed.

Lower left: A view of the trench looking west. More roots were observed across from tree #2 although there were very few.

Lower right: Arrow points to the trunk of an old dead tree.

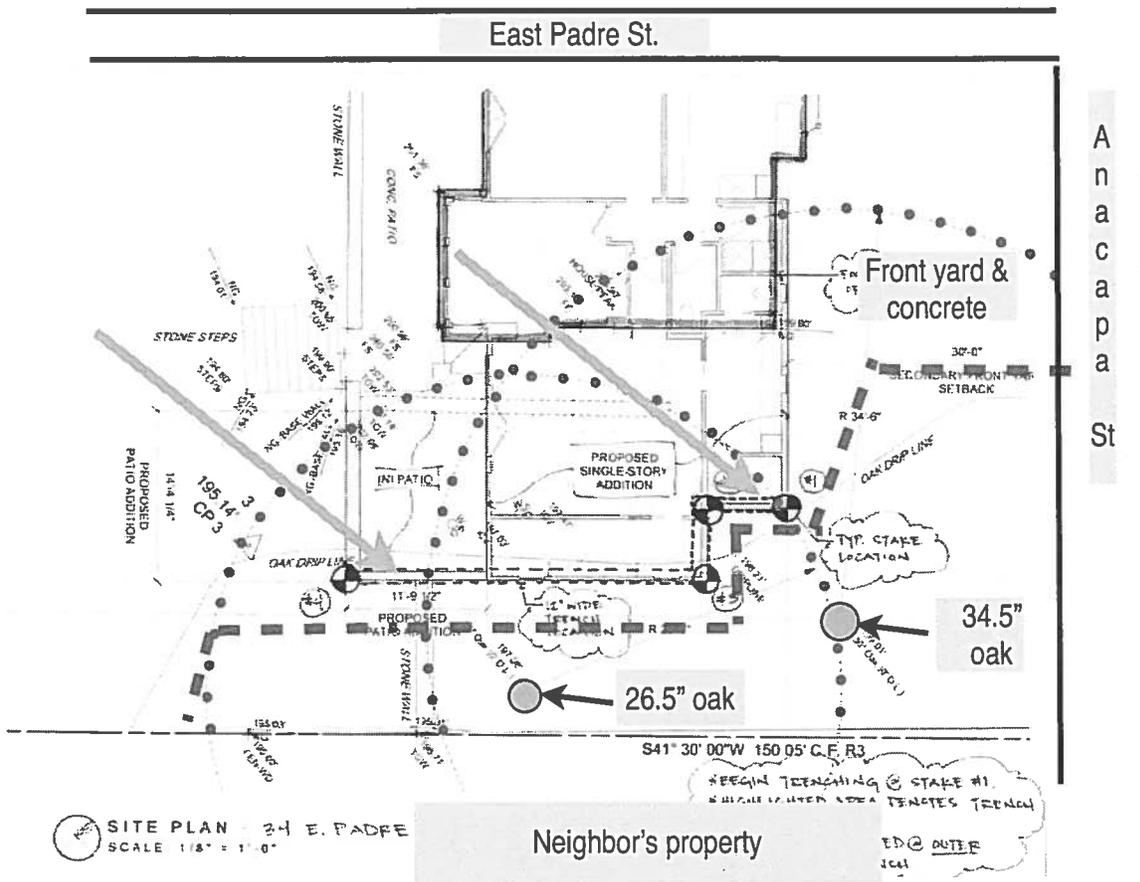
TREE PROTECTION FENCING PLAN

1. This site plan shows the proposed location of the southern footing (green arrows) and where the exploratory trench was excavated.
2. The blue dashed line is the location of the tree protection fencing. Everything to the south (below) the blue line is a tree protection zone.
3. The red dotted lines show the critical root zones of the two oaks.

1. Install fencing (orange construction type is adequate for this protect) around the tree as indicated on the site plan. Fences must be maintained in upright positions throughout the duration of the project.
