## **TREE ASSESSMENT AND PROTECTION PLAN**

**Project Site: 800 Santa Barbara St. Santa Barbara 93101**

February 24, 2016

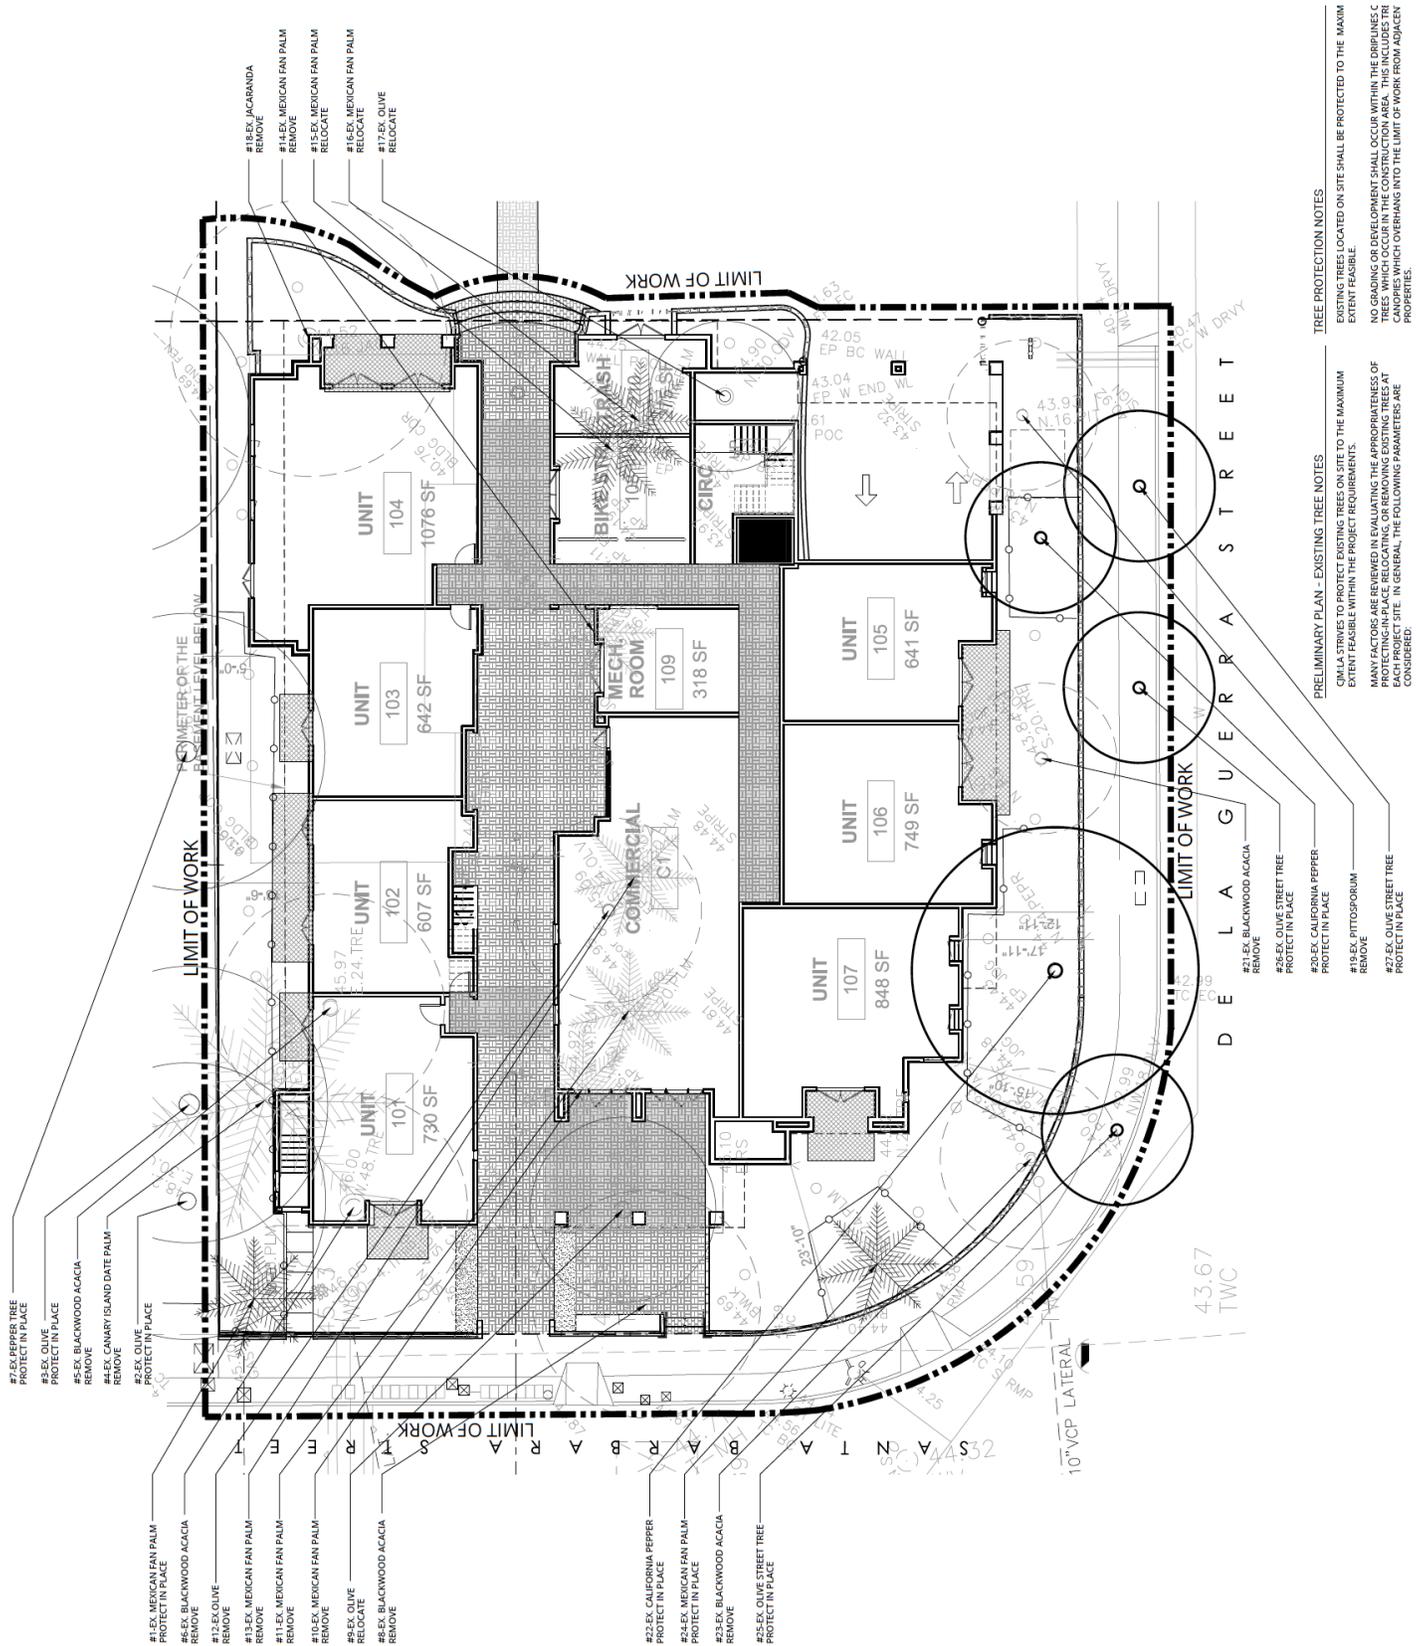
# SITE PLAN (for larger image, see pdf of Sheet L1.)

1. There are twenty seven trees within the parameters of the project. This includes twenty one trees on the subject property, three trees north of the northern property line on the Anacapa School property, and three city street trees along East De La Guerra St. The table on the next page identifies all of the trees. The site plan illustrates the tree locations by corresponding number.

- #19-EX. PITTOSPORIUM REMOVE
- #27-EX. OLIVE STREET TREE PROTECT IN PLACE
- #21-EX. BLACKWOOD ACACIA REMOVE
- #26-EX. OLIVE STREET TREE PROTECT IN PLACE
- #20-EX. CALIFORNIA PEPPER PROTECT IN PLACE
- #19-EX. PITTOSPORIUM REMOVE
- #27-EX. OLIVE STREET TREE PROTECT IN PLACE

1. Prior to commencement of work, a pre-construction meeting should be held with contractors, to discuss tree protection measures.
2. Establish tree protection zones (TPZs) by installing fences around all trees to be protected as depicted on the site plan. Use chain link, supported by metal posts driven in the ground every six to eight feet. Surface supports for fence posts are not adequate for this construction site. The fencing should be as far from the trunk as possible, at the outside edge of the work zone. Space should be available around the work zone for access by workers but not more than absolutely necessary.
