Bill Spiewak
 CONSULTING ARBORIST
 Registered Consulting Arborist #381 • American Society of Consulting Arborists

RE: 1298 Coast Village Rd. eucalyptus trees

RE: 1298 Coast Village Rd.

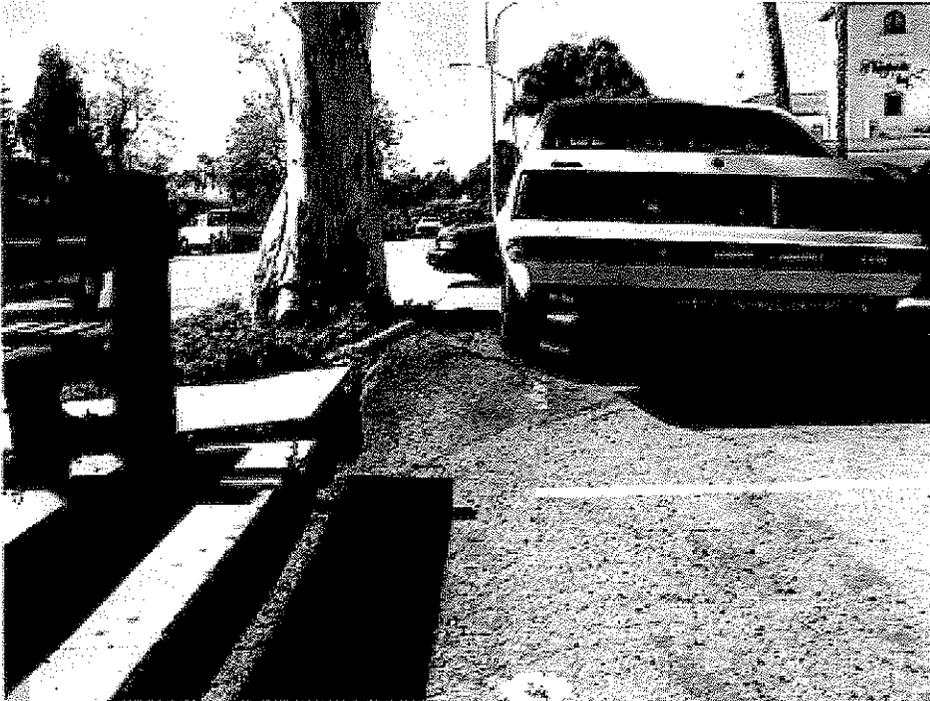
3. The tree grows in a small planter area between the asphalt parking lot and the concrete sidewalk.
4. Its root system has obviously lifted all asphalt and concrete. See photos #1 and #2.

Photo 1: View of tree #1 looking south. Note the asphalt and concrete damage from root growth.

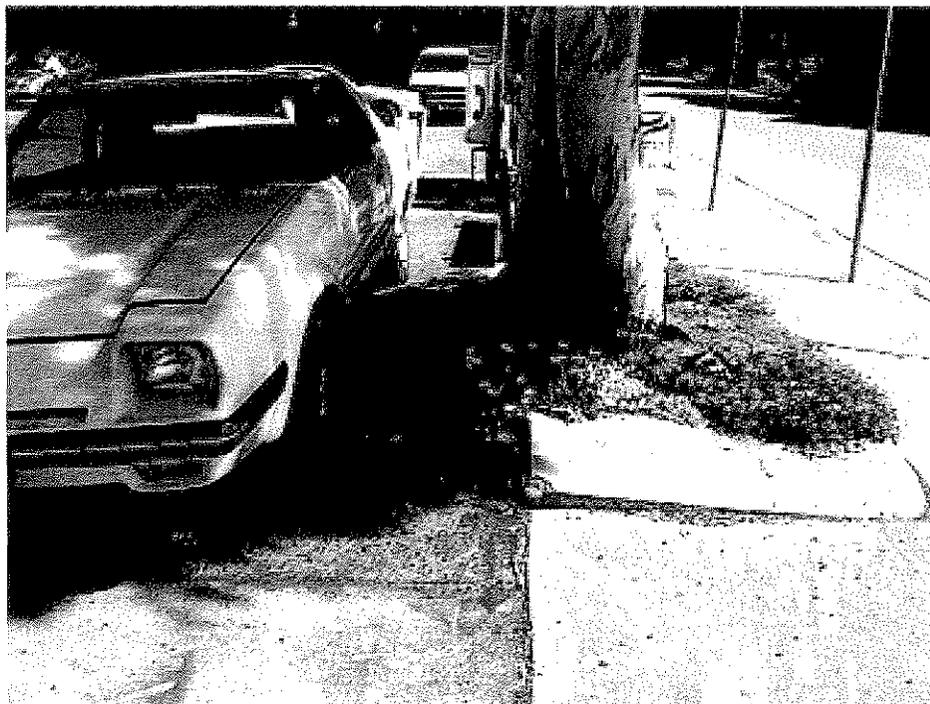
5. The project calls for an underground garage about 8' to the west of the tree.
6. At the same distance, it appears that newer asphalt was applied several years ago, in a line parallel to the sidewalk. A conversation with a mechanic at the service station indicated that a ground water remediation system was installed several years ago and the lines of the newer asphalt represents excavated trenches. He did not know the depth of the system or other details that could provide information about root cutting during that project.

Photo 2: Same tree looking north. Although not shown, the asphalt damage ends 8' to the west side of the tree where proposed construction will occur.

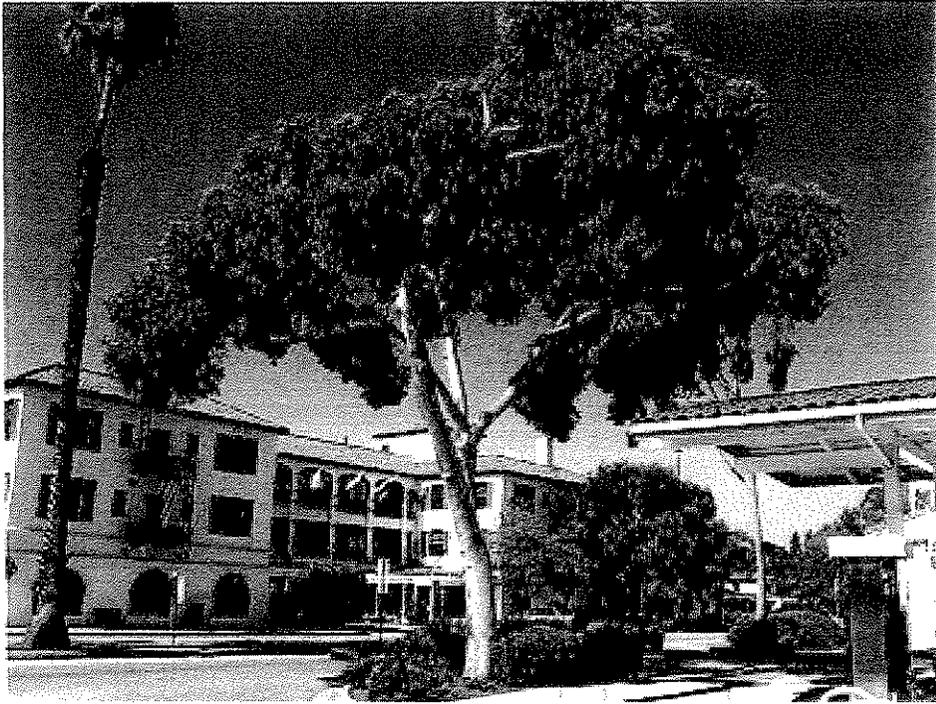
7. Tree #2 is also appears to be a Red Gum tree. It has a DBH of 24" and is about 50' tall. Although branches appear to be heavy, it is in good condition. See photo #3.

Photo 3: View of tree #2.

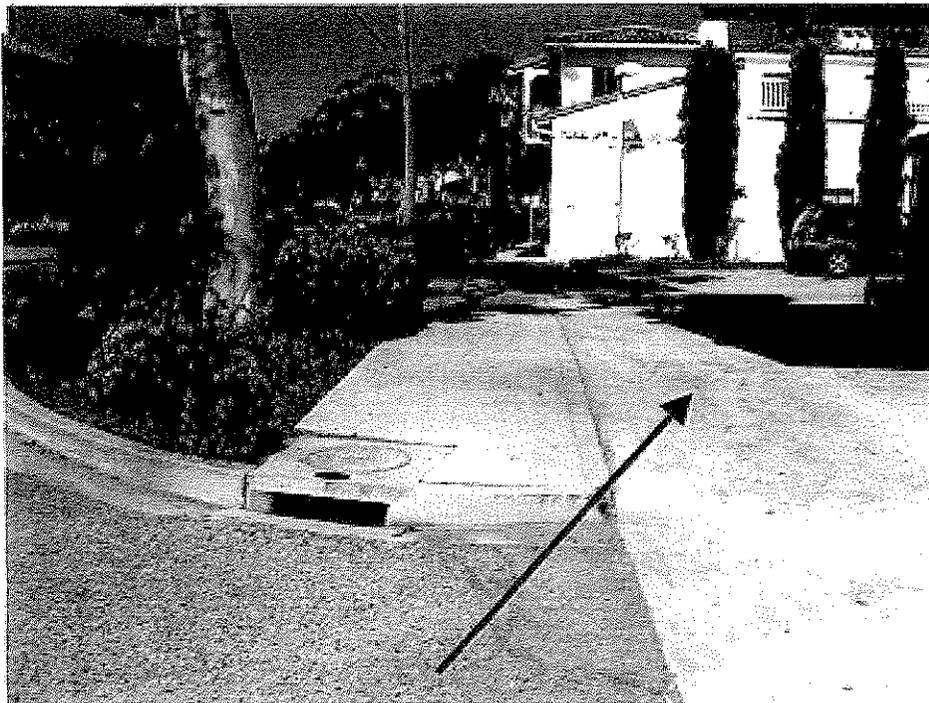
Photo 4: Note the manhole cover and storm drain on the east end of the sidewalk. The concrete by the pumps is new (arrow).

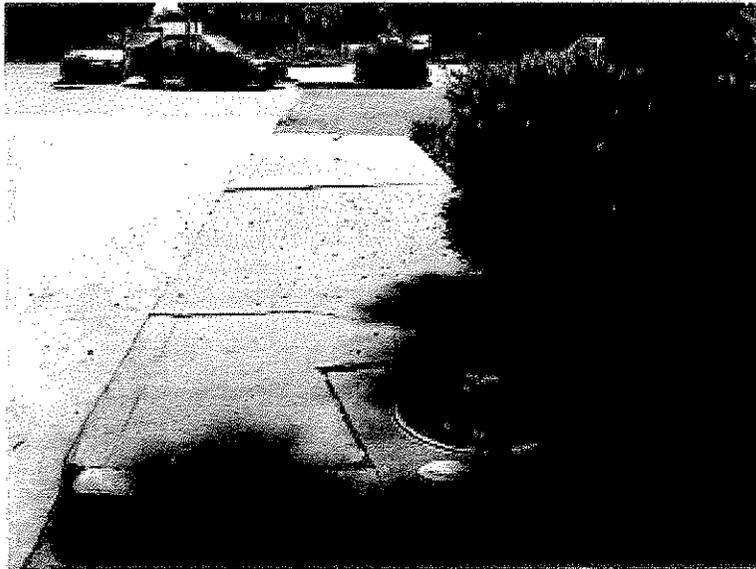
8. Eucalyptus #2 grows in a planter at the south side of the sidewalk, 3' from the edge of the concrete.
9. The concrete sidewalk (76" wide) is cracked and lifted adjacent to the tree trunk. See photos #5 and #6.
10. There is a storm water conduit that runs beneath the sidewalk. Manhole covers mark the storm strain, although I cannot see where the drain leads.
11. There are also new concrete islands in the service station, immediately to the north side of the sidewalk. There is also newer asphalt marking trenches throughout the parking lot, west of the tree.
12. The proposed underground garage will not come closer than the existing sidewalk.

Photo 5: West end of sidewalk with manhole cover and storm drain. Note cracks in concrete.

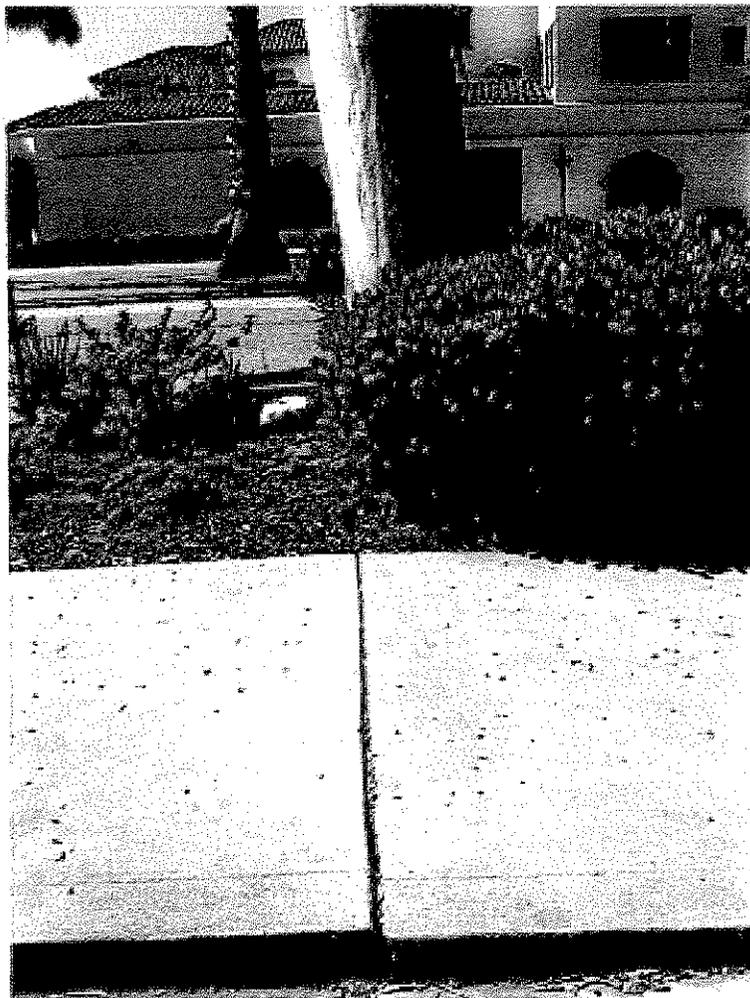
Photo 6: Lifted concrete sidewalk adjacent to trunk.

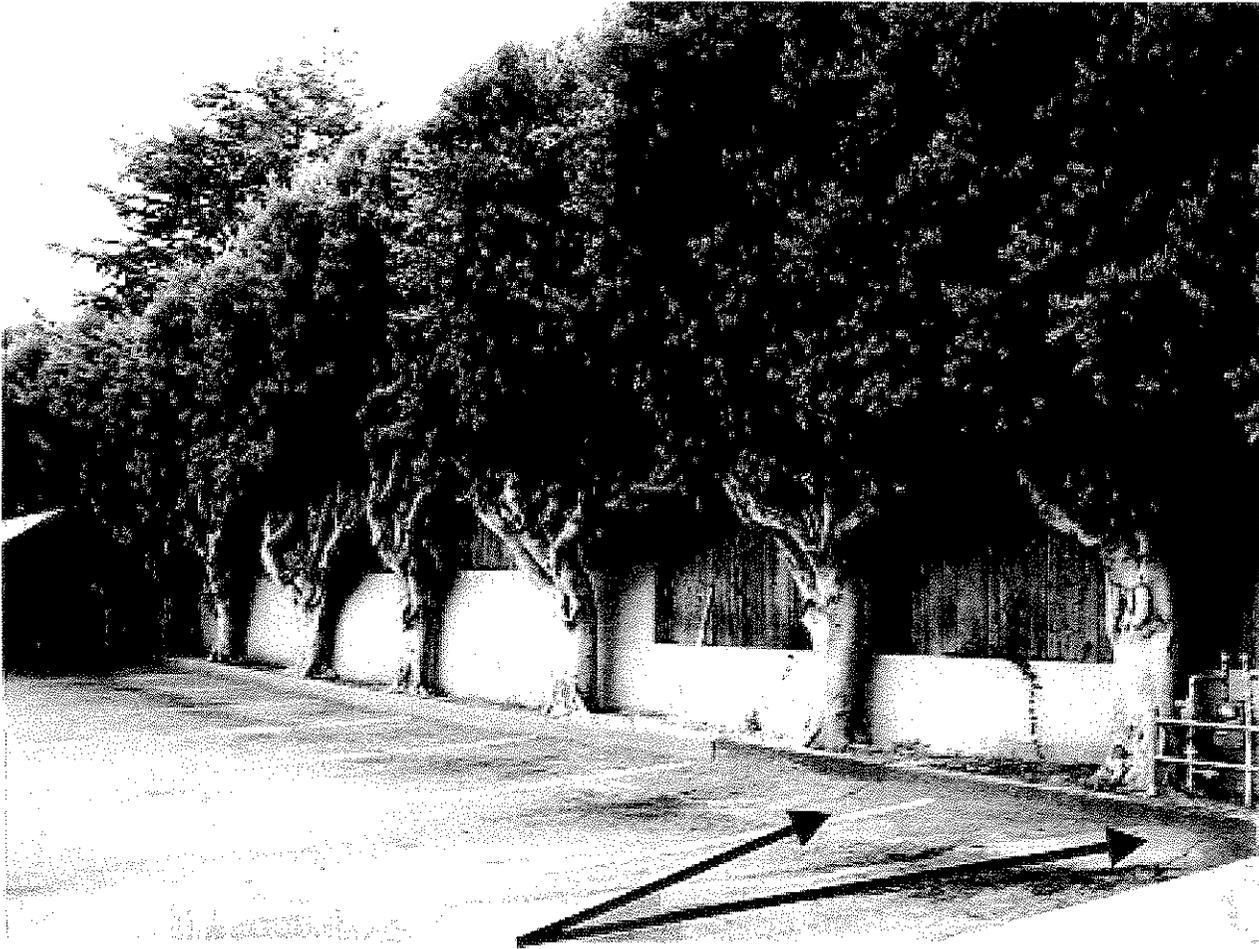
1. There are ten ficus trees (*Ficus macrocarpa nitida*) along the north property line of this parcel.
2. They vary in trunk diameter and height; between 16" and 24" in diameter, and 16' and 20' tall.
3. The trees are spaced about 8' – 10' apart.
4. They are planted in a narrow planting strip that is 32" wide. The roots abut the curb of the planter to the south and the retaining wall to the north.
5. One section of the curb is cracked and the adjacent asphalt in the parking lot has been lifted. There is a gas meter on the east side of the eastern tree.

Photo 1: View of the line of ficus. Arrows point to crack and gas meter.

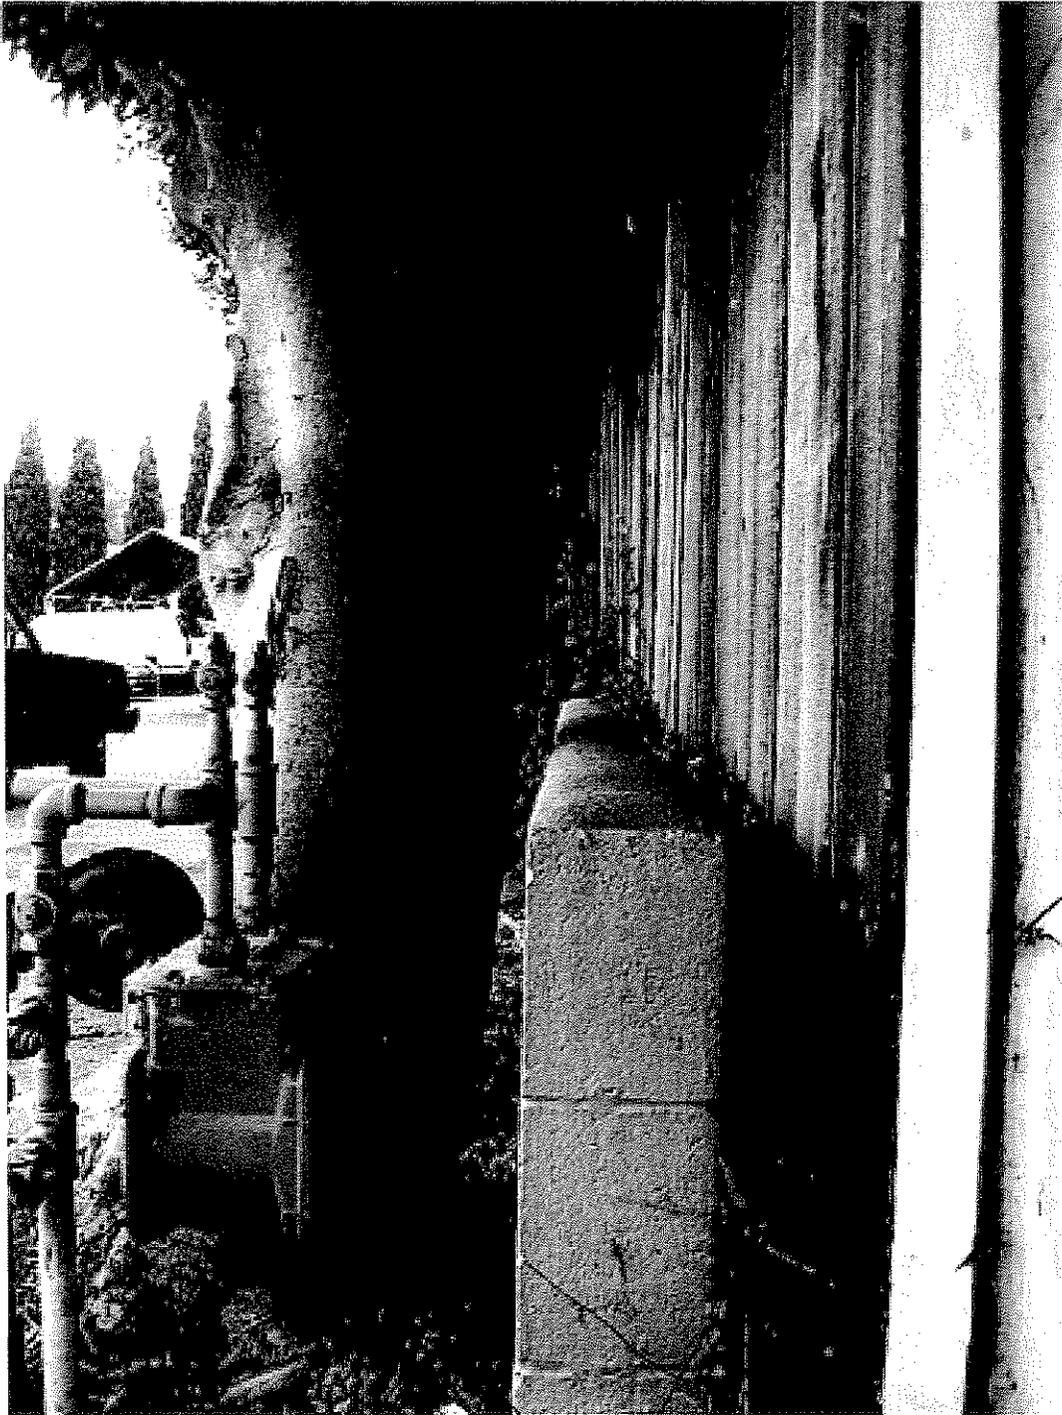
Photo 2: Note the proximity of the trees to the retaining wall.

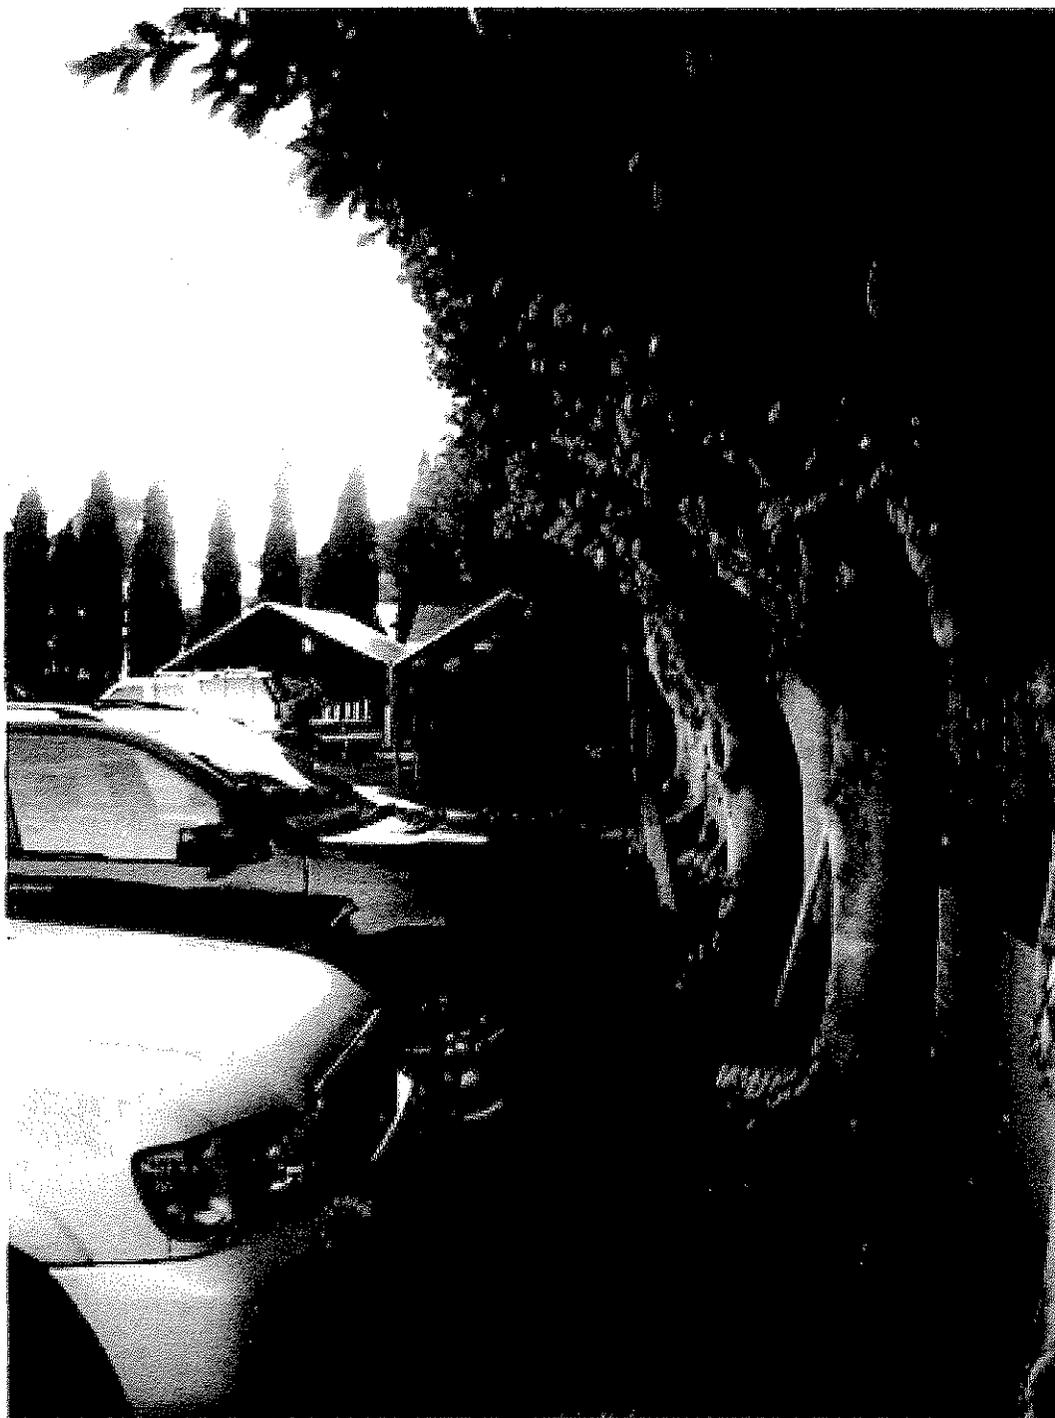
Photo 3: Note the proximity of the trees to the curb.
