TREE ASSESSMENT AND PROTECTION PLAN
July 31, 2009

Job location: 915 Anapamu St., Santa Barbara

SUMMARY

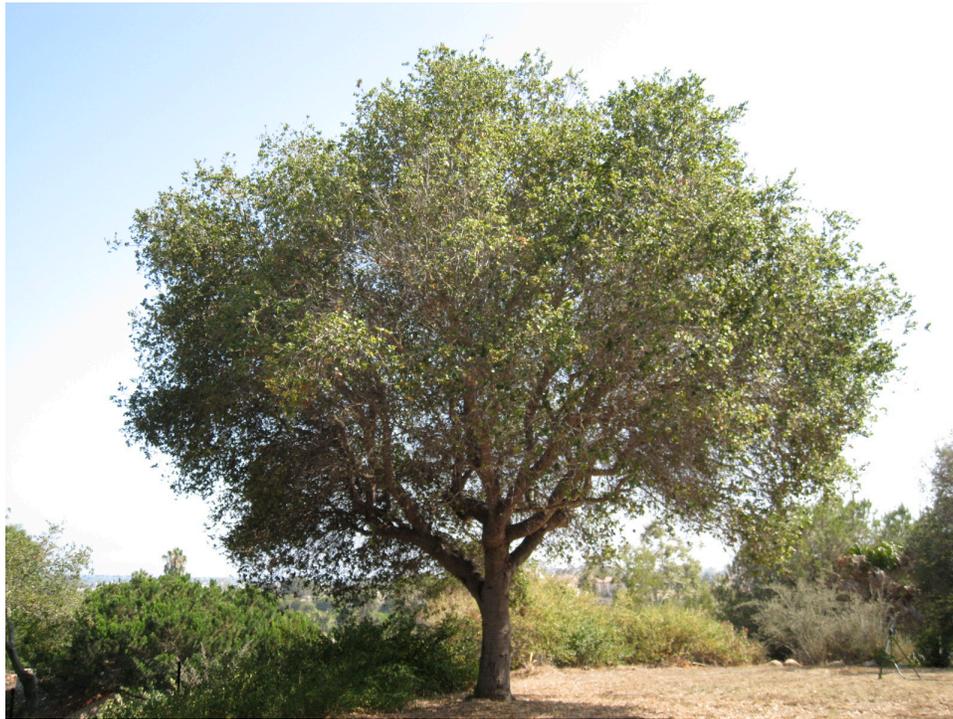
41	oak	14"	14'	Out of construction zone, but protect.
42	oak	8 x 6"	17'	Out of construction zone, but protect.
43	oak	15"	15'	Nicest oak in area. Adjacent to construction but no impacts. Protect.

Oak #43, the nicest oak on the property.

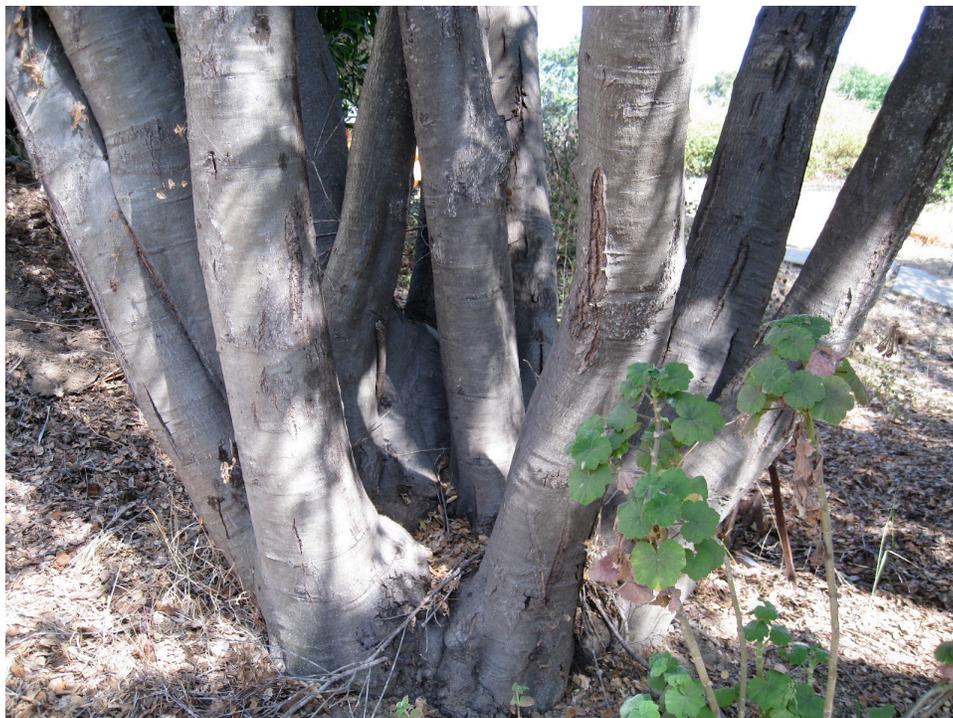
Multiple stems of oak #28. Although the tree has a lot of mass, this will become a problem over time. Removal and replacement is a good choice.

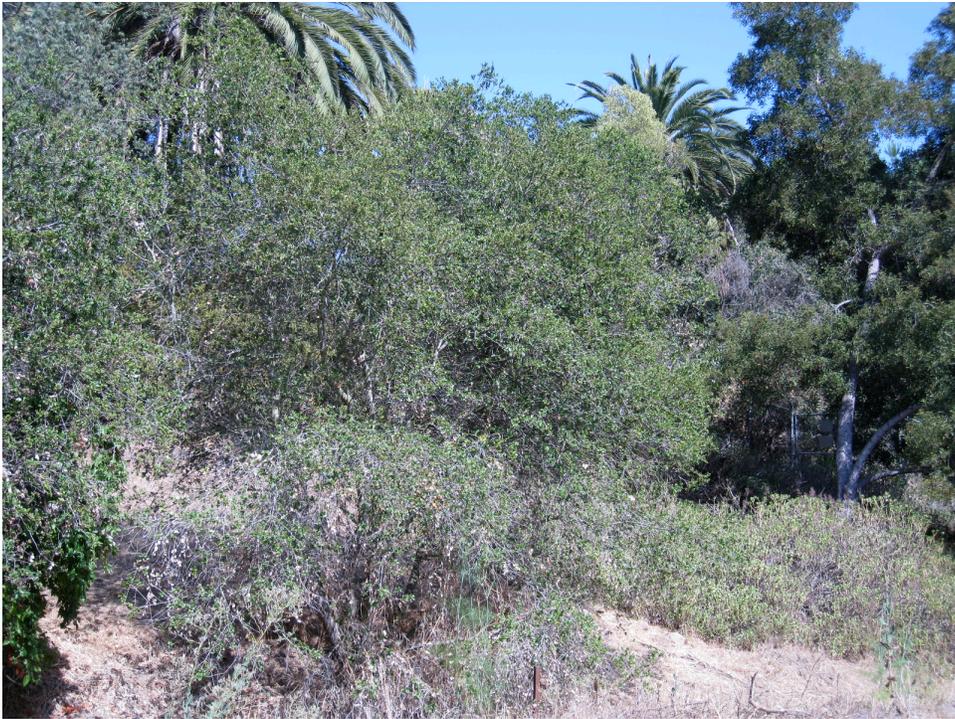
Looking south toward oaks #10, & #11. Note overgrowth of understory vegetation.

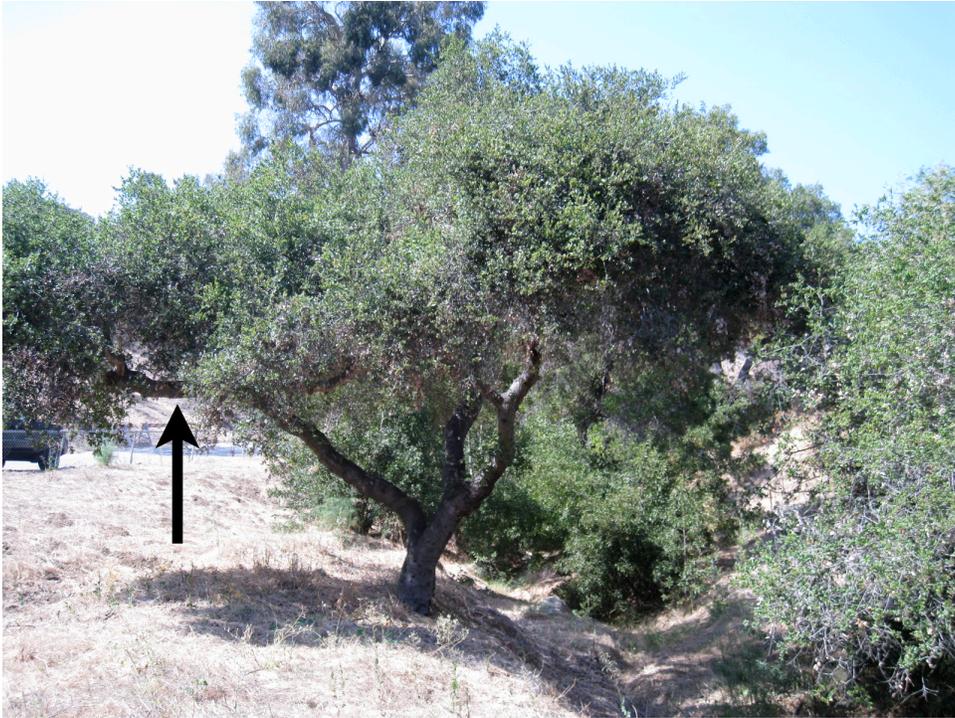
Oak #8. Arrow points to limb that will need pruning for clearance over carport.

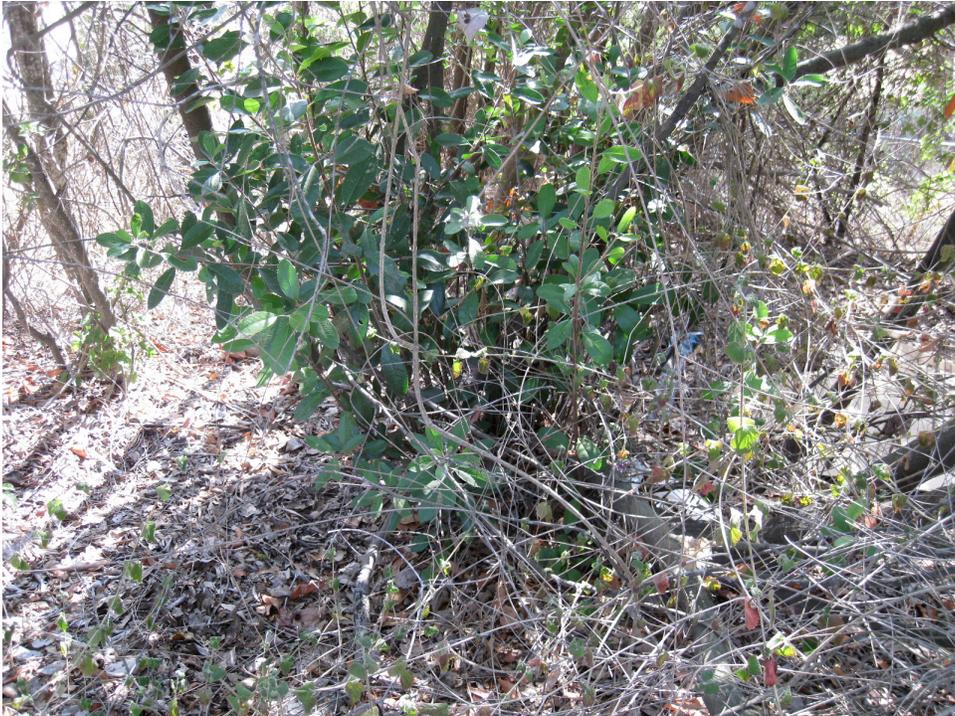
32	oak	6 x <4"		Poor condition due to origin of dense trunks from stumps sprouts. Remove for project and mitigate with 3 - 15 gallon oaks.
33	oak	4"/3"/3"		Poor condition due to origin of dense trunks from stumps sprouts. Remove for project and mitigate with 3 - 15 gallon oaks.

The base of multi-trunk oak #32 to be removed.

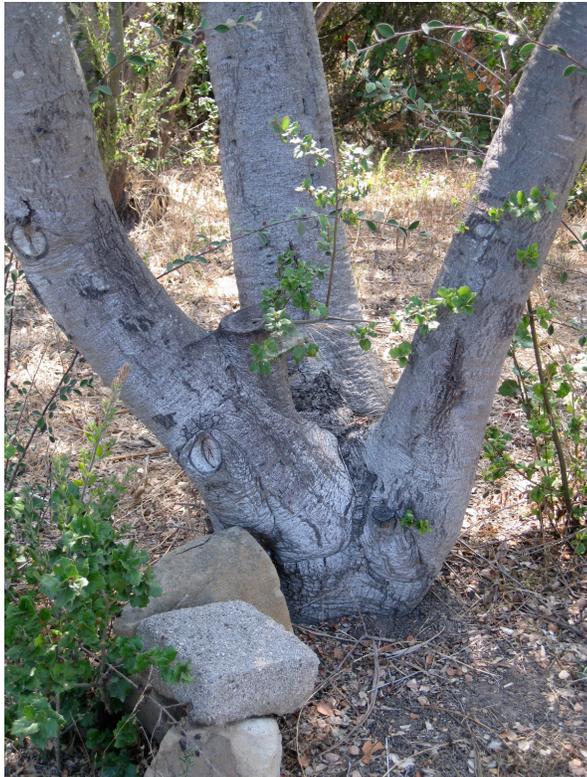
Tree #	Type	DSH	CRZ	Comment
34	oak	8"/5"/6"		Poor condition due to origin of dense trunks from stumps sprouts. Remove for project and mitigate with 3 - 15 gallon oaks.
35	oak	6"	6'	Fair condition due to competing vegetation. Away from construction zone but clean up area and protect during construction.
36	date palm	26"		Protect during construction.
37	stone pine	14"		Pines are too close together for this species. They should be pruned and/or one or two removed for more space to grow. Out of construction zone, protect.
38	stone pine	24"		Pines are too close together for this species. They should be pruned and/or one or two removed for more space to grow. Out of construction zone, protect.
39	fan palm	9"		Appears to be Livistona genus. Protect or relocate.
40	stone pine	14"		Pines are too close together for this species. They should be pruned and/or one or two removed for more space to grow. Out of construction zone, protect.

Note structural defects in base of oak #33 to be removed. Oak #34 is not shown but is similar in defective structure and is also to be removed.

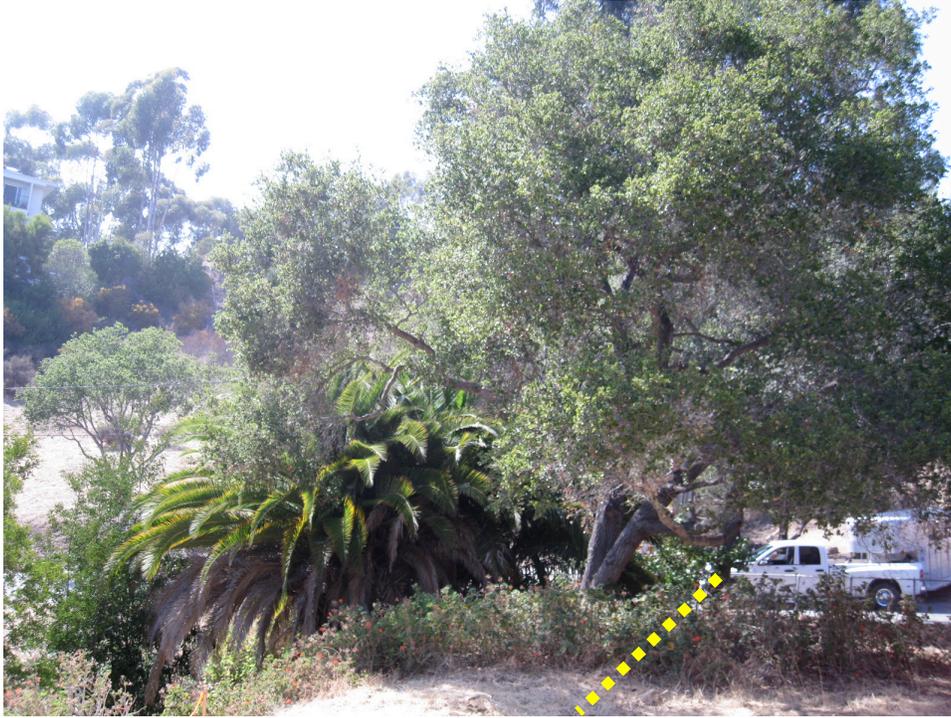
Tree #	Type	DSH	CRZ	Comment
6	oak	17"/11"	20'	Multi-stemmed oak in good condition although co-dominant trunks is a structural flaw. Approximately 40% encroachment into CRZ on east side from driveway. Follow tree protection measures and mitigate with 3 - 15 gallon oaks.
7	black acacia	14"		Remove non-native with severe lean to allow for mitigation oaks.
8	oak	20"	20'	Good tree with two major limbs that bifurcate several feet above ground. Low limbs to northwest will need to be cut back for proposed carport. Also approximately 40% encroachment into CRZ on northwest and west sides. Follow tree protection measures and mitigate with 3 - 15 gallon oaks.
9	black acacia	14"		Non-native conflicts with oaks. Remove to allow more space for oak trees.
10	oak	6"	6'	Fair condition. Cramped by adjacent acacia.
11	oak	6 x 4"	10'	Poor condition due to origin of dense trunks from stumps sprouts. Also severe competition with overgrown adjacent vegetation. Remove vegetation to encourage oak growth. Thin stems to encourage better structural condition.

Oak #6. Yellow line shows approximate location of newly proposed driveway. Overhang is one of the two trunks of this oak, which could be pruned or even removed. There is mitigation planting proposed for this oak. Note the palms / the drainage that conflict with other oaks.
