**Tree Species:** (5) *Platanus racemosa*      **Common Name:** California Sycamore

City of Santa Barbara  
Parks and Recreation Department  
STREET TREE REMOVAL APPLICATION

RE: SEPTEMBER 17, 2014  
ARLINGTON VILLAGE  
1330 CHAPALA STREET  
SETBACK TREE REMOVAL  
APPLICATION

# TREE INVENTORY, ASSESSMENT, & PROTECTION PLAN FOR ARLINGTON VILLAGE Chapala & Sola Streets, Santa Barbara

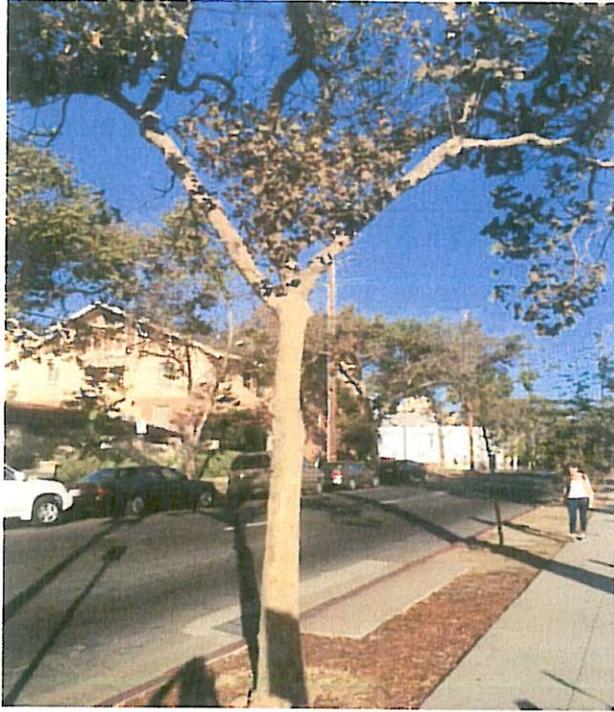
#3 Platanus racemosa, 4" DBH

| # | Common name / Botanical name | DBH | Condition | Arborist Recommendations | Design Team Direction |
|---|--|---|---|---|---|
| 3 | Sycamore / <i>Platanus racemosa</i> | 1 | 2 | Poor condition, likely to be root bound, infected, and drought stressed - remove & replace | Remove |

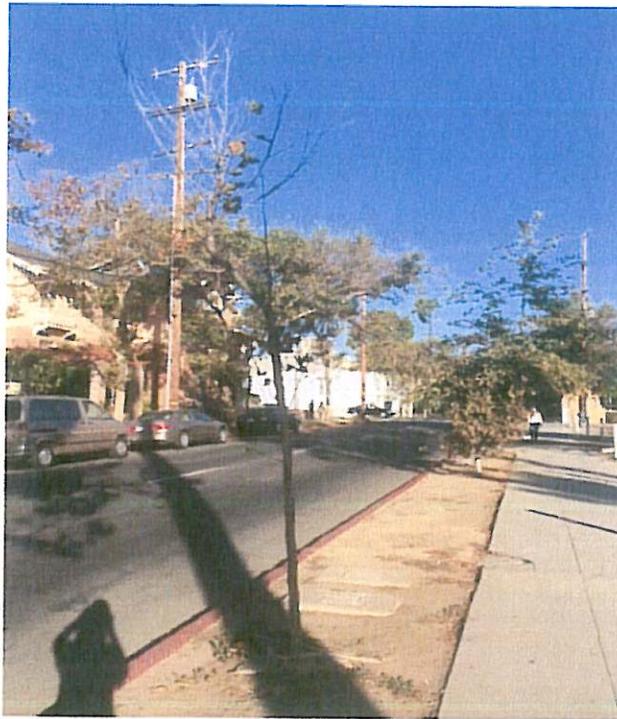
#4 Platanus racemosa, 2" DBH

| # | Common name / Botanical name | DBH | Condition | Arborist Recommendations | Design Team Direction |
|---|--|---|---|---|---|
| 4 | Sycamore / <i>Platanus racemosa</i> | 2 | 2 | Poor condition, likely to be root bound, infected, and drought stressed-remove & replace | Remove |

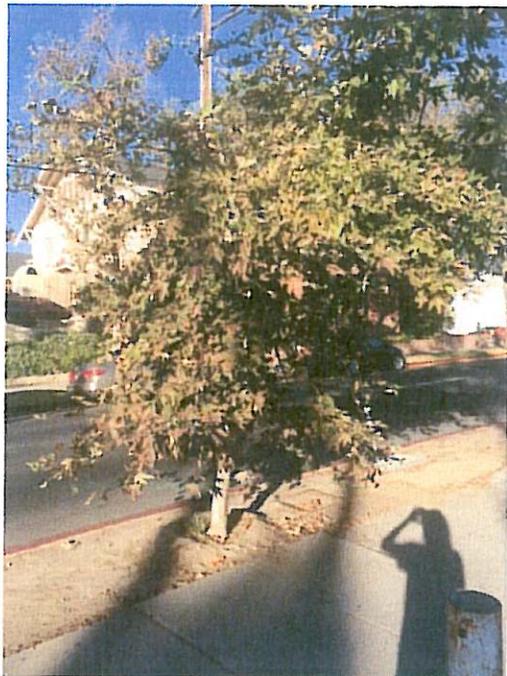
#5 Platanus racemosa, 4" DBH

| # | Common name / Botanical name | DBH | Condition | Arborist Recommendations | Design Team Direction |
|---|--|---|---|---|---|
| 5 | Sycamore / <i>Platanus racemosa</i> | 4 | 2 | Poor structure for street tree-remove & replace | Remove |

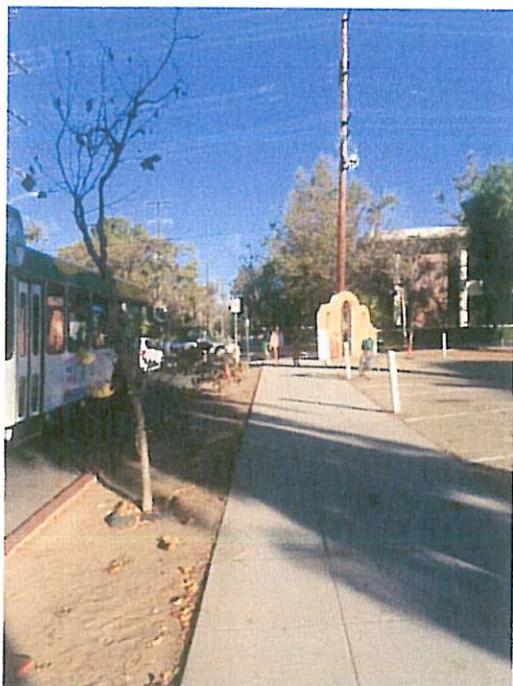
#6 Platanus racemosa, 2" DBH

| # | Common name / Botanical name | DBH | Condition | Arborist Recommendations | Design Team Direction |
|---|--|---|---|---|---|
| 6 | Sycamore / <i>Platanus racemosa</i> | 2 | 2 | Poor condition, likely to be root bound, infected, and drought stressed-remove & replace | Remove |

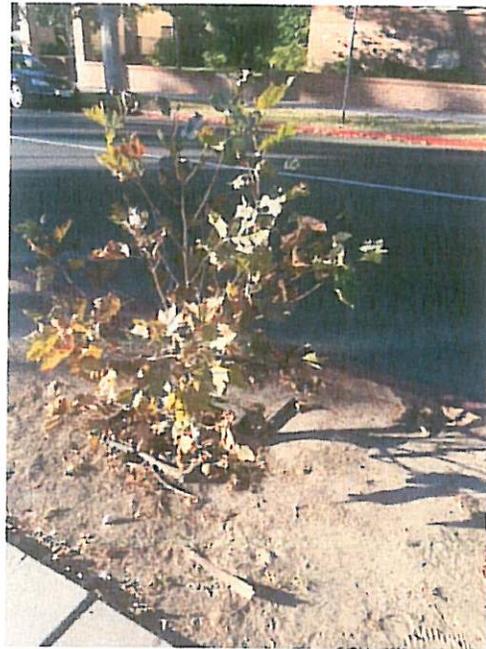
#7 Platanus racemosa, 2" DBH

| # | Common name / Botanical name | DBH | Condition | Arborist Recommendations | Design Team Direction |
|---|--|---|---|---|---|
| 7 | Sycamore / <i>Platanus racemosa</i> | 2 | 2 | Poor condition, likely to be root bound, infected, and drought stressed-remove & replace | Remove |
