**UPDATE OF PREVIOUS BIOLOGICAL RESOURCE REPORT FOR A
DRAINAGE ON PARCEL 017-113-030 NEAR CALLE CESAR CHAVEZ**

June 2006

URS Corporation
130 Robin Hill Road, Suite 100
Goleta, California 93117

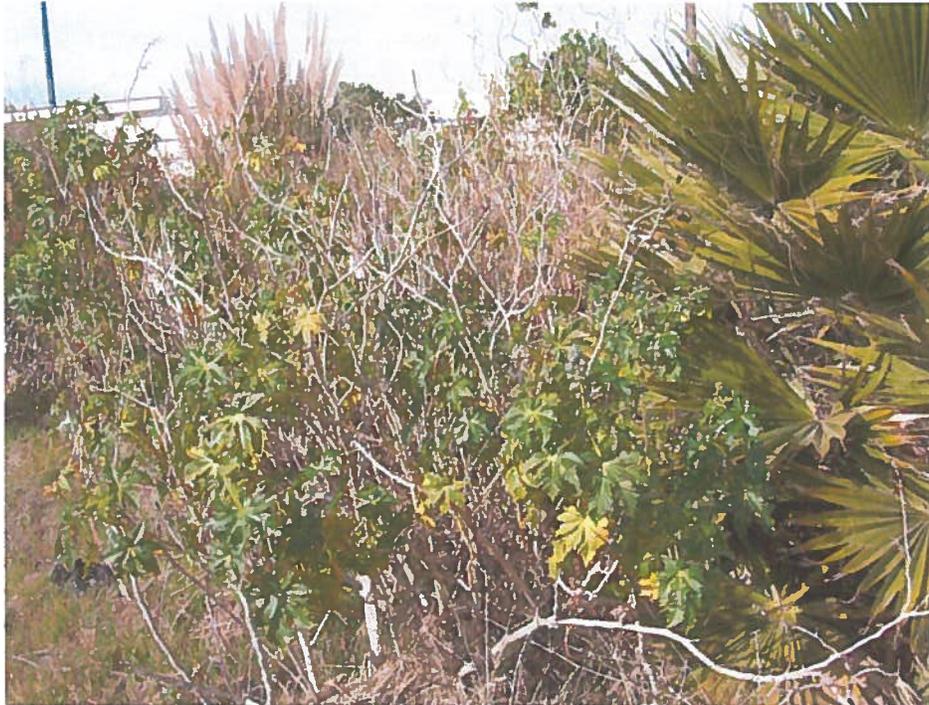
The configuration and dimensions of the channel have not changed in the past six years. The bottom of the channel is still dominated by California bulrush. Plant density and height were greater in 2006 compared to 2000 because the earlier survey was conducted after a vegetation thinning event. It did not appear that water was present in the channel during the 2006 survey. The arch culvert at Calle Cesar Chavez has become overgrown with dense vegetation and sediment, so that the height from the channel bed to the ceiling of the culvert is not more than three feet.

Photograph No. 2 View of the concrete box culvert over Calle Cesar Chavez. View to the west. Note that box culvert is blocked by dense vegetation.

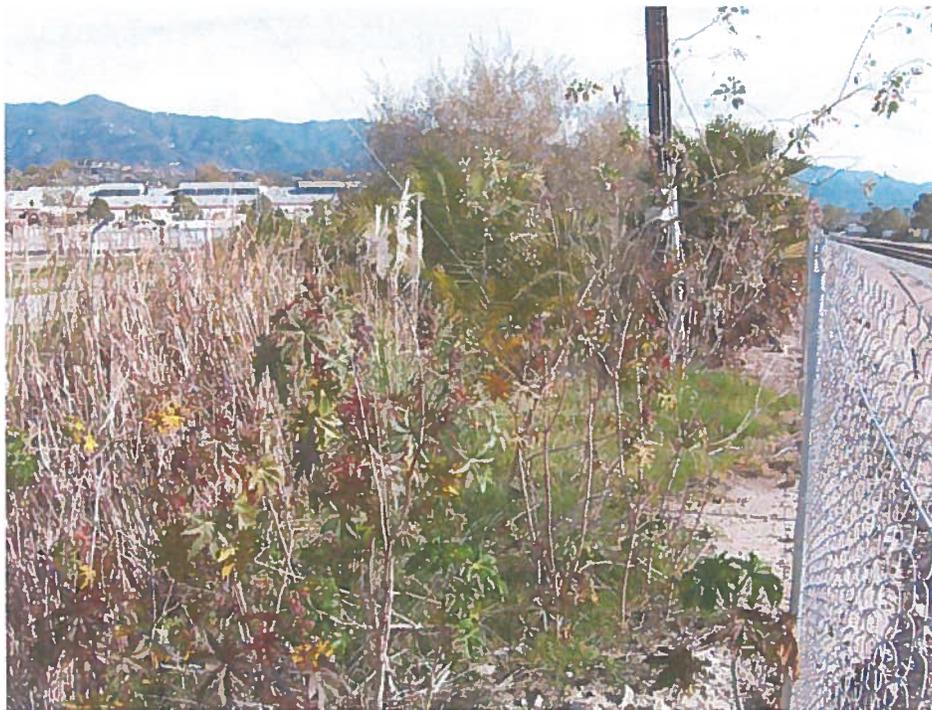
**Photograph No. 4. View of drainage ditch to the east. Vegetation in
ditch is dense with mostly bulrush in the bottom with castor bean,
palms, saltgrass, and non-native grasses on the top of the banks.**

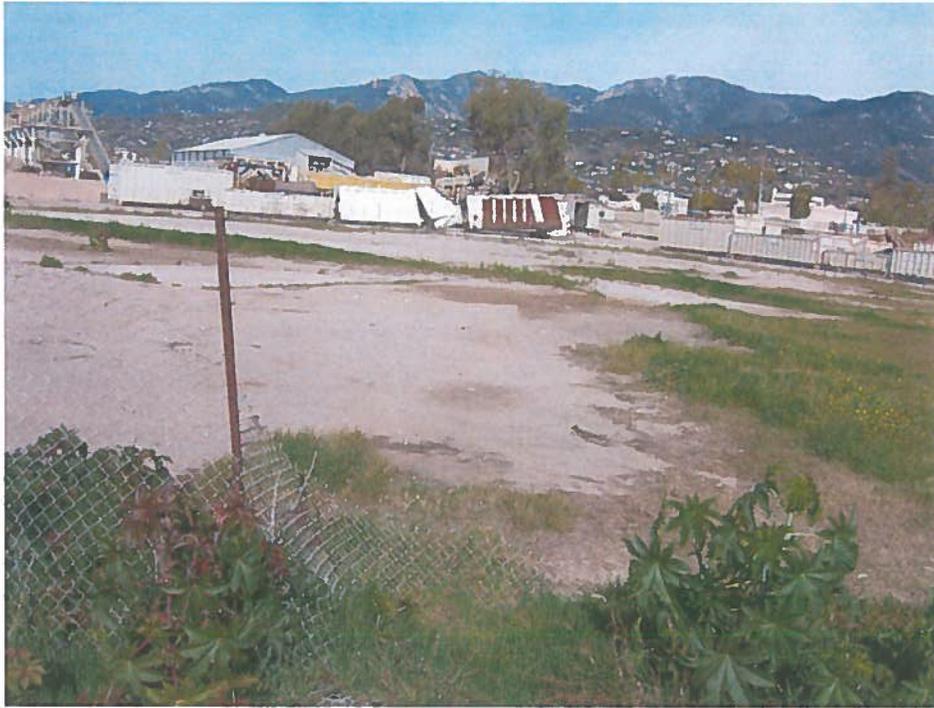
Photograph No. 5. View from the east end of drainage ditch facing northwest. Note the area is mostly concrete with some scattered weeds.

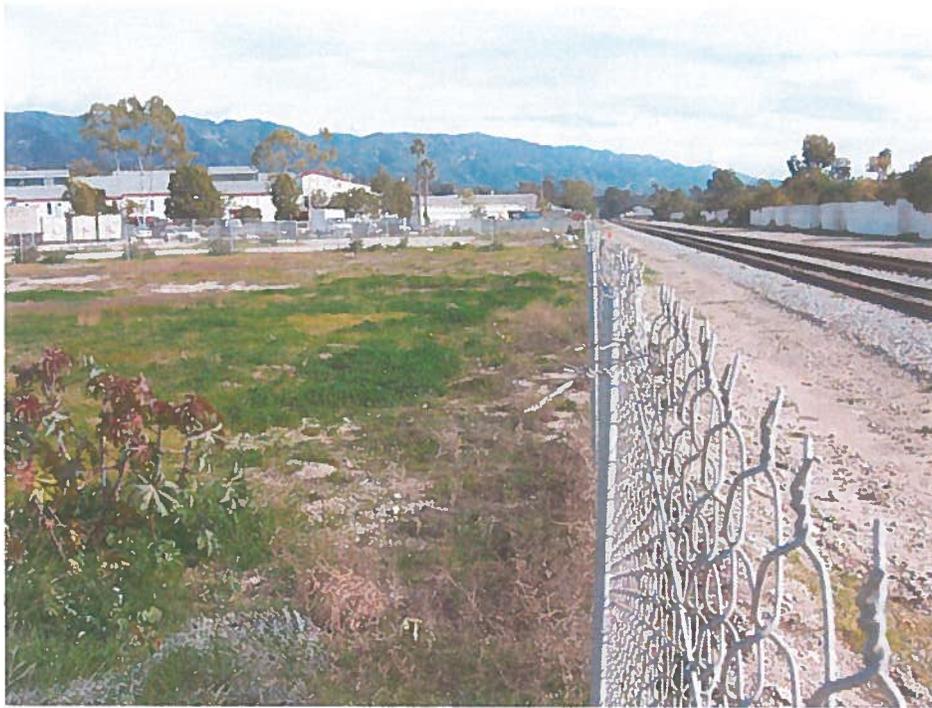
The lower banks have a few scattered palms, castor bean, and pampas grass (*Cortaderia selloana*) which were not present or dominant in 2000. The upper banks of the drain contain mostly weeds and non-native grasses. Weeds on the upper banks include castor bean, pampas grass, fennel (*Foeniculum vulgare*) and English plantain (*Plantago lanceolata*). Non-native grasses on the upper banks include Bermuda grass, ripgut brome (*Bromus diandrus*), red brome (*Bromus madritensis*), kikuyu grass (*Pennisetum clandestinum*), and smilo grass (*Piptatherum millaceum*). In general, the cover and diversity of non-native weeds have increased over the past six years.

Photograph No. 6. View from east end of drainage ditch facing east along the fence line. Note the area consists of weeds and non-native grasses.

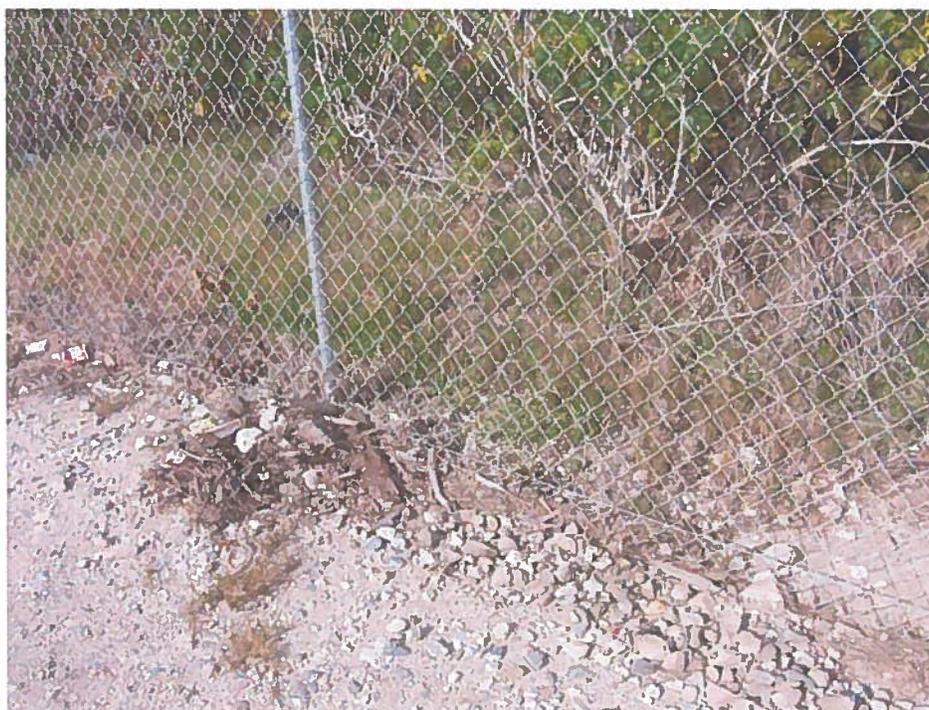
The four small patches of saltgrass observed in 2000 on the flat area south of the drain are still present, although they do not appear to be healthy.

Photograph No. 8. View of saltgrass patch No. 1. Note saltgrass is scattered among non-native grasses.
