**HISTORIC LANDMARKS COMMISSION
LANDMARK DESIGNATION
STAFF REPORT**

**THE SAN MARCOS BUILDING
1129 STATE STREET
SANTA BARBARA, CALIFORNIA
APN 039-231-037
JULY 15, 2015**

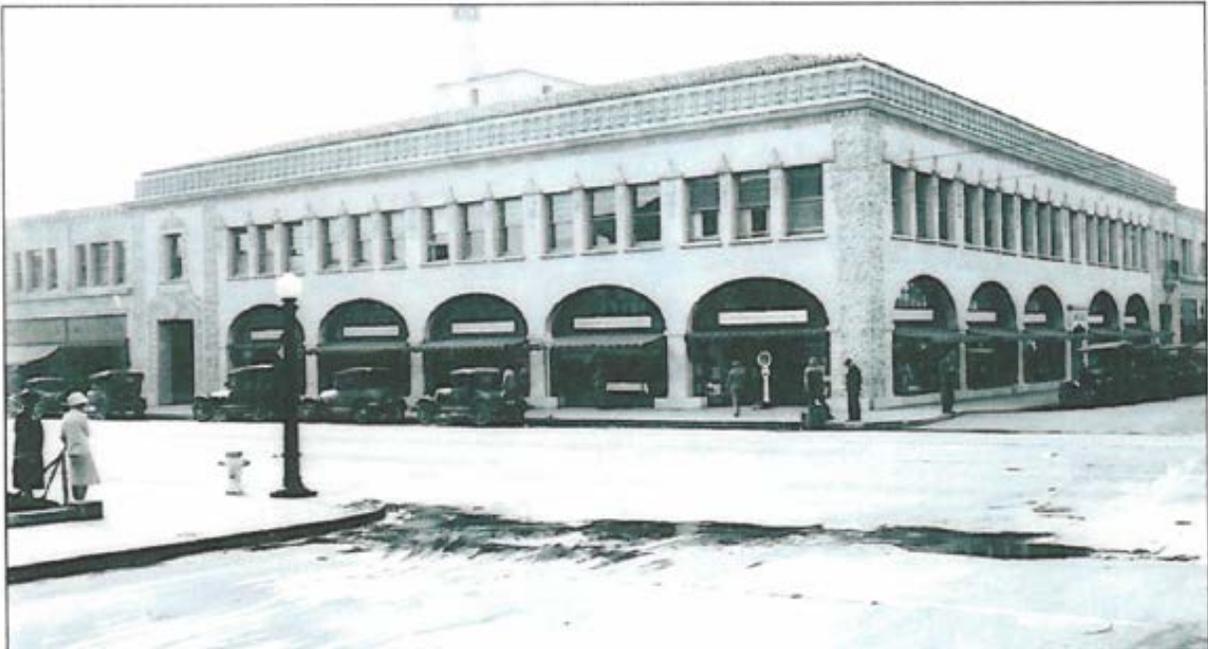
*Above: San Marcos Building after 1926 reconstruction.
Robert Easton Collection, Santa Barbara Public Library*

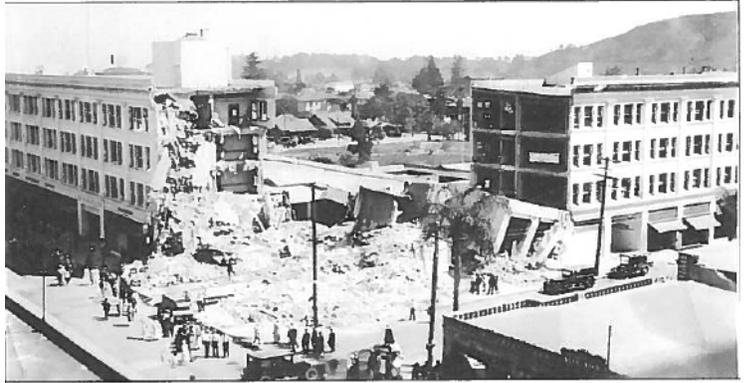
*Above: San Marcos Building after 1925 earthquake. The State Street and Anapamu Street elevations were reduced to two stories and the corner reconstructed in the Churrigueresque style in 1926.
Robert Easton Collection, Santa Barbara Public Library*

In 1913, architect J. Corbley Pool designed a rectangular-shaped commercial building for merchant banker John S. Hawley. In 1923, a four-story adjunct was added at the west side of the Anapamu Street façade to form an L-shape building. The 1925 earthquake razed the northeast corner of the building (see photo 3). The earthquake coincided with profound changes in the architectural expression in Santa Barbara, where the city could be unified through the Spanish Colonial Revival Style. Santa Barbara was looking for a visual image with which to link its Spanish past to

The portions of the building that survived the earthquake were reduced to two-stories. The second floor triple sets of windows were left unaltered. The rectangular storefronts on Anapamu Street with glass tile transoms remained unchanged from their appearance before the earthquake. Although the San Marcos building was one unified structure, Hunt and Chambers created the illusion of three buildings fronting State Street by designing three separate and unique facades along State Street and the older portion on Anapamu. The older portions were differentiated from the 1926 construction because the roofline was slightly lower and Churrigueresque styling was absent (see photos 5 and 6).

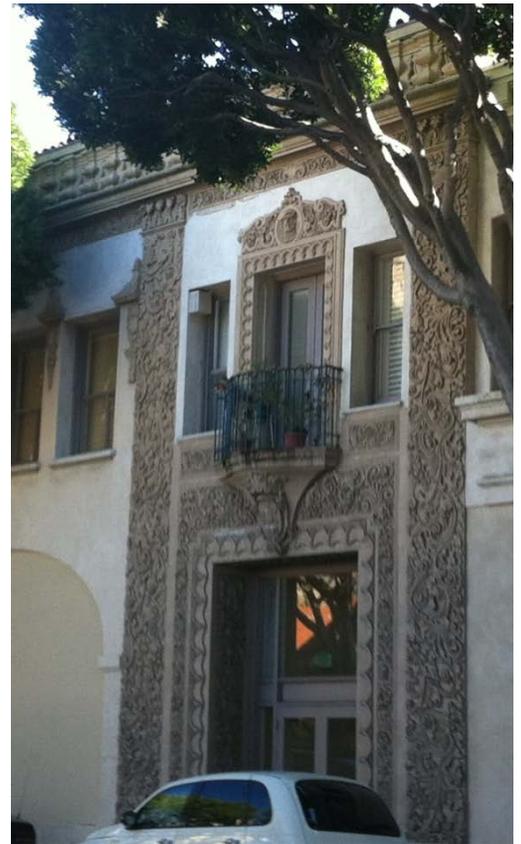
Above: East elevation of San Marcos building illustrating Churrigueresque detailing around door and window.

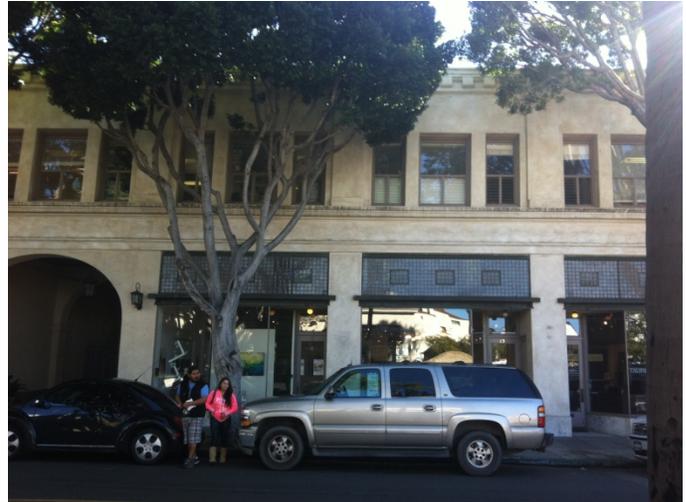
Above: Anapamu St. elevation of San Marcos building illustrating the 1923 section of the building reduced to 2 stories in 1926 with original storefront transoms. December, 2012.

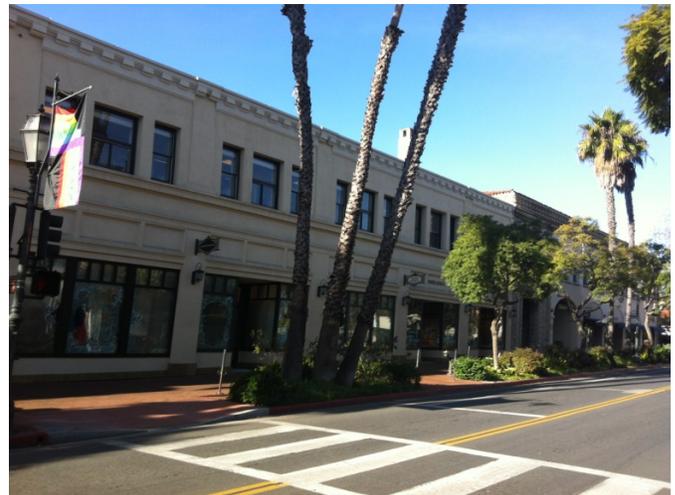
Above: State St. elevation of San Marcos building illustrating the 1923 section of the building reduced to 2 stories in 1926. December, 2012.

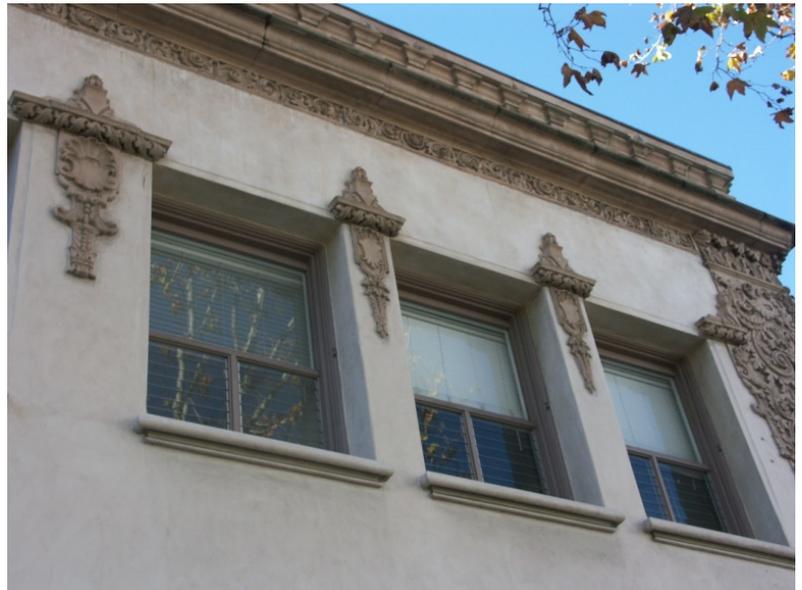
Above: Churrigueresque detailing on the San Marcos Building. December, 2012.

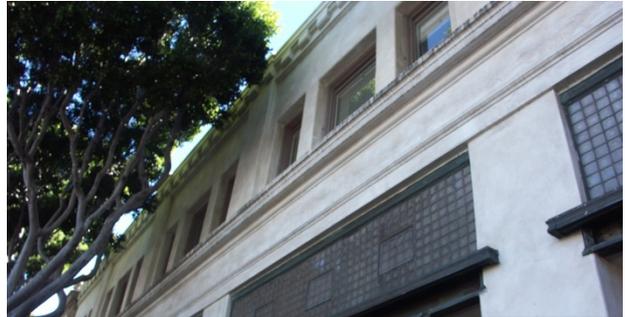
Above: The original transoms over the storefronts on Anapamu Street feature small detailed divided lights . December, 2012.

4. Design: The original design of 1926 storefronts included wide, arched, storefront openings that were altered in 1949. The arched intention has been restored to the storefront bays and filled with either glass or stucco. The storefronts on the west annex built in 1923 at 11 and 13 and installed in 15 West Anapamu Street have retained their original materials and design with the original glass tile transoms, recessed offset doorways and plate-glass display windows. The original paseo leading from Anapamu Street to the courtyard was re-installed,

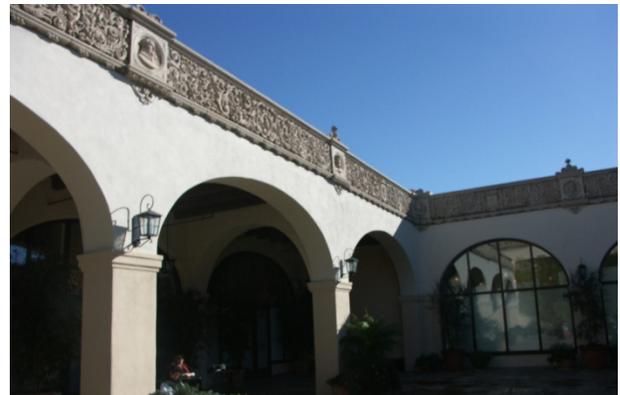
Above: View of the courtyard that demonstrates the ornate cast stone cornice and medallions. December, 2012.

5. **Interior courtyard:** There were modifications and additions done to the design of the interior courtyard space in 1949 by Woothworth's where the northeast corner of the courtyard was filled with an addition to the building. The courtyard originally had an arcade of arched openings on each elevation that have been filled with storefront glass, although the Churrigueresque cornice band remains.
