# **PHASE 1 HISTORIC SITES/STRUCTURES REPORT**

**610-612 AND 618 CASTILLO STREET**

**Santa Barbara, California**

**January 5, 2016**

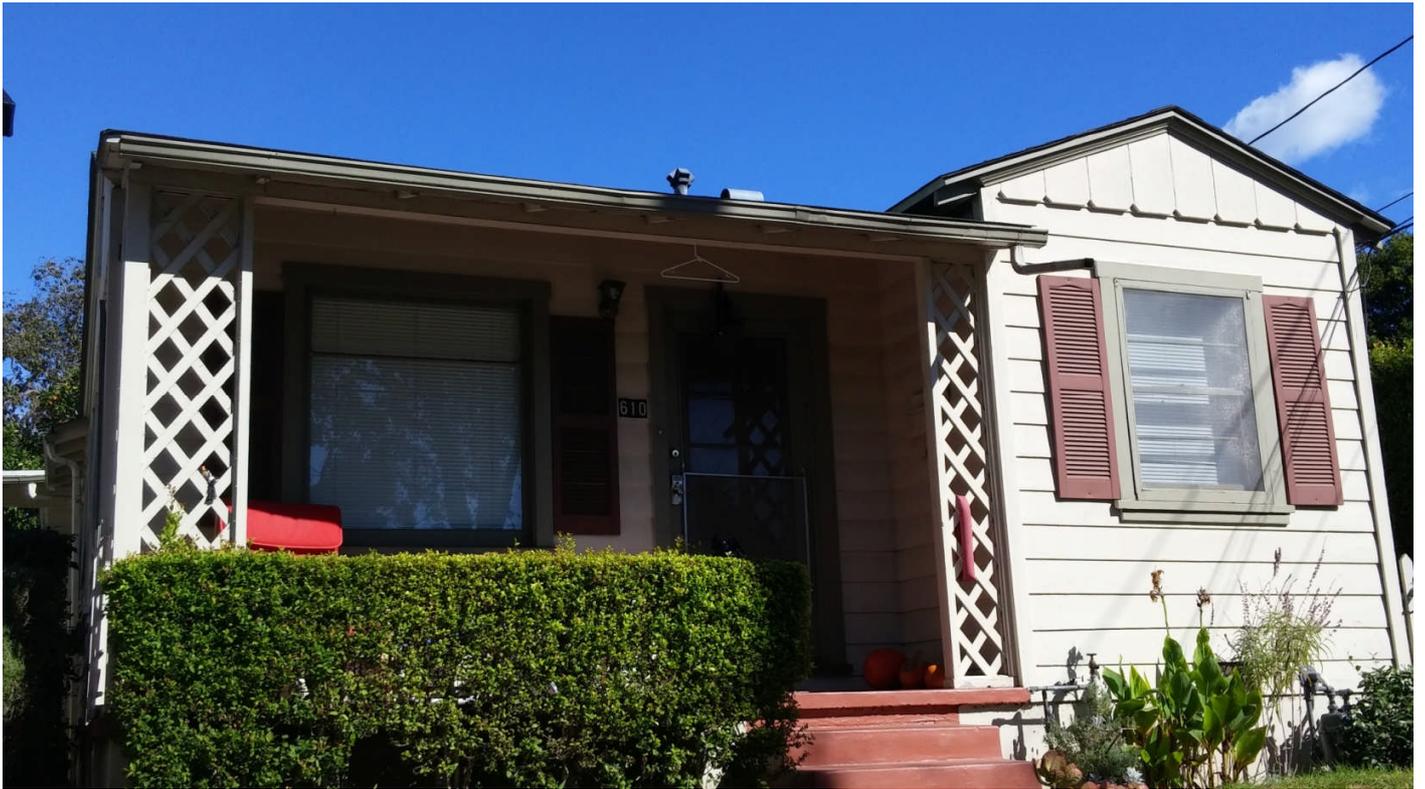
Figure 5  
West Elevation of 610 Castillo Street, looking east

The street façade is essentially L-shaped in configuration with a recessed three-quarters length front porch capped by a side gable roof flanked on its south by a projection set under a front facing gable (Figures 5 & 6). Latticed posts set at either end of the porch support the roof. The porch shelters a multi-light French style front door which is flanked on its north by a large rectangular window with a fixed transom in its upper register. At the east end of the elevation a one-over-one wood sash window is set beneath the front facing gable. Decorative wood shutters flank either side of the street façade's windows.

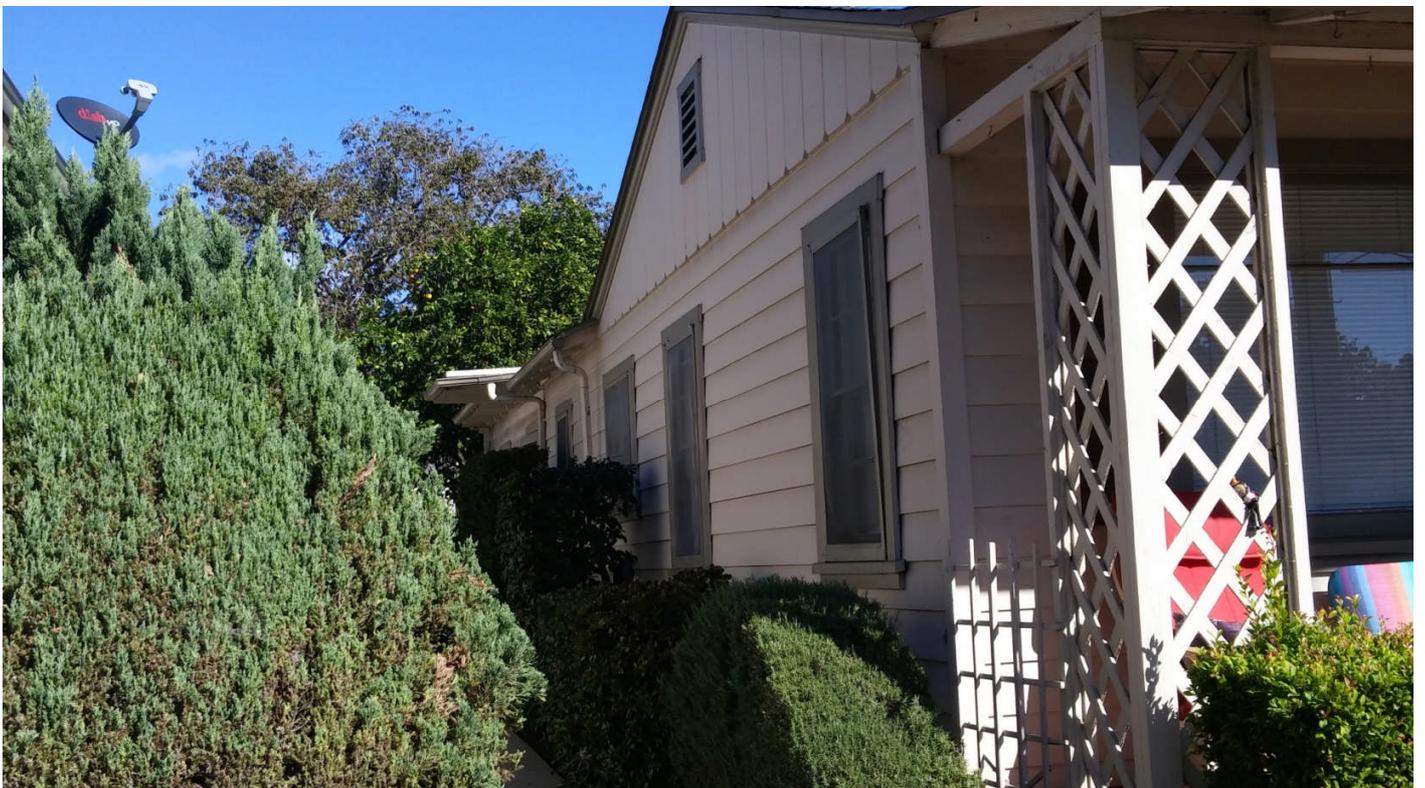
Figure 6  
North Elevation of 610 Castillo of Street, looking southeast

This elevation is composed of the original house built in 1941 which is capped by a front-facing gable with flush eaves and a rear wing built in 1965 which is capped by a side gable roof with moderately projecting eaves (see Figure 6). The fenestration of the original wing of the house is composed of two one-over-one wood sash windows flanked on their east by a glazed wood door set beneath a shallow shed roof. The fenestration of the rear wing is composed of two wood sash windows.

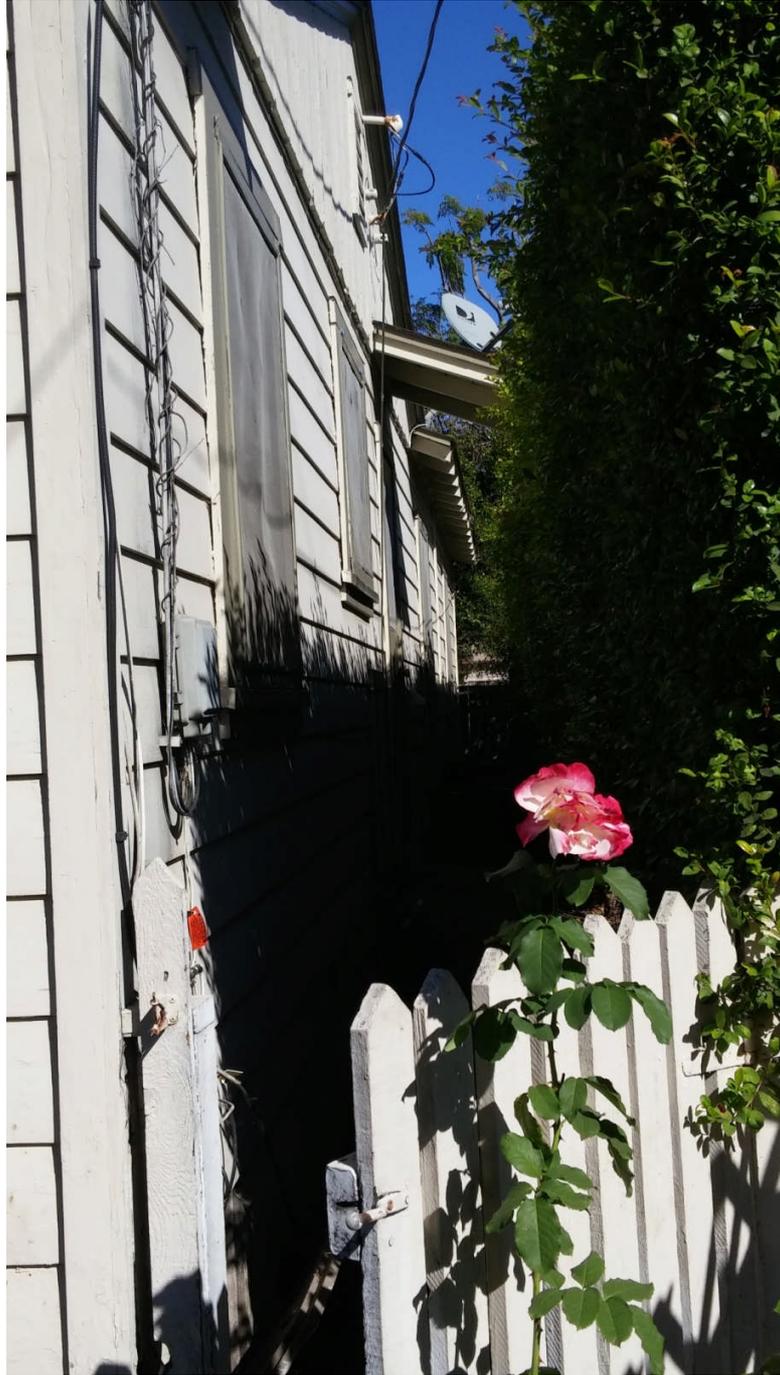
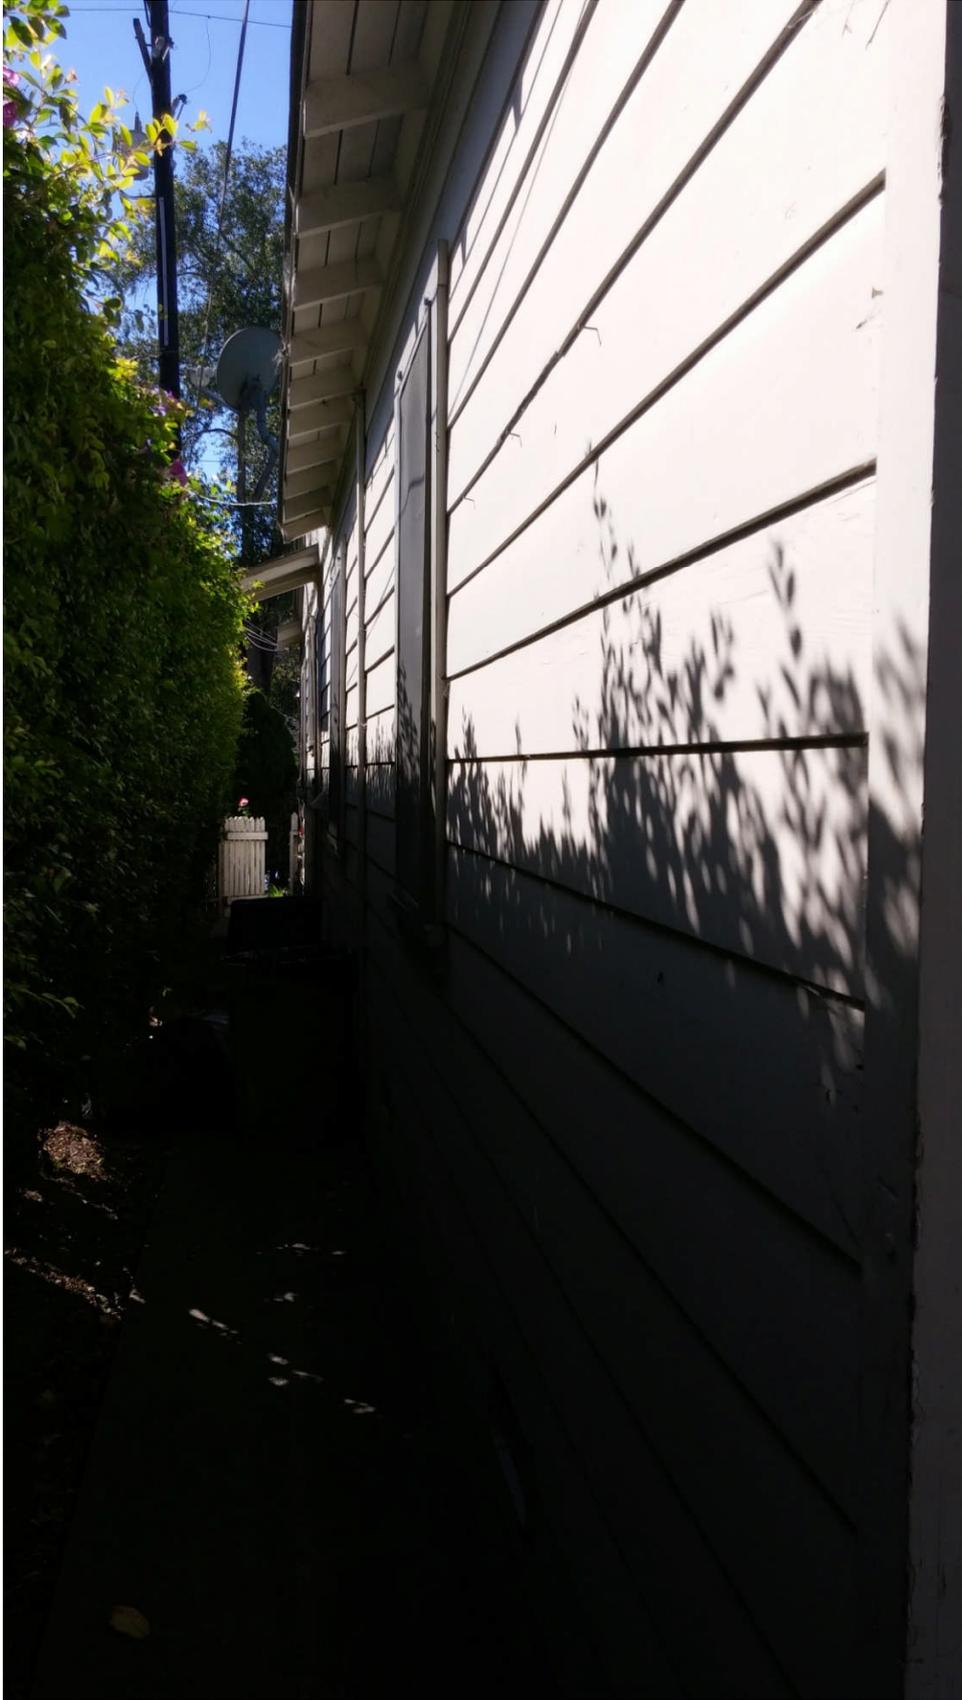
This elevation is linear in configuration; its fenestration is composed of a series of rectangular wood frame windows (Figures 7 & 8). A glazed wood panel door capped by a small shed roof is set near the west end of the elevation.

Figure 7  
South Elevation of 610 Castillo of Street, looking east

Figure 8  
South Elevation of 610 Castillo Street, looking west

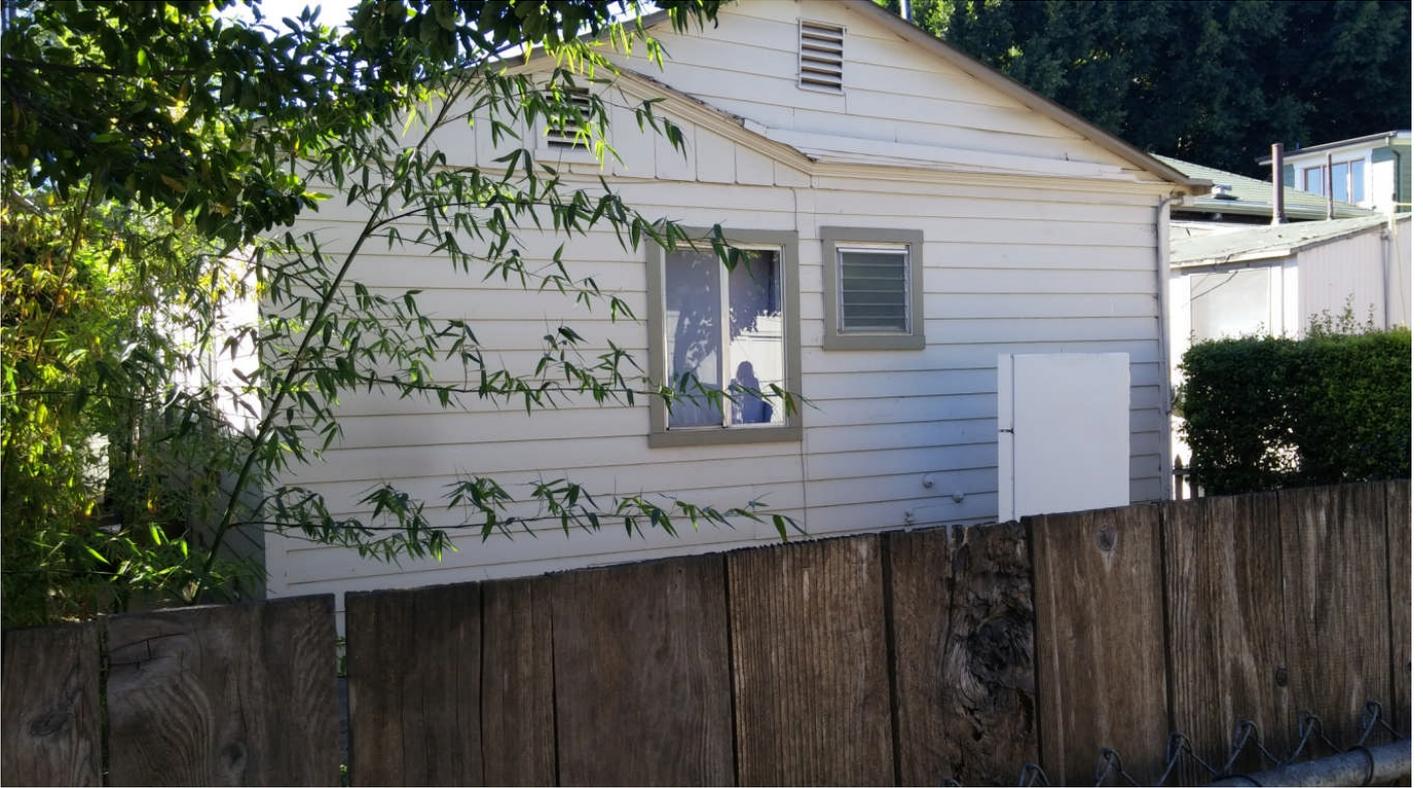
Figure 9  
East Elevation of 610 Castillo of Street, looking northwest

The rear elevation is composed of the addition built in 1965 (Figure 9). It features a main roof sheathed in horizontal siding and subsidiary gable roof covered in "dog-ear" vertical boards with flush eaves. Fenestration is composed of a two-light metal slider and a square louvered window.

- **1965:** Bedroom and bathroom addition to the rear of house in 1965 (City of Santa Barbara Building Permit #12811, April 2, 1965);
- At an unknown date decorative wood shutters were added to the street façade's windows; and
- At an unknown date, the concrete foundations were sheathed in plywood panels.

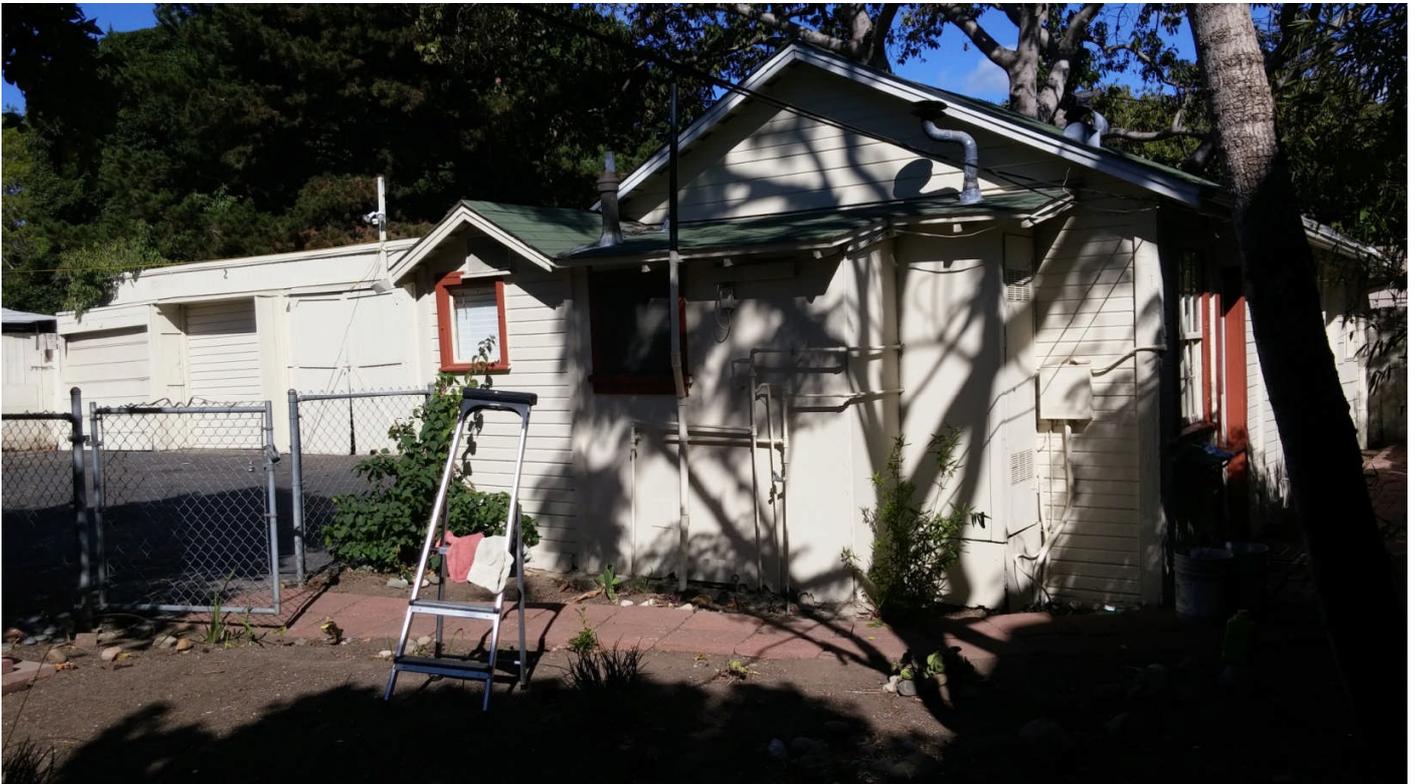
Figure 10  
West and Partial South Elevation of Cottage at 610 Castillo of Street, looking northeast

This wood frame single-story cottage is rectangular in configuration. Its exterior walls are sheathed in a variety of siding types including narrow, horizontal tongue-and-groove, wide horizontal tongue-and-groove, plywood sheeting and horizontal wood boards and wood shingles (Figures 10-13). Fenestration is composed of a series of rectangular windows of varying dimension. Glazing types include fixed wood frame one-light, metal louvers, and multi-light wood sash. The roof incorporates front gable and shed types; both covered in composition shingle roofing. The presence of a variety of siding and window types is indicative of the extensive series of alterations made to this building since its original construction. The front double gabled shallow-pitched roof is covered in composition shingles.

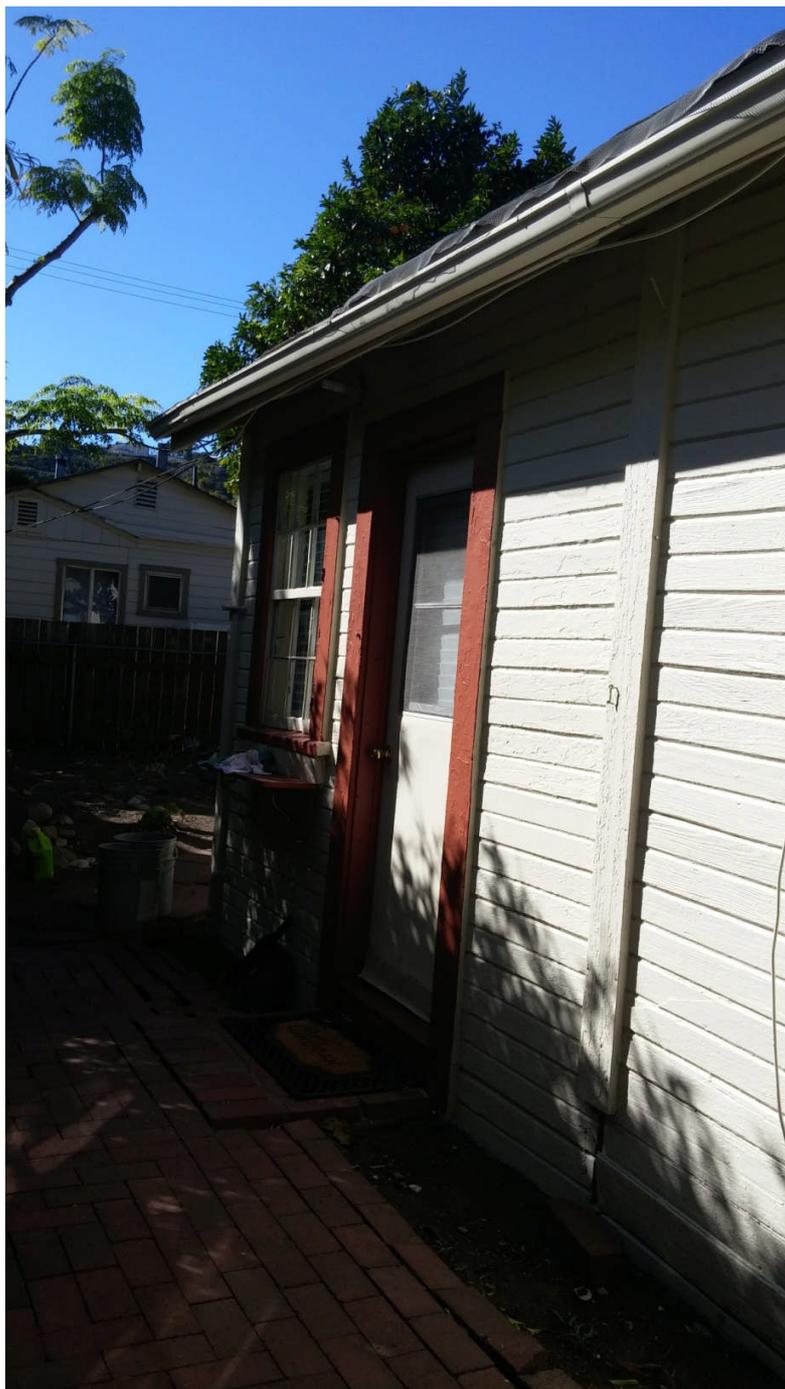
Figure 13  
South Elevation of the Cottage at 610 Castillo of Street, looking west (east end  
of elevation)

The south elevation is the primary façade and features a series of three doors including a glazed front panel front door located near the west end of the elevation; this door is flanked on its east by two multi-light doors and a number of rectangular louvered windows. This elevation is sheathed in three different siding types including narrow tongue-and-groove, horizontal wood plank and wood shingles. The west elevation facing towards Castillo Street features a main front gable roof with a subsidiary gable over a small addition. The remainder of the elevation is composed of a shed-roofed addition and a small enclosed closet for a hot water heater. The north elevation, which is set close the five-car garage behind 612 Castillo Street, is sheathed in two types of horizontal tongue-and-groove siding and features two louvered windows. The rear (east) elevation is sheathed in vertical wood planks and has no doors or windows.

- **After 1961:** Subsequent alterations were made after 1961, these changes which are not recorded by permits, included the insertion of an exterior closet housing a water heater at the south end of the west elevation; the construction of a small shed-roofed addition off the west elevation and the insertion of glazed doors, a flush panel door and louvered windows on the south and north elevations. Headers set above the existing doors and windows on the south elevation indicate the location of sliding or swing-type bay doors that provided access to the interior of the garage.

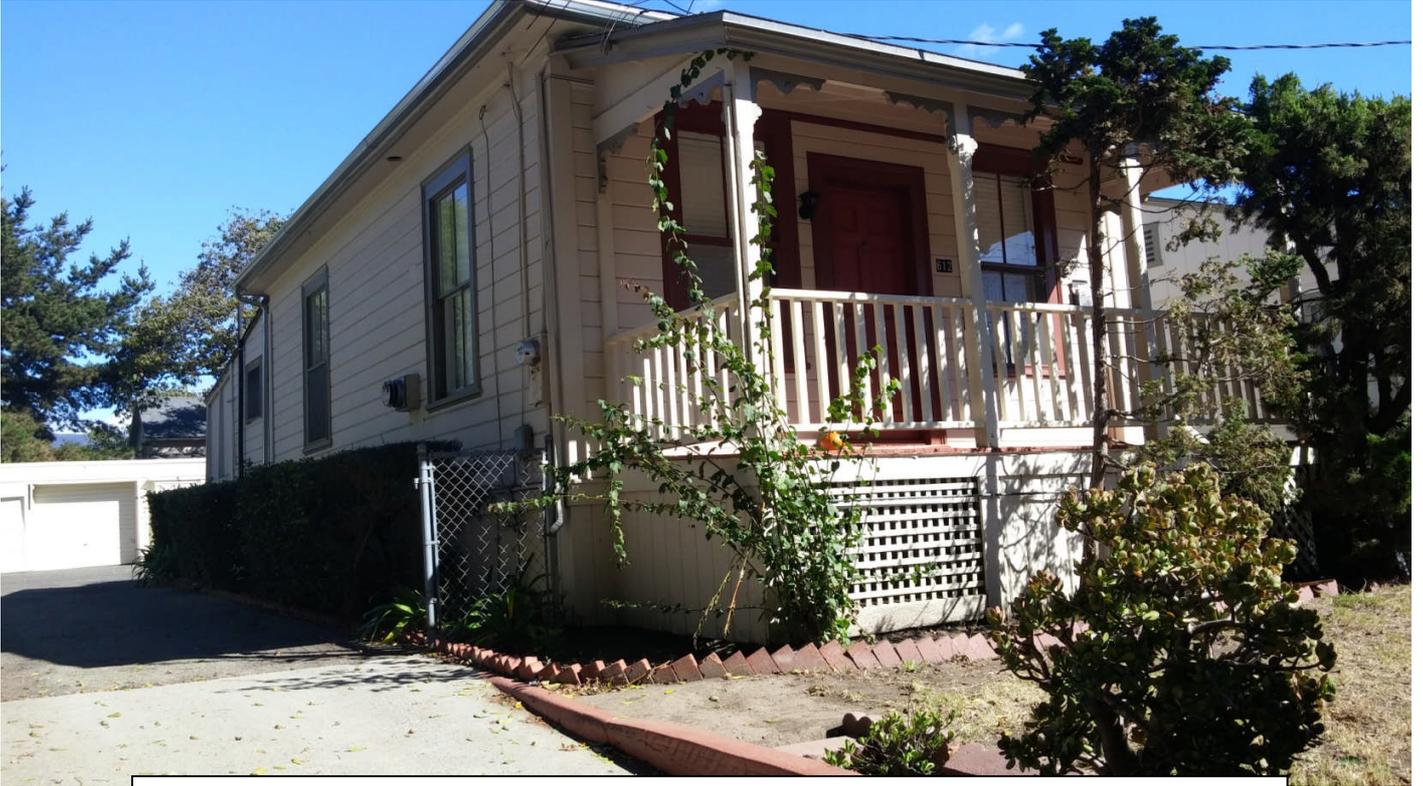
Figure 14  
West and North Elevations of the House at 612 Castillo of Street, looking southeast

The west elevation is linear in configuration with a full-length porch supported by four chamfered wood posts embellished with decorative scrollwork supporting a shed roof (Figure 14). A wood railing incorporating an arched motif extends along the north, south and west sides of the porch. The centrally-placed six-panel front door is flanked on either side by narrow, two-over-two wood sash windows with narrow glazing bars.

- The front door has been replaced (date unknown); and
- The porch's rafters have been replaced (this did not alter the configuration or exterior appearance of the porch) (date unknown).

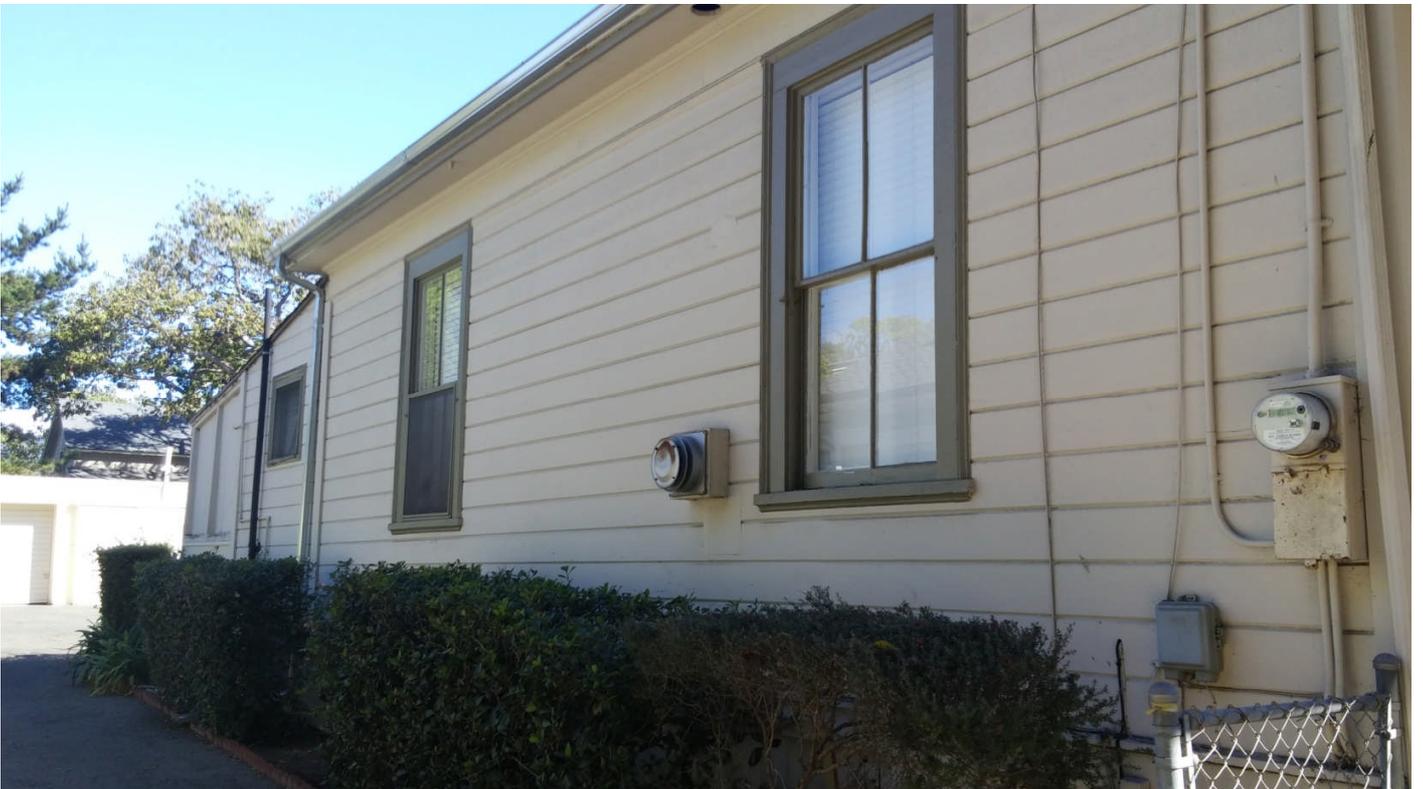
Figure 15  
North Elevation of the House at 612 Castillo of Street, looking southeast

The north elevation is linear in configuration with the original wing of the house flanked on its east by two shed-roofed additions (Figure 15 and see Figure 14). Fenestration consists of two, narrow two-over-two wood sash windows with narrow glazing bars on the original wing of the house and a one-light window set in the shed-roofed addition at the east end of the elevation. What was originally a screened porch at the east end of the elevation has been enclosed with sheets of plywood.

- A shed-roofed addition was made to the east end of the original wing of the house sometime before 1907, but after the original house was built;
- A screened porch was added to the east end of the elevation sometime after 1930, no permit could be found for this alteration; and

- Subsequently, the porch's screening was removed and replaced with plywood sheeting (date unknown).

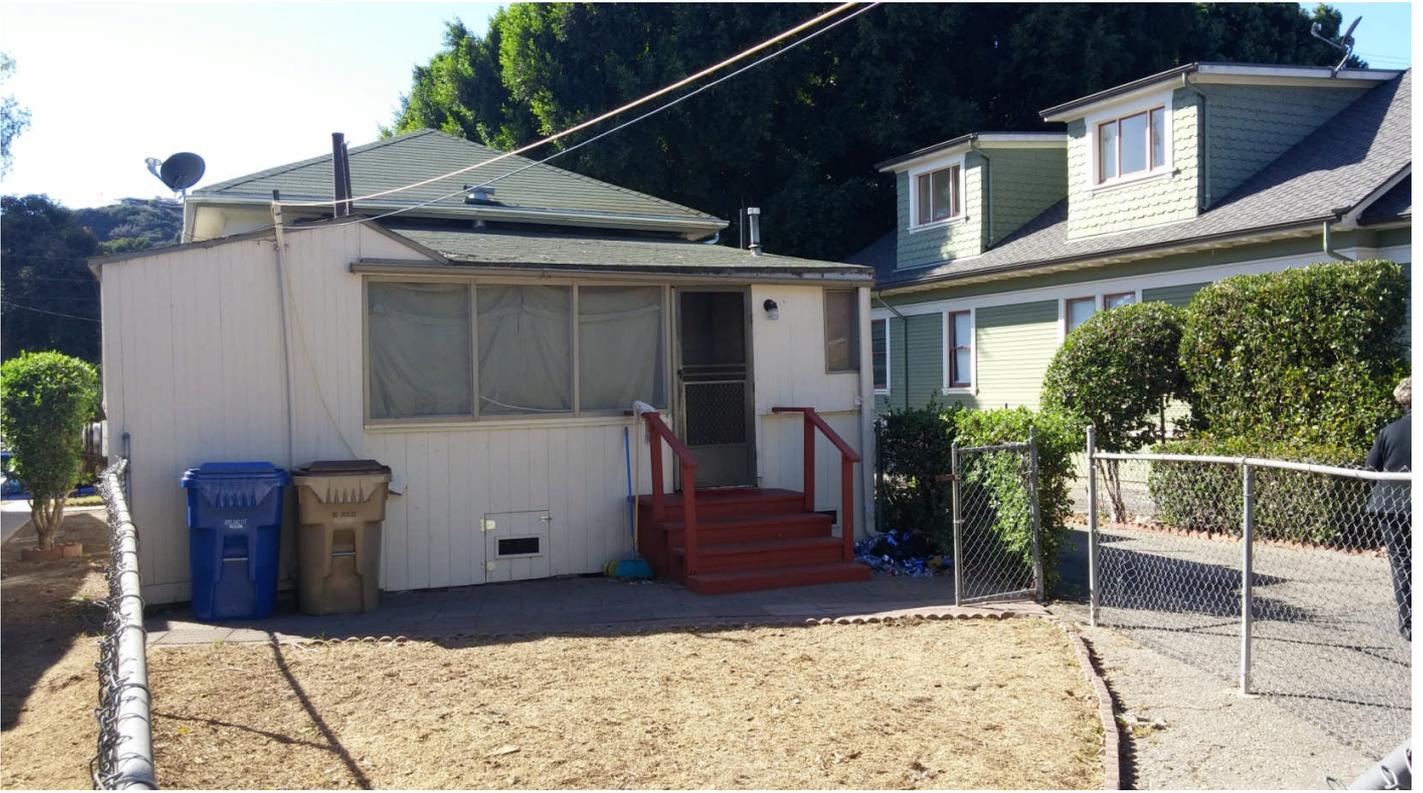
Figure 16  
East Elevation of House at 612 Castillo of Street, looking west

The east (rear) elevation is linear in configuration. A screened porch runs three-fourths of the length of the elevation (Figure 16). This addition is composed of two-shed roofed elements, with south end of the elevation featuring narrow vertical board siding capped by steeply pitched shed roof set at right angles to the main shed roof. This element is flanked on its north by a screened porch sheathed in wide, vertical wood planks. The porch's fenestration consists of a wood door opening on a shallow wood deck. The door is flanked on its north by a narrow wood frame window and on its south by three rectangular opening covered in screening.

- A small shed-roofed addition was made off the south end of the original wing of the house sometime before 1907, but after the original house was built;
- A screened porch was added to elevation sometime after 1930, no permit could be found for this alteration; and
- The existing porch appears to be less than 30 years of age (date unknown).

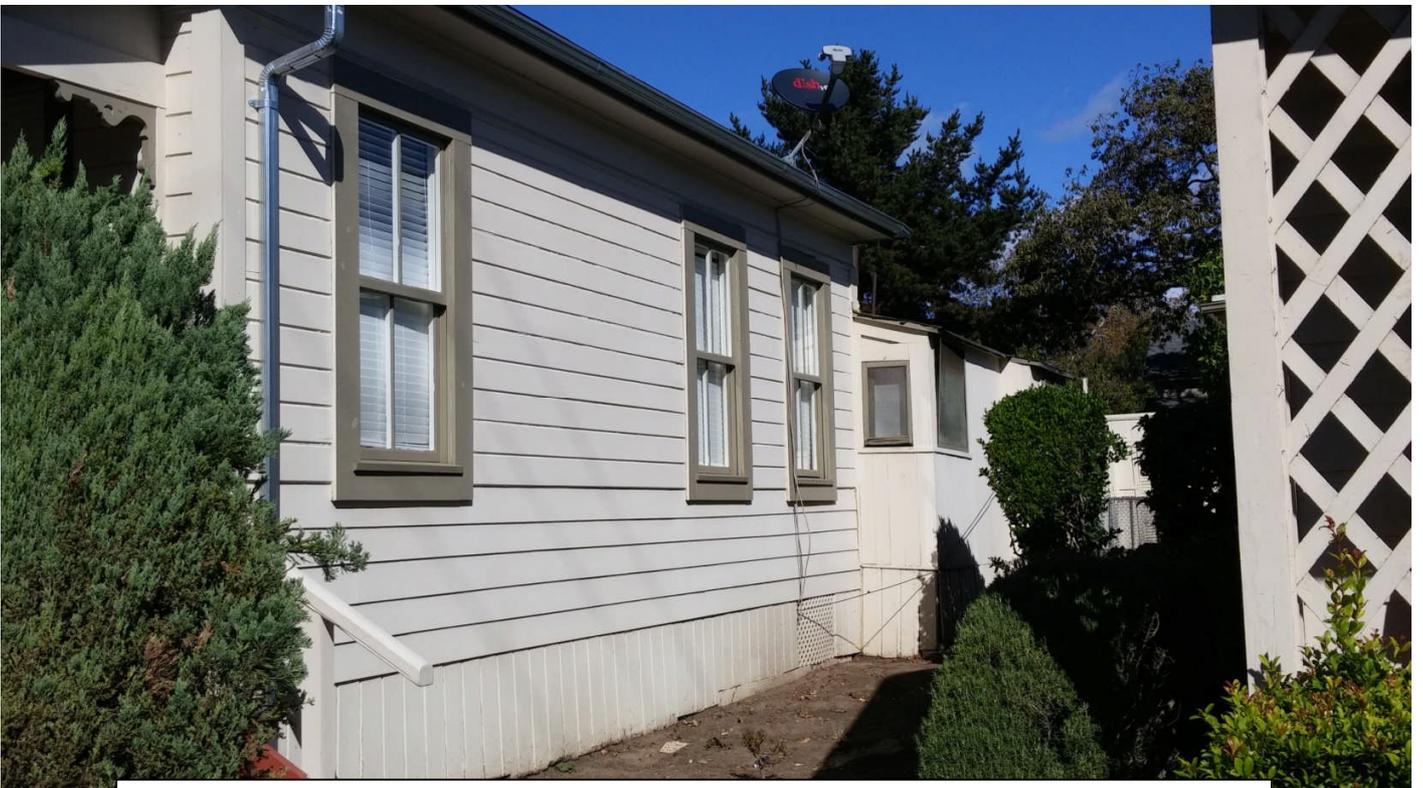
Figure 17  
South Elevation of House at 612 Castillo of Street, looking northeast

The south is linear in configuration. Fenestration consists of three, two-over-two wood sash windows with thick glazing bars on the original wing of the house (Figure 17). The shed roof additions located at the east end of the elevation features two, small wood frame windows on the south elevation and a smaller one-light wood frame window on the west-facing elevation of this wing.

- A shed-roofed addition was made to the east end of the original wing of the house sometime before 1907, but after the original house was built;
- A smaller shed-roofed addition was made sometime after 1930, no permit could be found for this alteration; and
- The three window in the original wing of the house have had their sash

replaced with new sash with thicker glazing bars than the original windows (original windows of this type are preserved on the house's north elevation). A date for this alteration is not recorded by permits, although based on the details of the replacement sash it would appear to have taken place within the last 30 years.

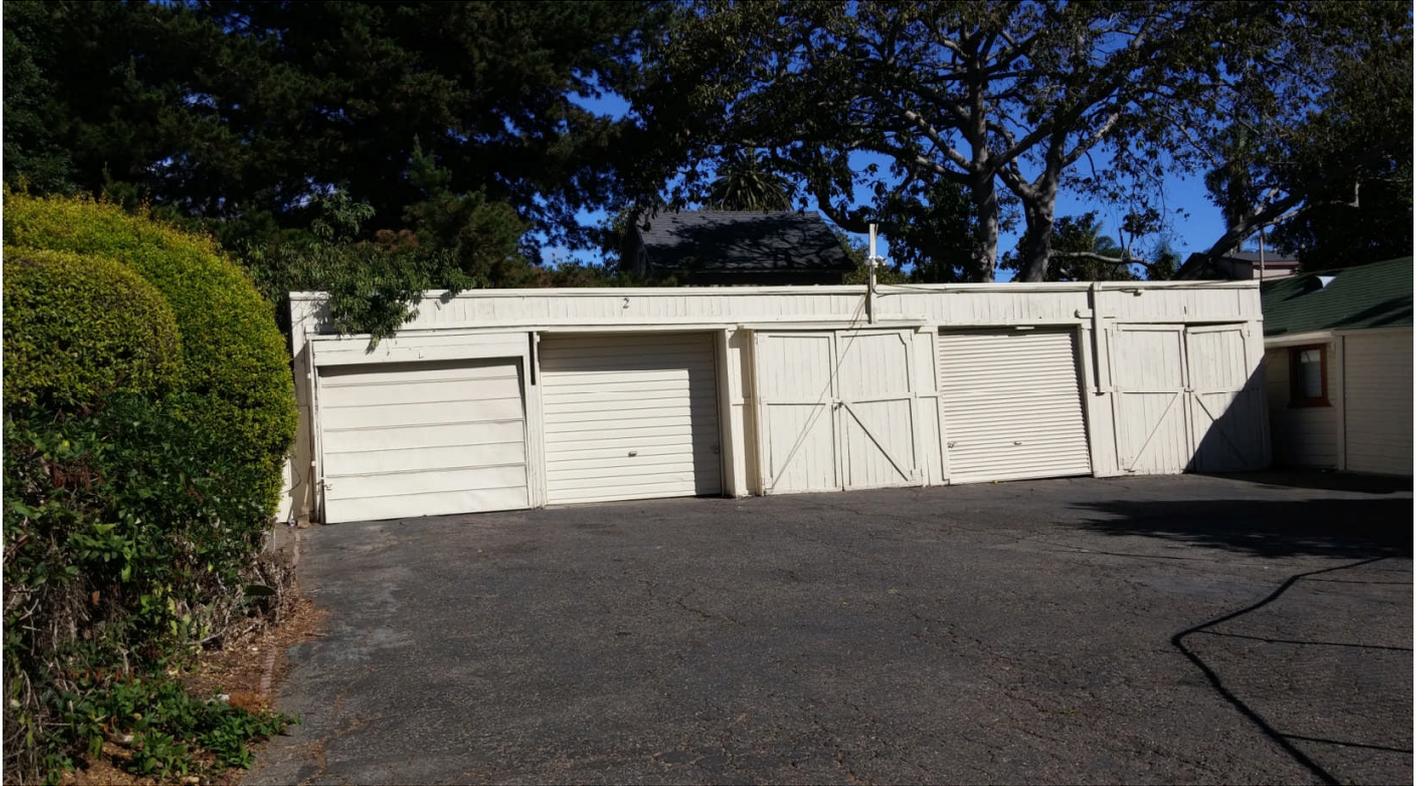
Figure 18  
West Elevation of the Garage at 612 Castillo of Street, looking southeast

Built in 1926 (Permit A-1910) this detached, wood-frame, five-bay garage with a rectangular footprint is located to the rear of the lot (Figure 18). The garage is sheathed in wide, wood plank and board-and-batten siding and is capped by a shed roof. Five garage bays extend the length of the west elevation facing towards Castillo Street. Two of the garage bays preserve their original wood plank double doors while the remaining bay doors have been replaced with tilt-up metal doors.

- Three of the original bay doors were replaced with metal doors sometime in the post World War II period, no permit could be located for this alteration.

Detached Five-Car Garage: Alterations since its construction in 1926 are confined to the replacement of three pairs of the original bay doors with tilt-up metal doors. The remainder of the building appears to have retained most of its original building materials. The loss of three pairs of the original doors and their replacement with metal doors has substantially impacted the building's integrity of design.

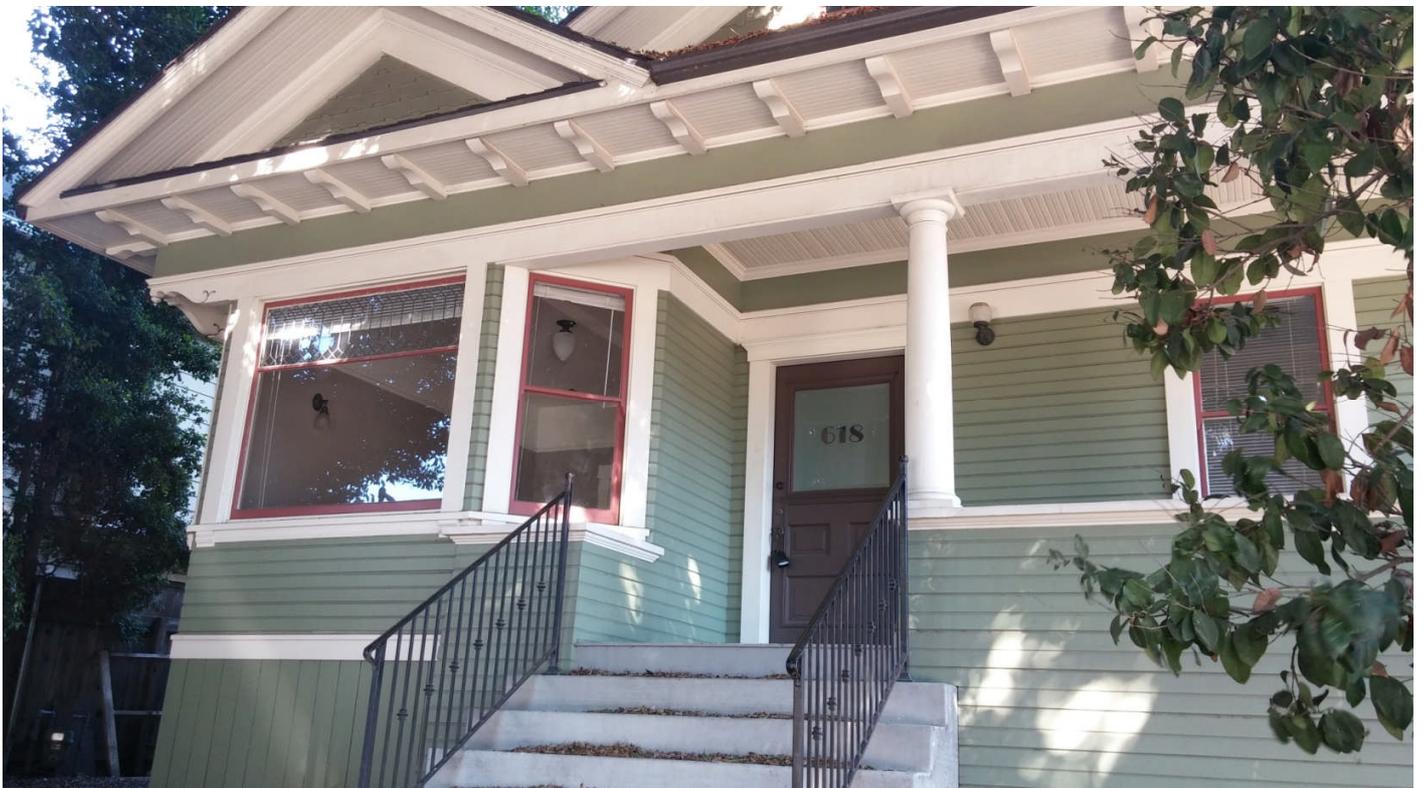
Figure 19  
West Elevation of the House at 618 Castillo of Street, looking east

Built in 1905 for Mrs. Katie Doone (Permit Log Book, November 10, 1905), the house at 618 Castillo Street is designed in the Free Classic Subtype of the Queen Anne style. The wood frame, story-and-a-half house is set on a raised concrete foundation. Narrow, clapboard style siding sheath covers the exterior walls while the raised foundation is sheathed in a combination of vertical board and clapboard siding. The house is capped by a complex gable on hipped roof with a secondary front gable on the street façade (west elevation), dormers on the north and east elevations and a hipped roof on the east elevation. The boxed eaves feature decorative rafter tails. The rafter tails rest on a wood board frieze. Fenestration is composed of one-over-one wood sash windows. Architectural detailing including moldings, porch columns and trimwork is broadly within the Free Classic style.

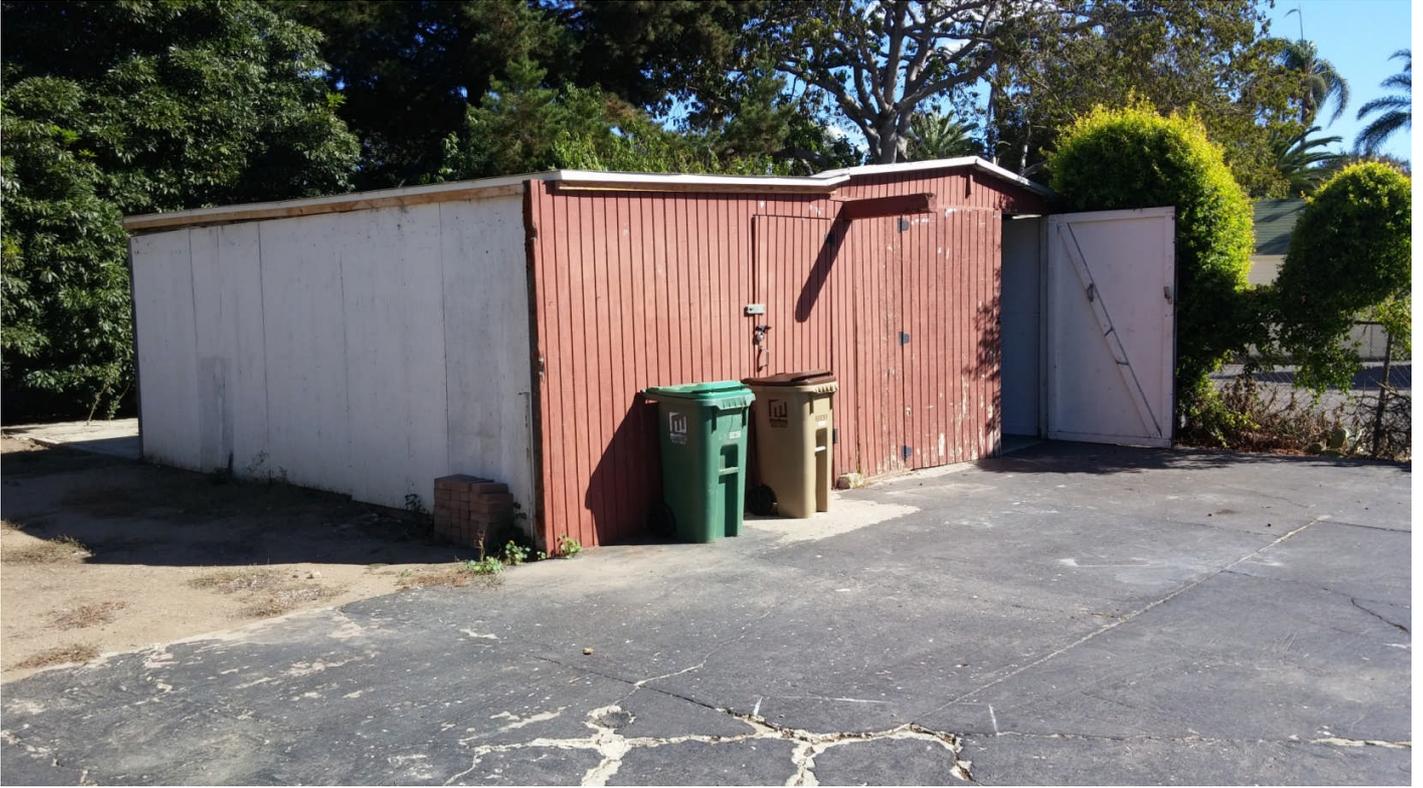
Figure 24  
Garage/Storage Room behind the House at 618 Castillo Street, looking  
southeast

The one-bay detached garage and storage room has a rectangular footprint. Set on a concrete slab foundation, its exterior is clad in manufactured vertical board style siding and plywood sheeting (Figure 24). The roof is a combination front gable and shed type. The west elevation facing towards Castillo Street is the primary elevation. It features a set of double doors opening into the garage and a person door providing access to the storage room.

- The garage/storage room, which included an office and unpermitted bathroom, was reduced in size to its current configuration in 2005 (BLD2005-00339). The slab foundations for the demolished sections of the building are still in place. A precise date for its construction could not be determined as a building permit or an entry in the Permit Log Book (1902-1925) could not be located. A review of Sanborn Fire Insurance Company maps reveals the original garage was built sometime between 1907 and 1930.
