## **POST/HAZELTINE ASSOCIATES**

### **Architectural Historians**

#### **1.0 INTRODUCTION AND REGULATORY FRAMEWORK**

## **5.5 Revised Plans for the Pedestrian Pathway along Puesta del Sol**

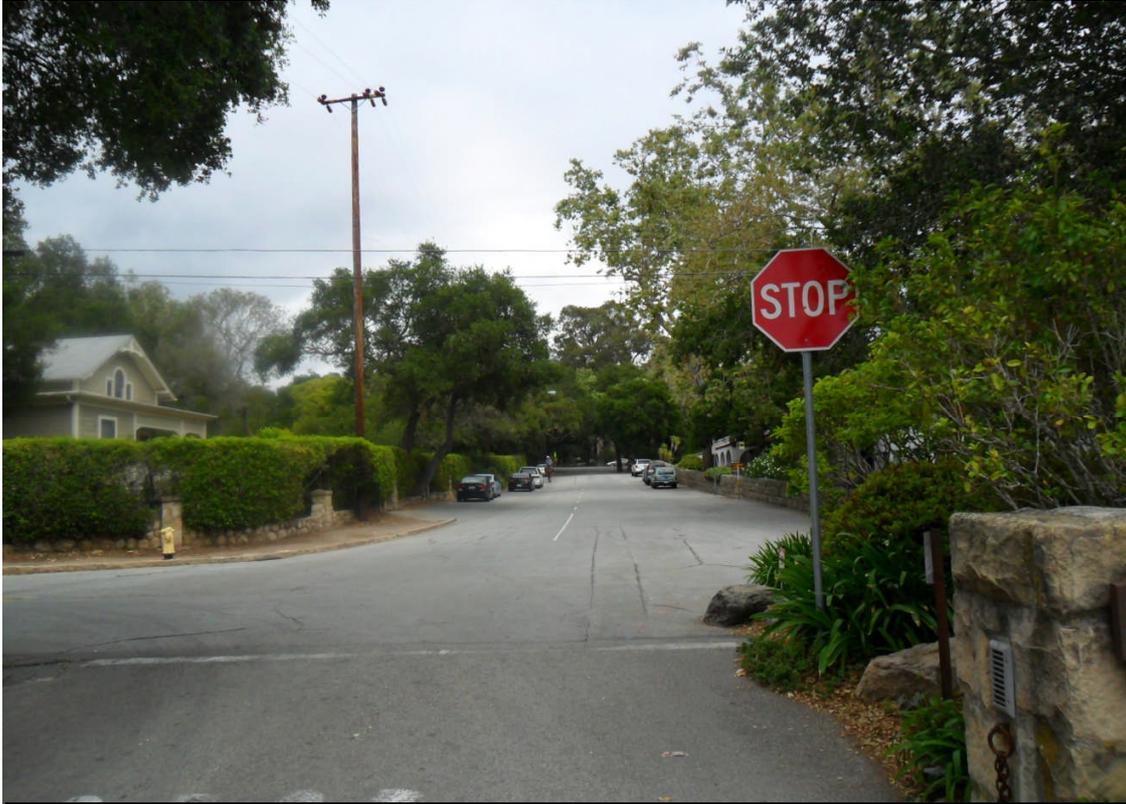
Figure 1  
South and North Sides of Puesta del Sol (looking east)

Puesta del Sol is a one-way asphalt-paved street exiting onto Mission Canyon Road (Figures 1 & 2) (further images may be found on the landscape architect's plan). On its north side the road is delineated by the following three residential properties owned by the Santa Barbara Museum of Natural History: 1) 653 Mission Canyon Road; 2) 2556 Puesta del Sol; and 3) 2565 Puesta del Sol (the history and significance of these properties are delineated in the Phase 1 and Phase 2 HSSRs previously prepared by Post/Hazeltine Associates). On its north side the roadway is defined by informal hedges and in some places, low sandstone walls. The south side of the street is defined by the Hazard Estate wall which extends west from Mission Canyon Road to the gates flanking Fleischman Auditorium. To the south of the Hazard estate wall is the main Museum building flanked on its east by the former Hazard carriage house at 2539 Puesta del Sol. The roadway itself is bordered on either side by streetside parking. A section of sandstone curbing, likely dating to the early 20<sup>th</sup> century, is located on the eastside of the street where it turns to the north to intersect with Las Encinas. Originally the street was likely unpaved, which matches the condition

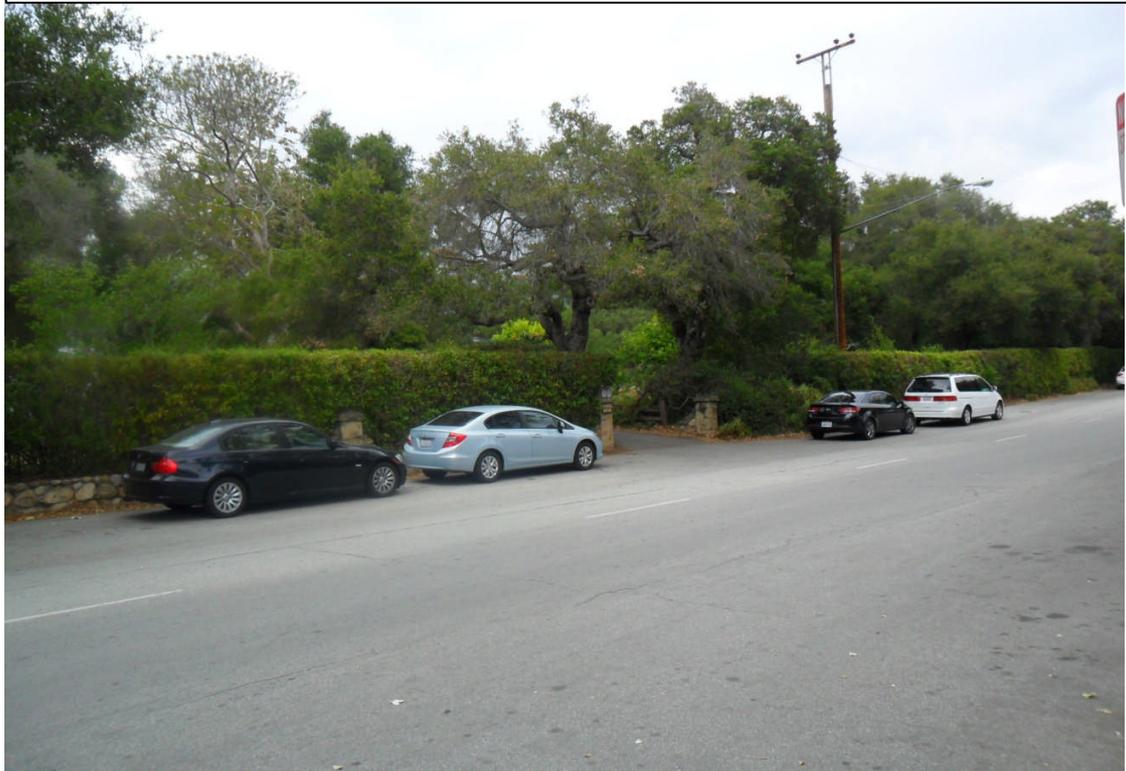
Figure 2  
North Side of Puesta del Sol (looking northeast)

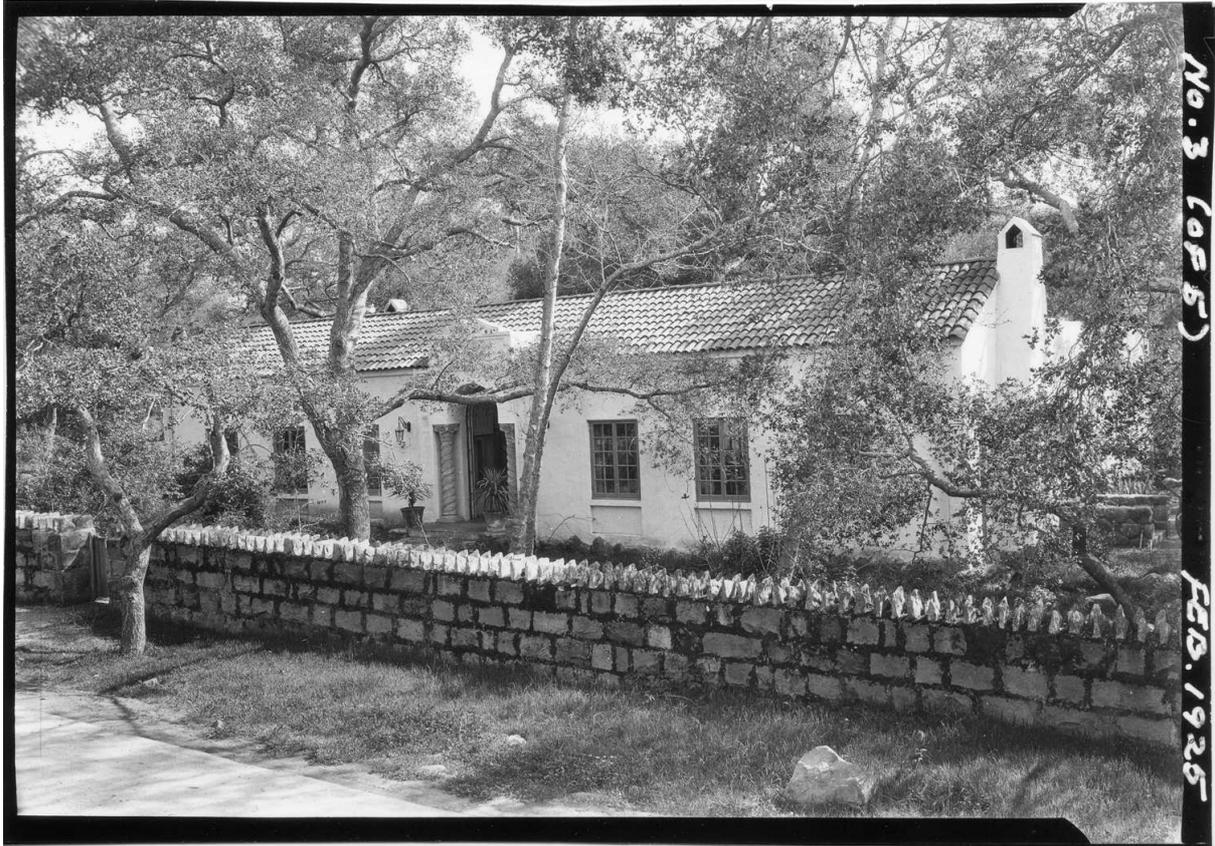
Figure 3  
South Side of Puesta Del Sol in February of 1925

depicted on a 1898 Bird's Eye Map of Santa Barbara. A photograph of the Museum frontage, taken in February of 1925 indicates that the roadway original paving may have been concrete based on an inspection of the photograph, which depicts a light-colored material with a hard edge and what appears to be an expansion joint (Figure 3). The south side of Puesta del Sol was bordered by a wide bed planted with grasses and native oaks set amongst sandstone rocks (Figure 4 and see Figure 3). The appearance of the north side of the roadway is not documented by early photographs. It is not clear as to when the current asphalt paving was installed although it appears to have been in place by the late 1940s or early 1950s based on an inspection of photographs taken between the late 1930s and the early 1950s. It is not clear as to when the landscaped area bordering the Hazard estate wall was converted to paved parking, although it appears to have occurred by the early to mid-1960s.

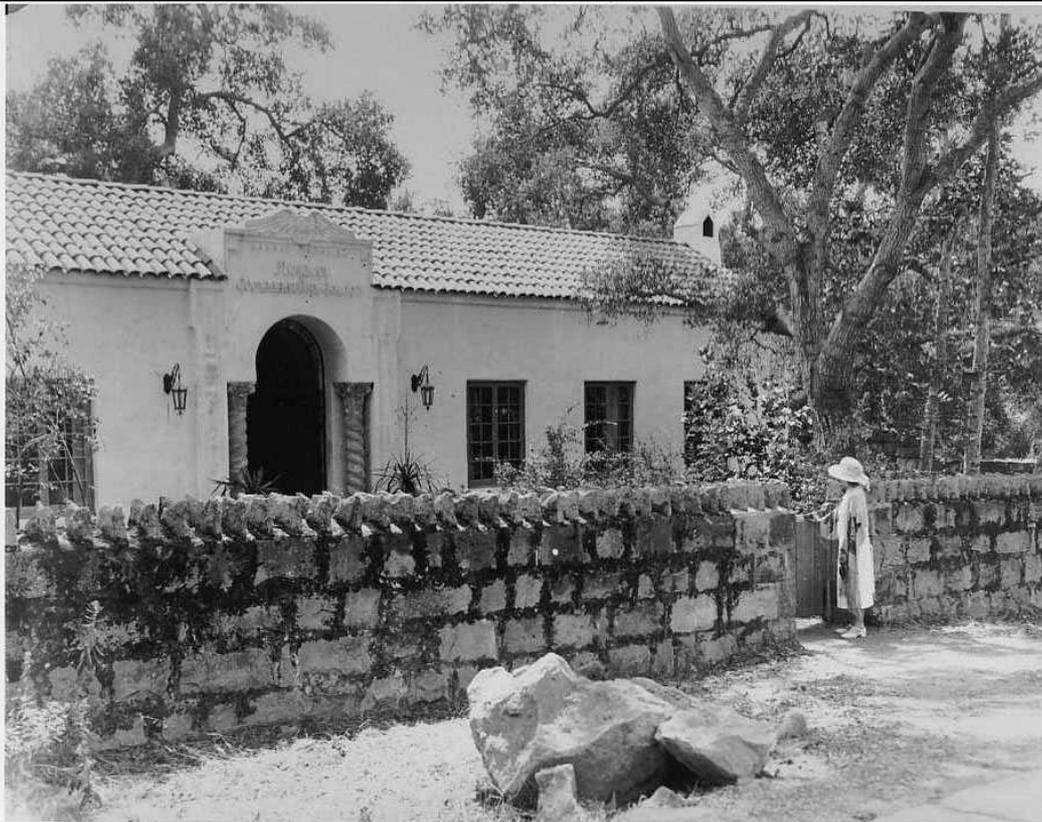
Figure 4  
Entrance to Museum in circa-1925
