**HISTORIC STRUCTURES/SITES REPORT
314 WEST ORTEGA STREET
SANTA BARBARA, CALIFORNIA
APN 037-073-012**

FINAL

March 2016

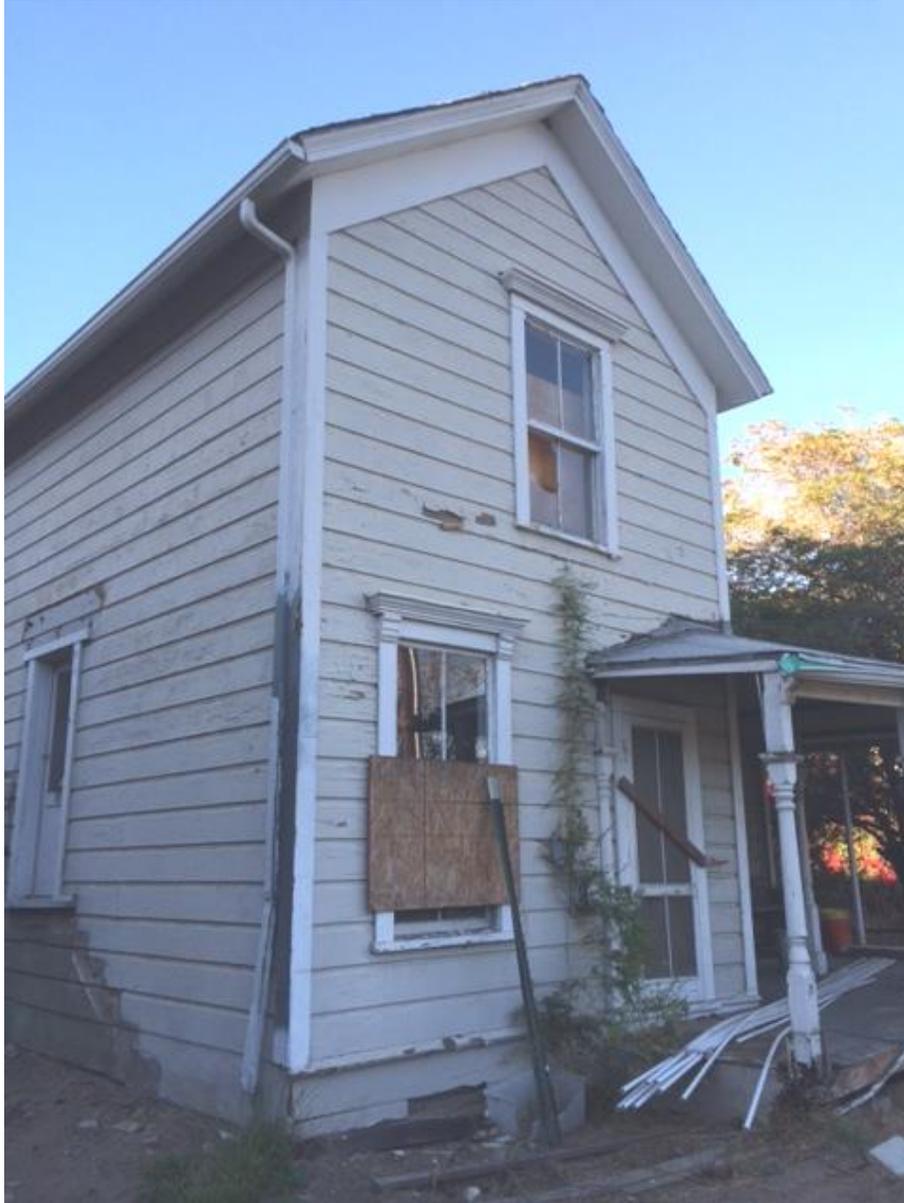
Plate 4. Façade facing West Ortega Street. Facing northeast.

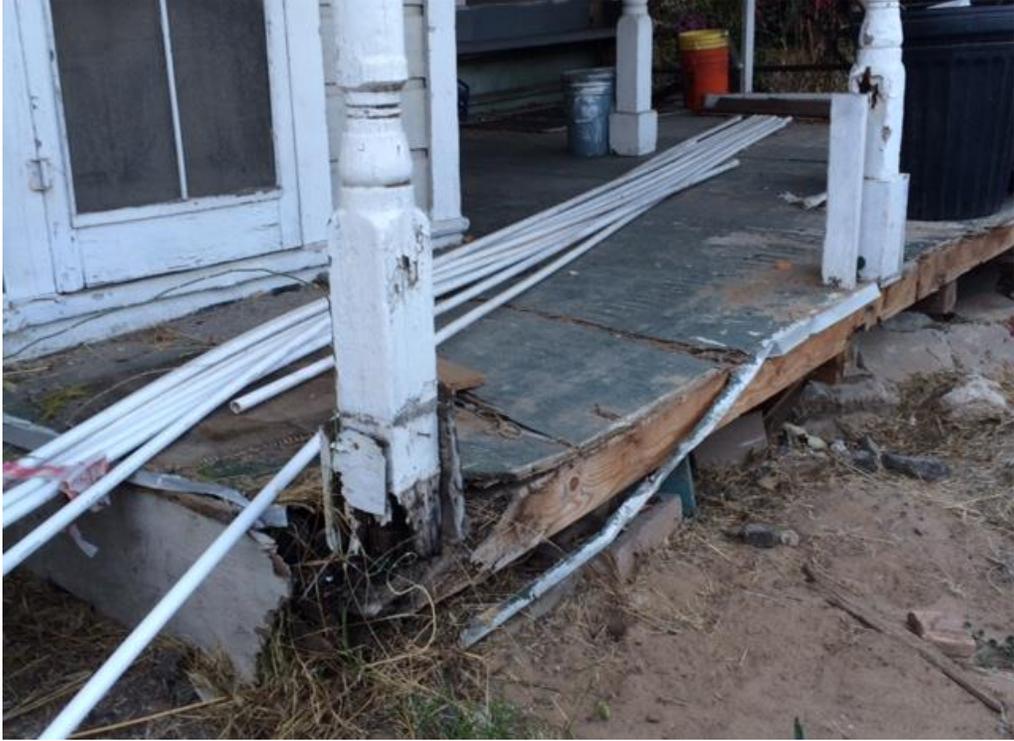
Plate 5. Detail showing replacement plywood decking at front porch. Facing northeast.

Façade. The porch was expanded to cover the entire front of the house, cutting off the decorative lintel on the window in the east wing. The new posts to support the widened porch were simple square wood. The porch stairs were removed and the decking was altered to plywood. A new door was added on the main block, and the original front door was moved there. A new modern door was added at the original front door entry in the east wing. The original decorative porch posts have been repainted with a rough-finish non-historic paint.

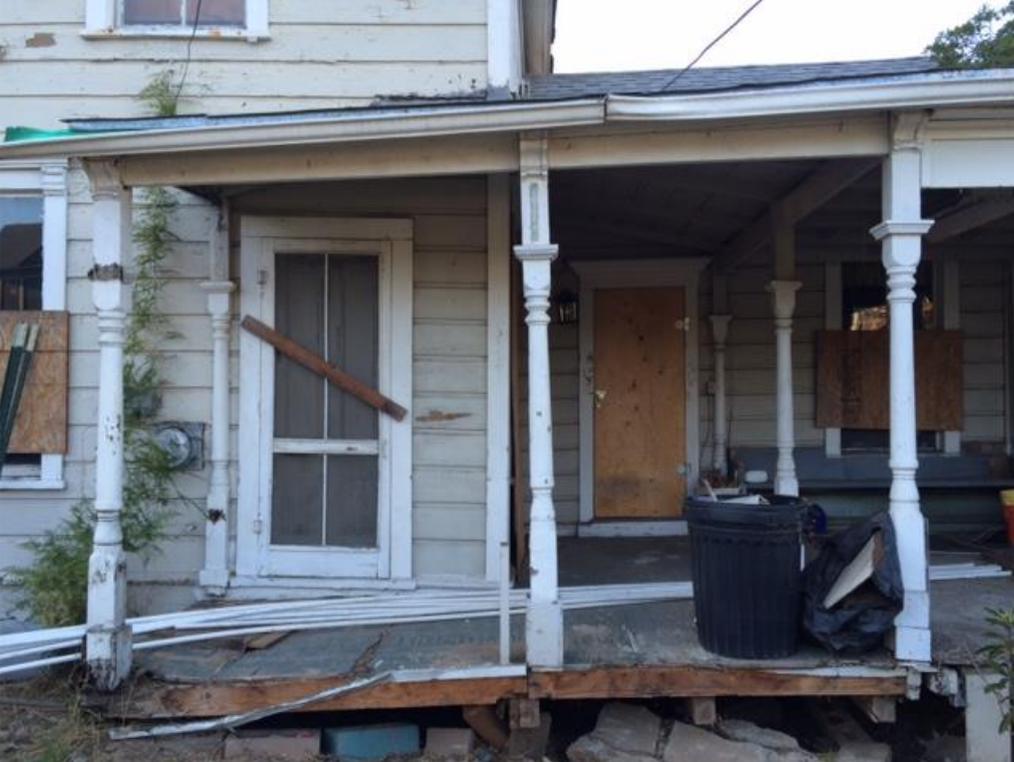
Plate 6. Detail showing new door opening at left, original door opening at rear, and turned posts showing the original L-shaped configuration of the entry porch. Facing north.

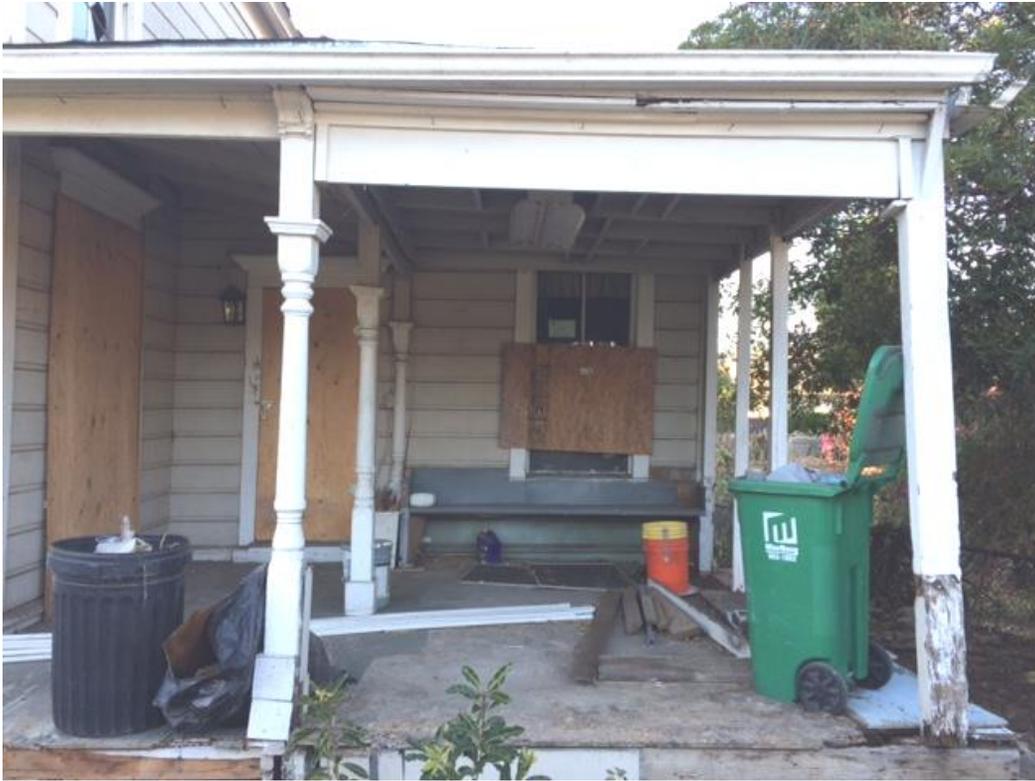
Plate 7. Detail showing porch extension with wood posts, and roof extension which has cut off the decorative lintel at the rear window. Facing north.

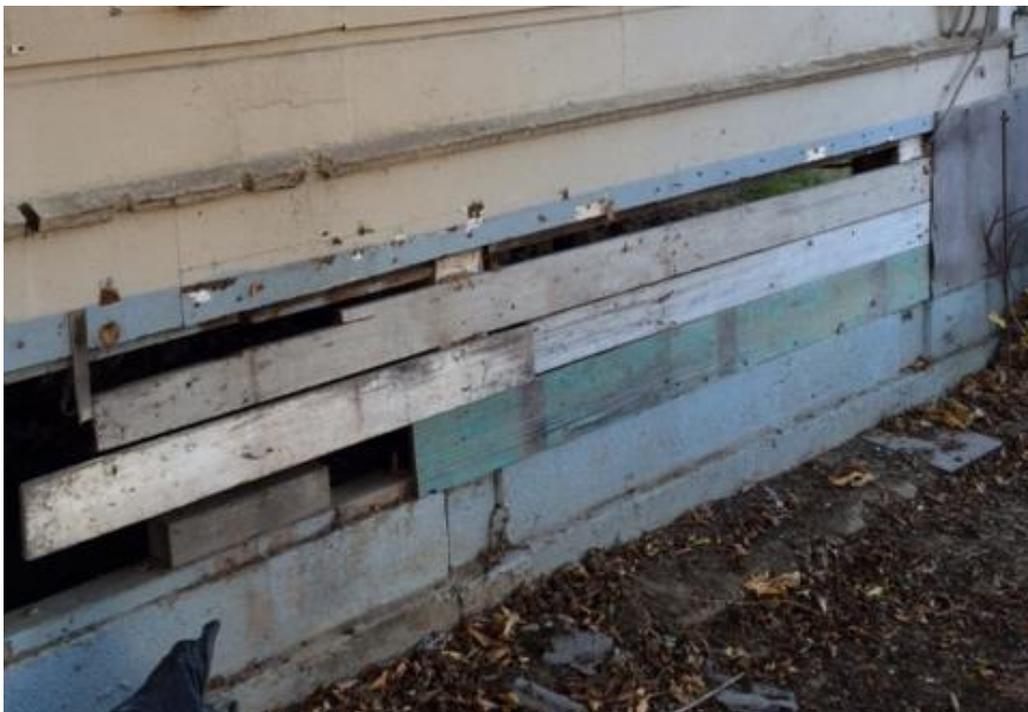
Plate 8. Detail of modern siding enclosing open foundation area at east elevation. Facing northwest.

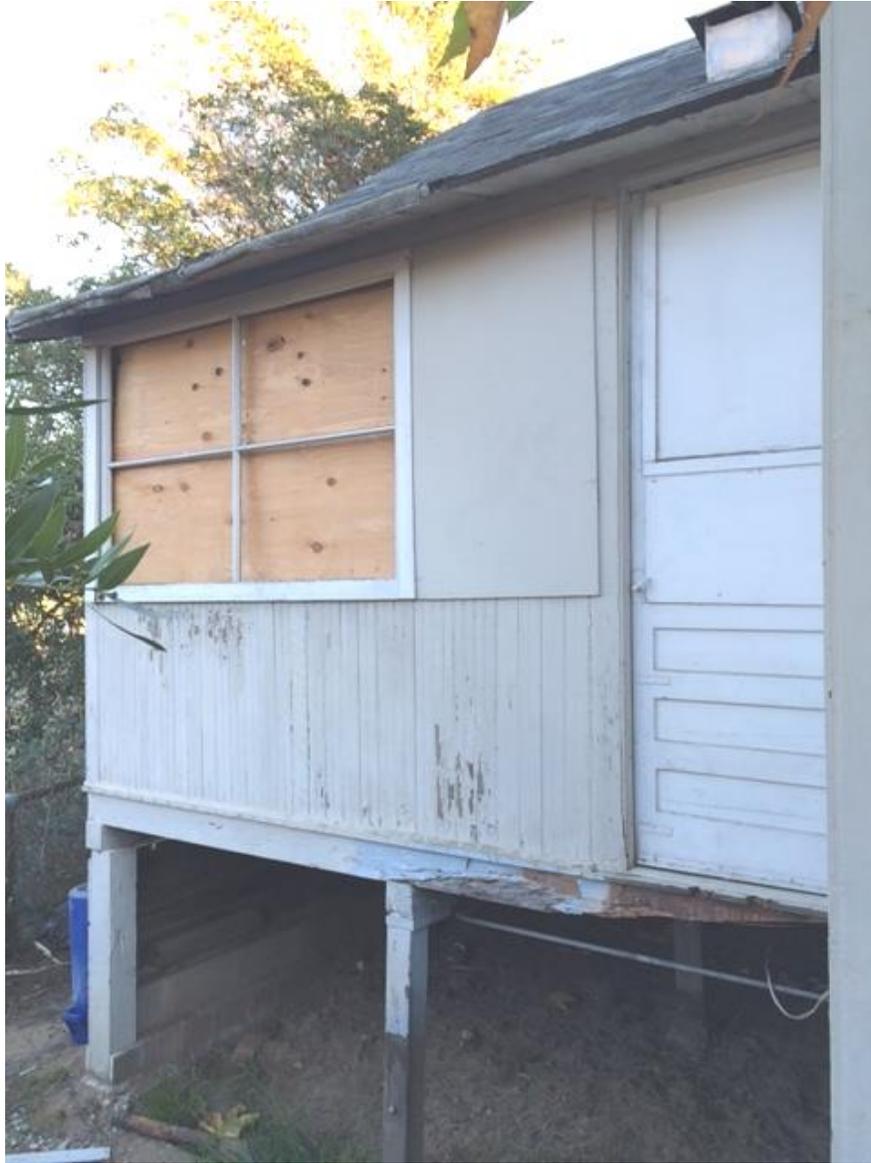
Plate 9. 1943 porch enclosure at northeast corner. The stairs to this door have been removed. Facing southeast.

North elevation. The stairs at the northeast infilled porch were removed. The shed roof bay at the northwest corner was added onto for a storage room, and its west side was stuccoed. Its rear doorway is missing.

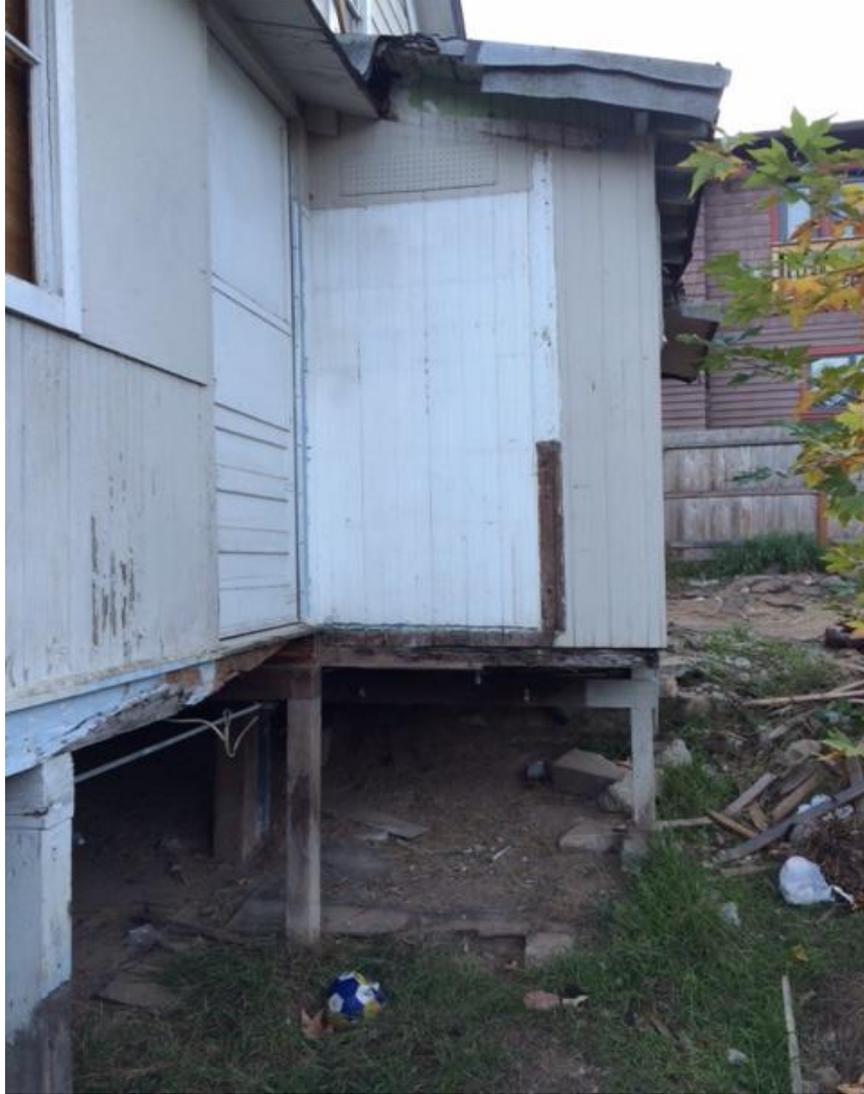
Plate 10. 1943 bathroom addition at northeast corner. Facing west.

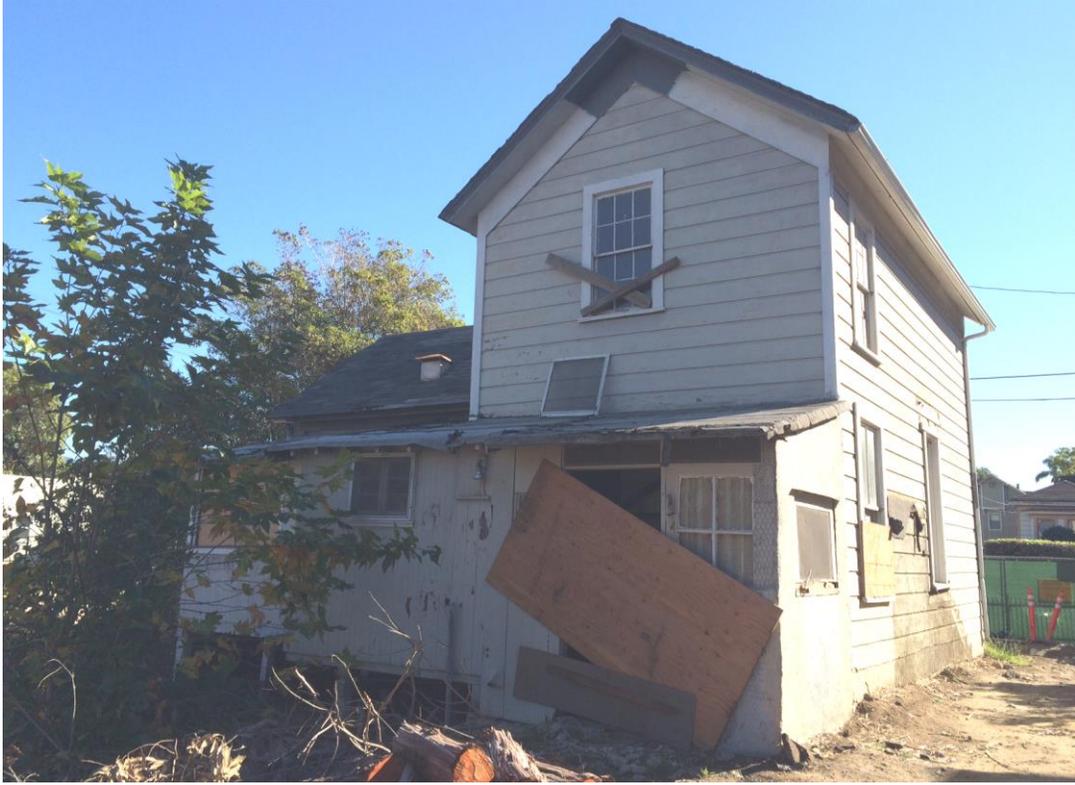
Plate 11. Rear north elevation showing modern additions. Facing southeast.

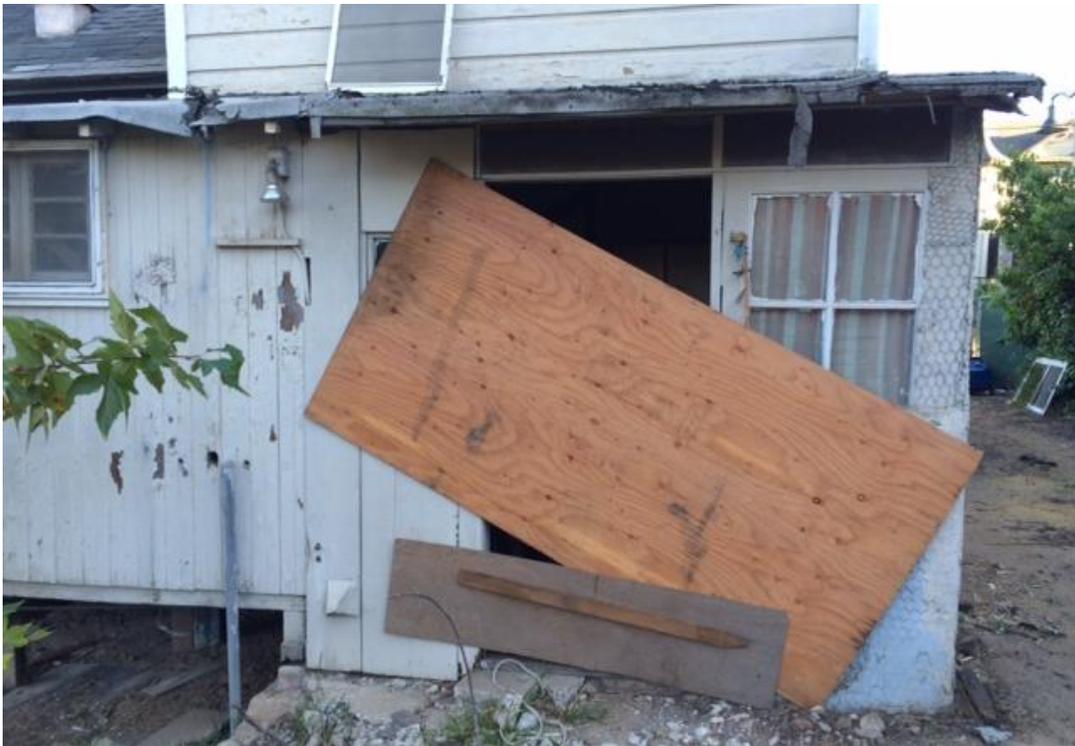
Plate 12. Detail showing storage extension at northwest corner. Facing south.

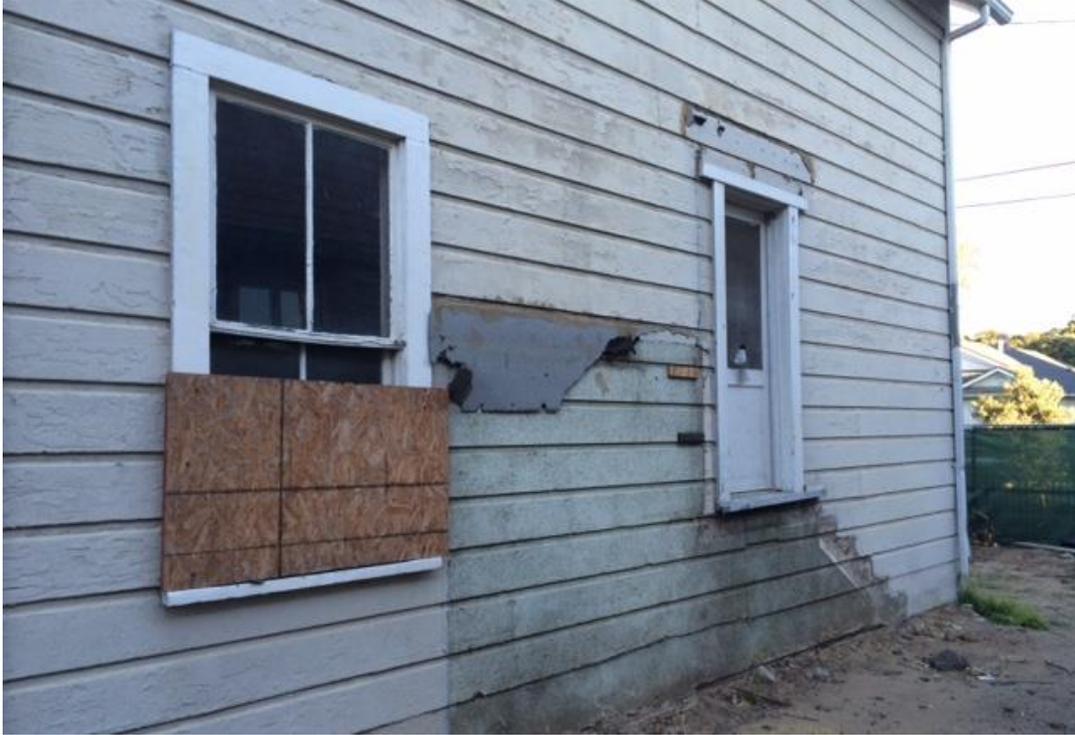
Plate 13. Detail of west elevation showing door cut into the siding. Facing southeast

West elevation. A new high door was cut into this elevation, with a flight of stairs which have since been removed.

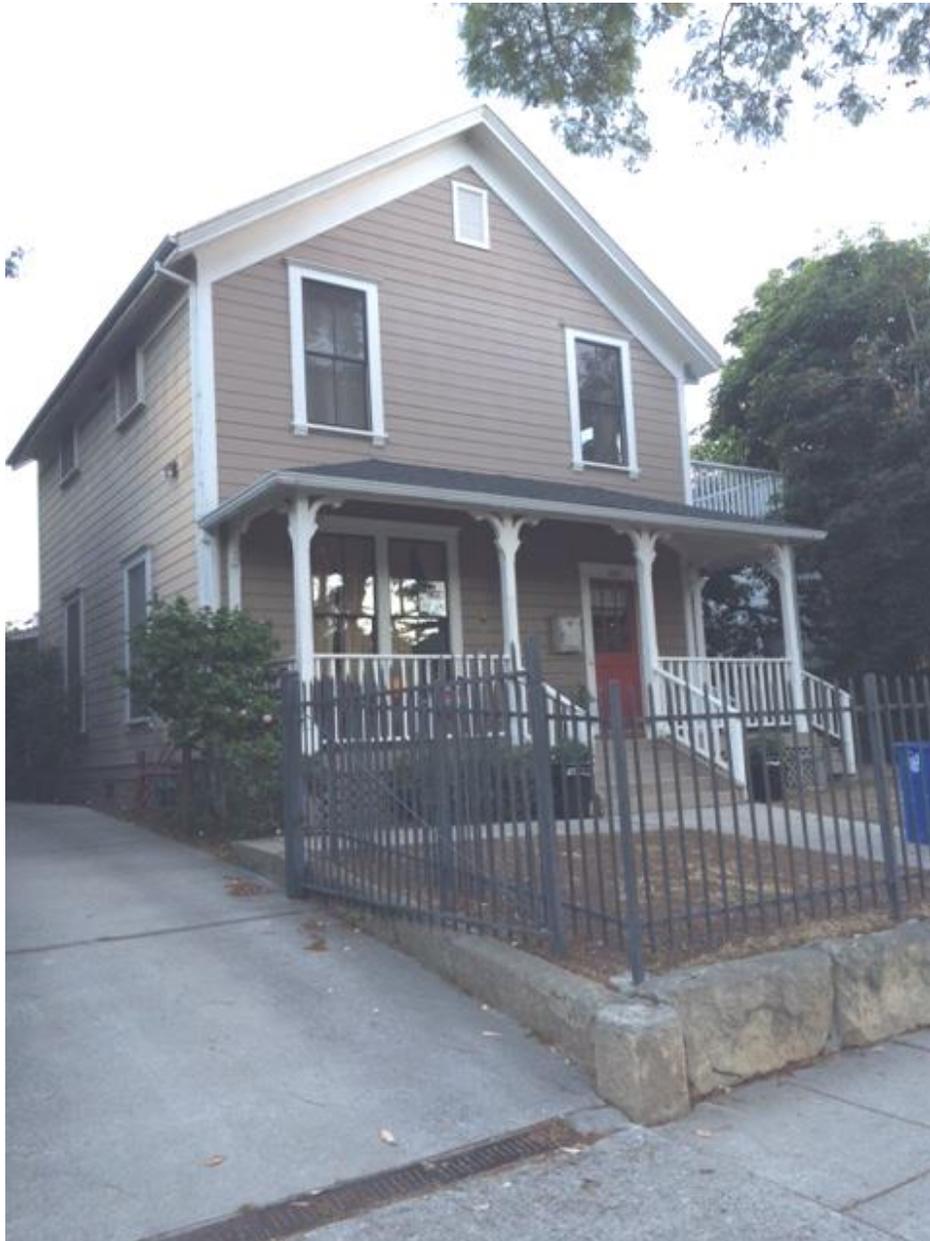
Plate 14. Vernacular house at 329 West Ortega Street determined a contributing property to the West Downtown Castillo Street Historic District. Facing southwest.

Criterion 6. The building is not eligible under Criterion 6. Because of its alterations, it no longer contributes to the overall visual character of the neighborhood. Within the immediate vicinity is a two-story house at 329 West Ortega which retains the architectural details of the National style and is listed as a contributing member to the potential district (see Plate 14).
