Phase I Environmental Site Assessment

1722 State Street
Santa Barbara, California

Rincon Consultants, Inc.
July 27, 2005

July 27, 2005
Project 05-19400

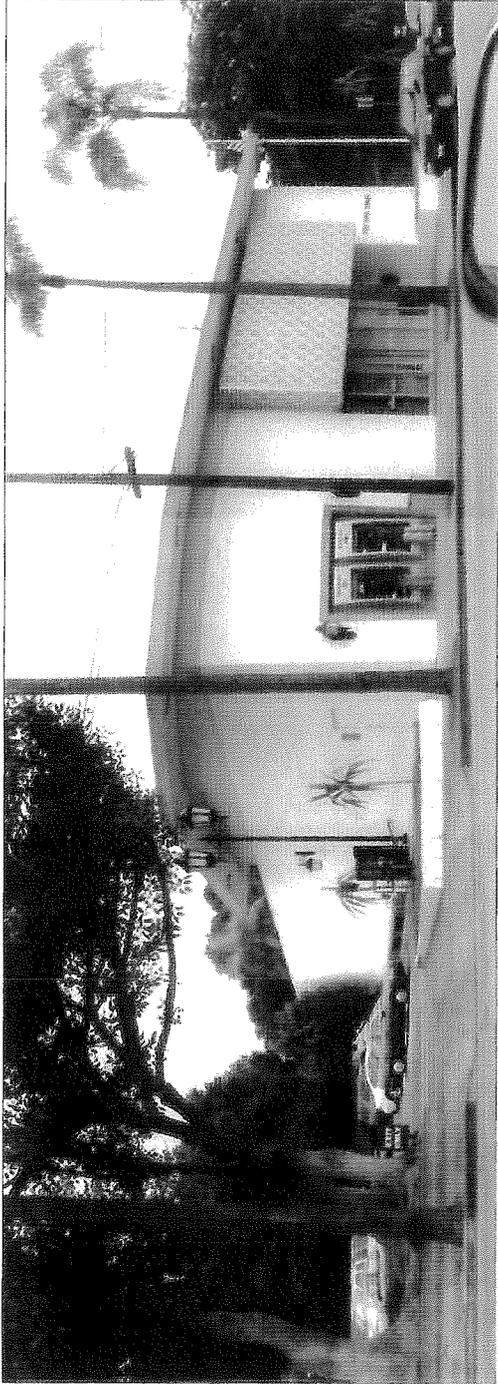
Photograph A: View of the subject property from across State Street, facing east.

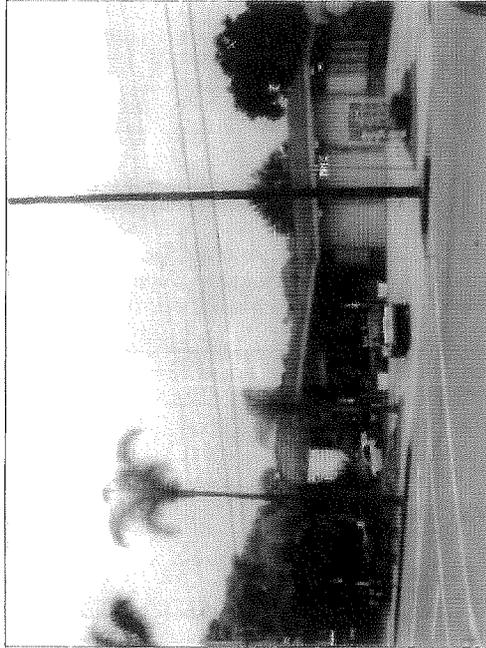
Photograph B: View of the nearby upgradient, existing Exxon (former Chevron) Service Station located at 1800 State Street, facing north.

A reconnaissance of the site was performed on June 15, 2005. The purpose of the reconnaissance was to observe existing site conditions and to identify obvious indicators of hazardous materials that could affect the subject site. The two-story, 7,600-square-foot building located on the site was originally developed as a bank. The interior of the bank building has been converted into offices and classrooms for the Brooks Institute. Automatic teller machines (ATMs) are located on the southwest side of the building, fronting State Street. The remaining portions of the site are paved parking areas and landscaped areas. During the site reconnaissance, the storage of miscellaneous household cleaners was observed in the janitorial closet on the second floor. No other hazardous substances were observed at the site. During the site reconnaissance, four groundwater monitoring wells were observed within the parking lot areas on the subject property. These groundwater monitoring wells were installed by Chevron to monitor a plume of gasoline-impacted groundwater originating from a nearby upgradient Chevron site located at 1800 State Street.

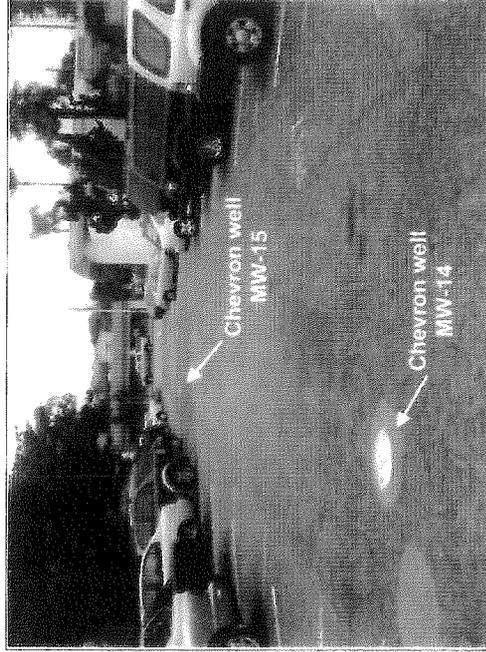
Photograph C: View of the parking lot located on the eastern and southeastern portion of the site, facing southwest.

During the site reconnaissance, several storm drains were observed in the parking areas of the subject property.

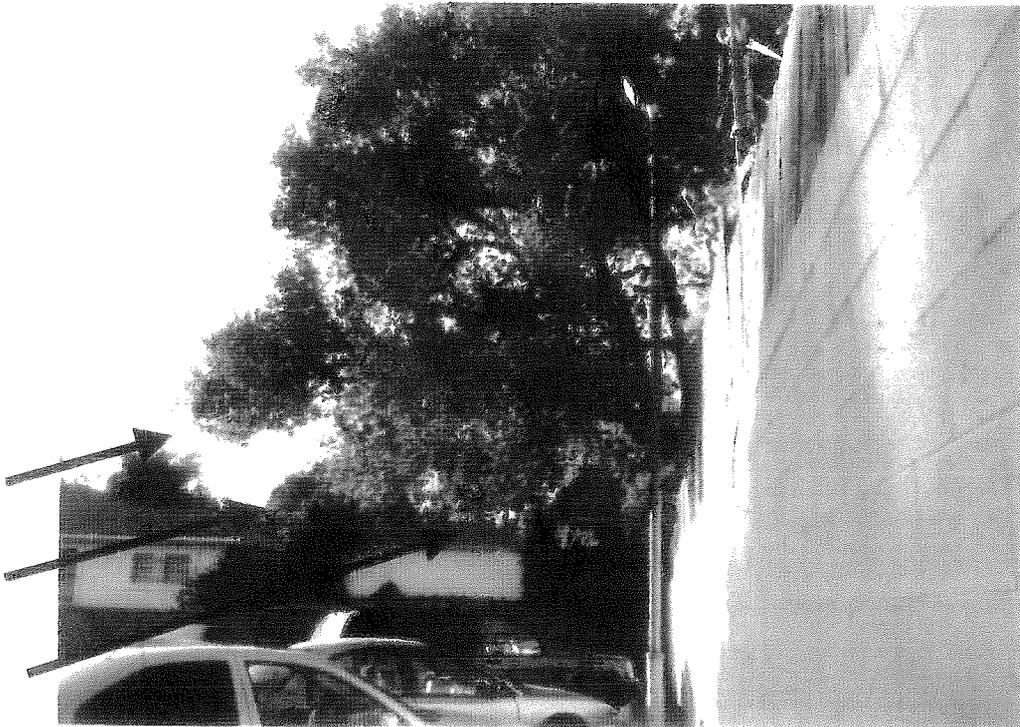
Despite limitations to the root system, the crown of foliage is growing vigorously and overhangs 1722 State St. The removal of several low limbs on the oak to avoid conflicts between the proposed structure and the tree will not cause harm to its health. There will be adequate foliage, remaining on the oak to sustain physiological processes. In fact, the current condition of the lower limbs pose risks to people and vehicles in the parking lot and is overdue for pruning, with or without the project. See photos below.

Figure 2: Looking from the south, a view of the overhanging limbs. The arrow points to limbs that need to be removed.

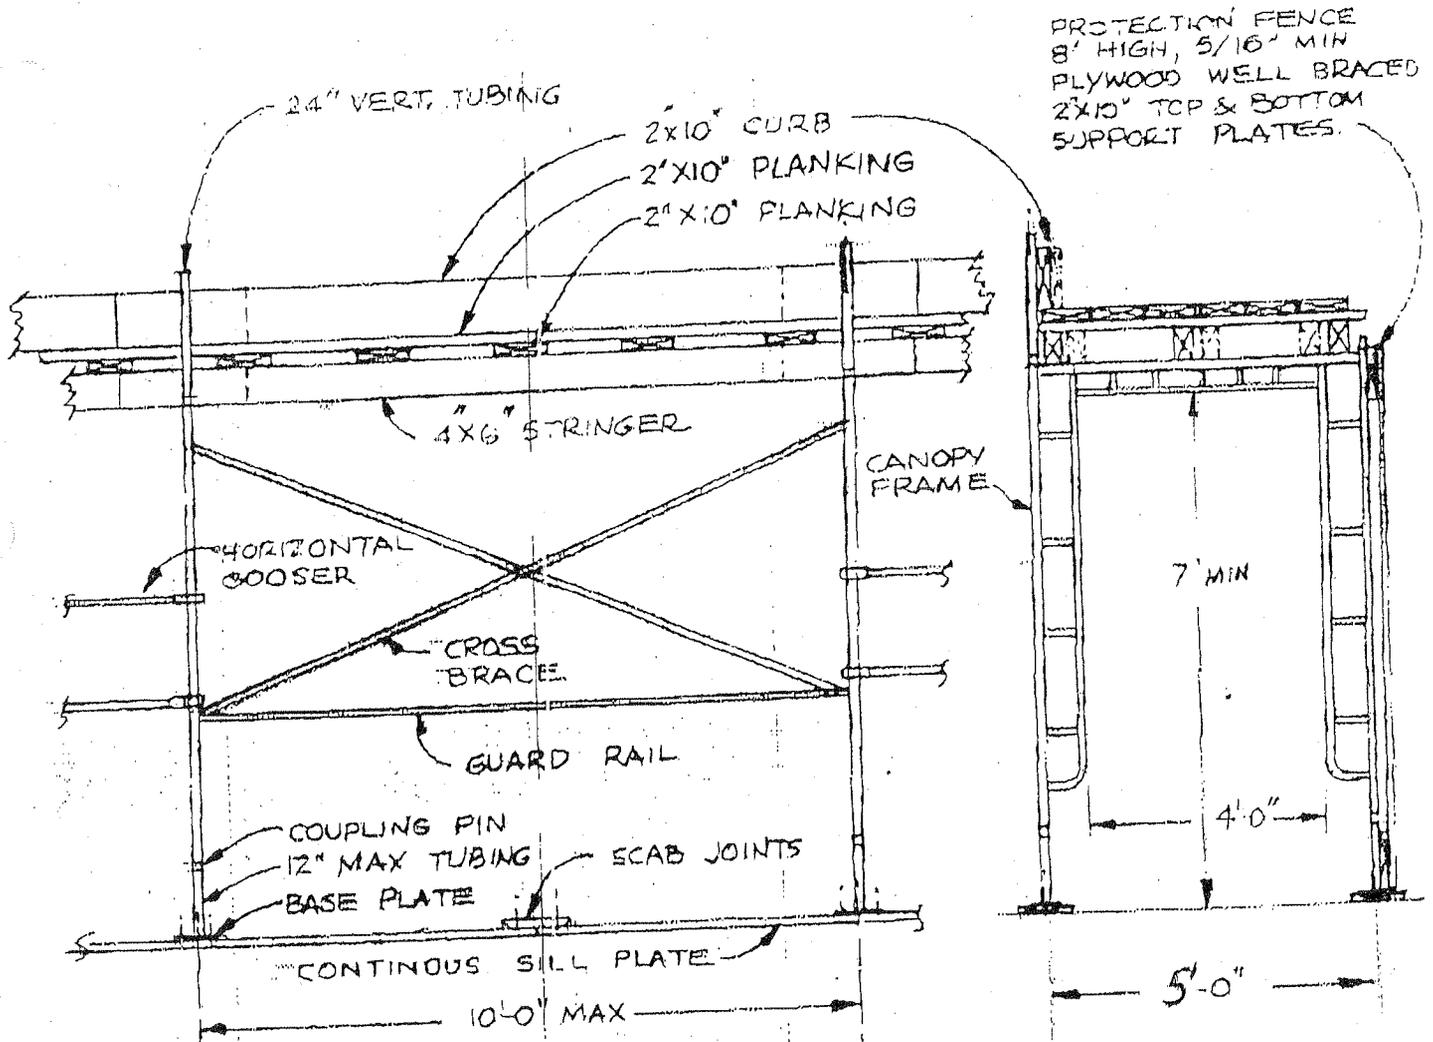
EXHIBIT 'A'

CONSTRUCTION STANDARD HEAVY DUTY CANOPY & FENCE

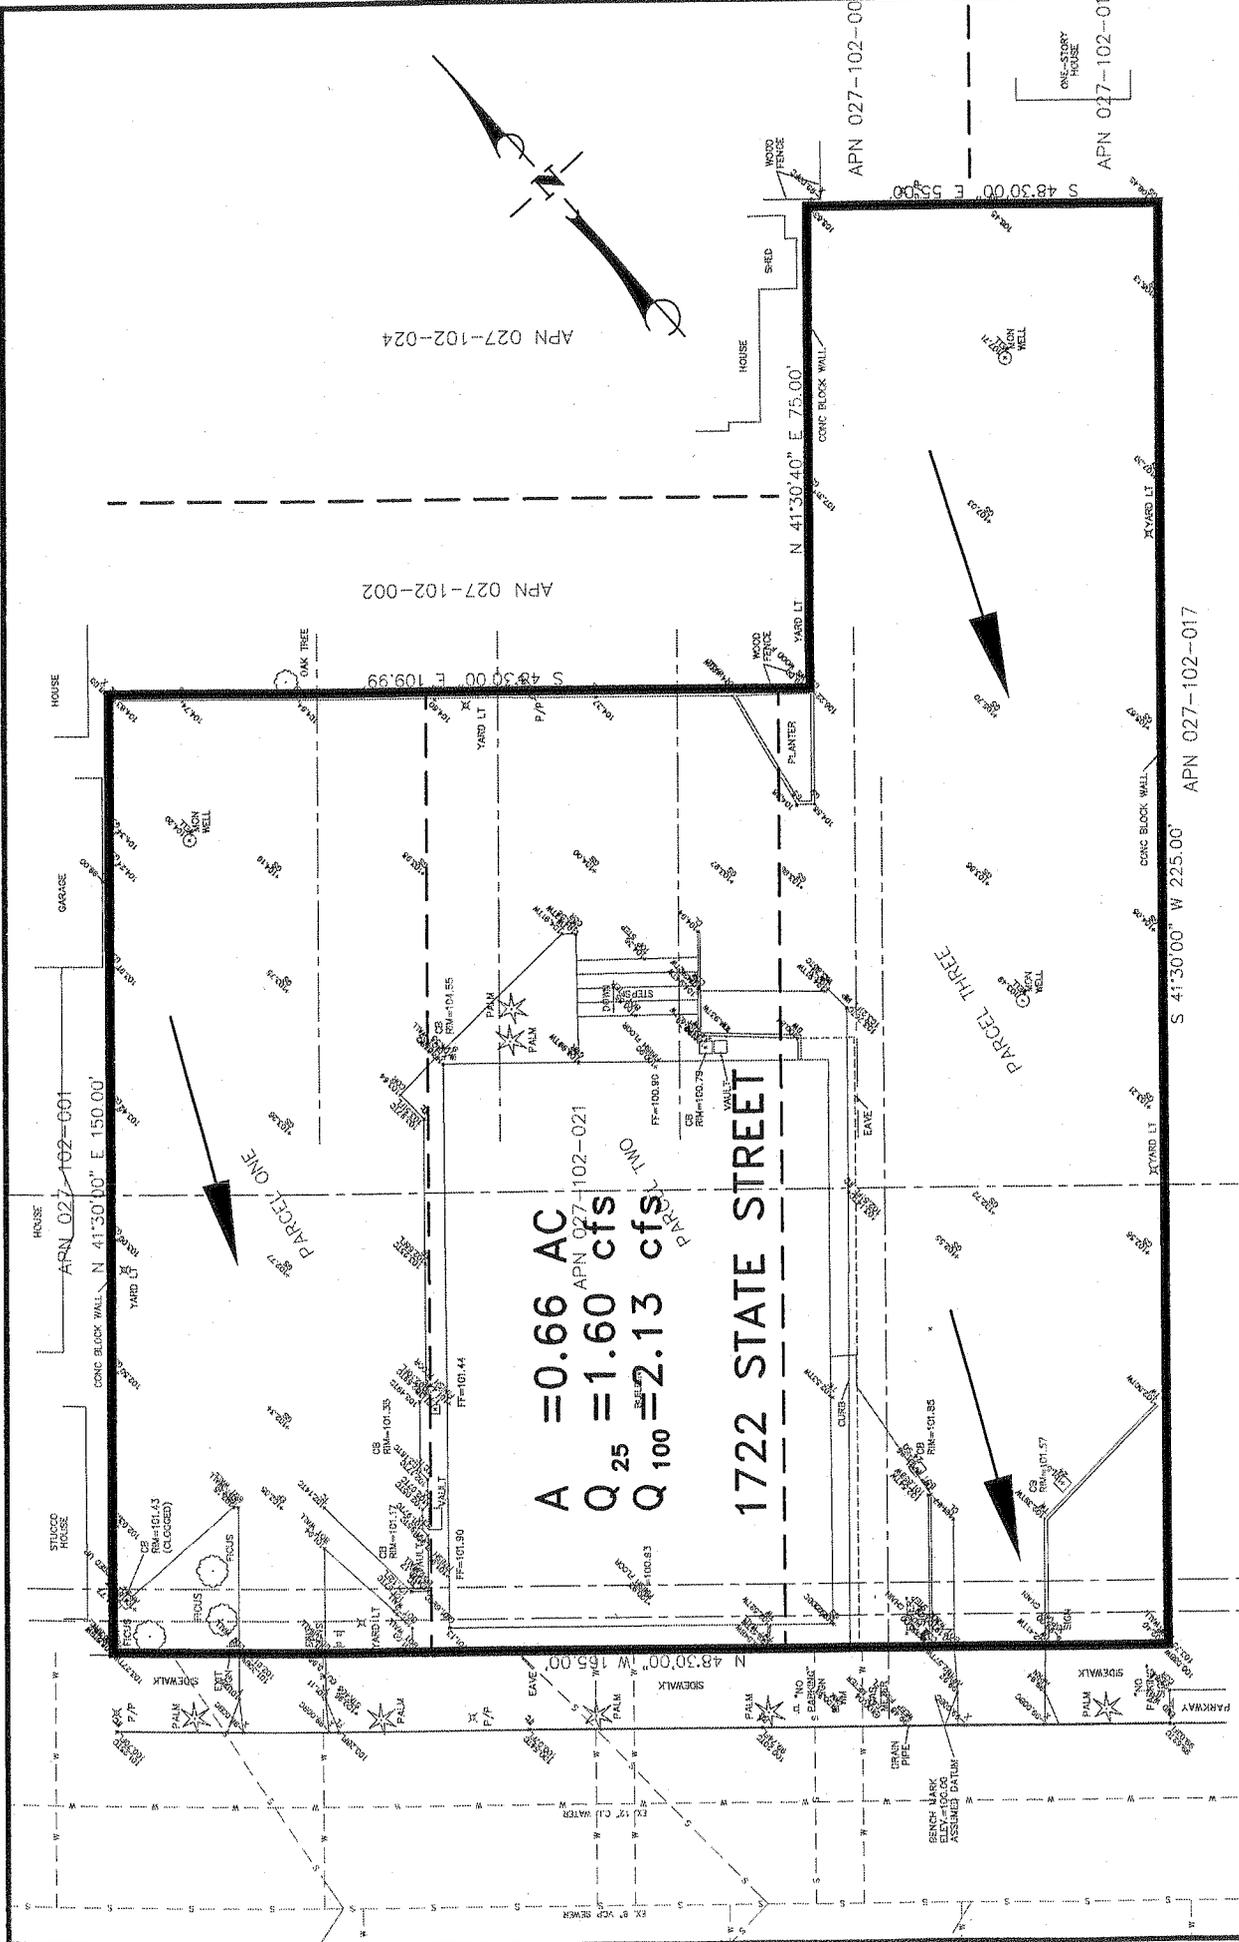
Results:			
	Rainfall Intensity:	Runoff Coef:	Q (cfs):
Q10:	2.61	0.73	1.26
Q25:	3.18	0.76	1.60
Q50:	3.68	0.79	1.92
Q100:	4.03	0.80	2.13
			<input type="button" value="View RI Curves"/>
			<input type="button" value="Print"/>
			<input type="button" value="View RC Curves"/>
			<input type="button" value="Exit"/>

A = 0.66 AC
Q₂₅ = 1.60 cfs
Q₁₀₀ = 2.13 cfs
