City of Santa Barbara California

PLANNING COMMISSION STAFF REPORT

REPORT DATE: April 14, 2016
AGENDA DATE: April 21, 2016
PROJECT ADDRESS: 801 Cliff Drive (MST2014-00586)
TO: Planning Commission
FROM: Planning Division, (805) 564-5470, extension 4539
Beatriz Gularte, Senior Planner *BGB*
Tony Boughman, Assistant Planner *TB*

**BIOLOGICAL ASSESSMENT OF EUCALYPTUS TREE REMOVAL,
HONDA VALLEY, 801-831 CLIFF DRIVE (APN 045-250-008),
SANTA BARBARA, CALIFORNIA**

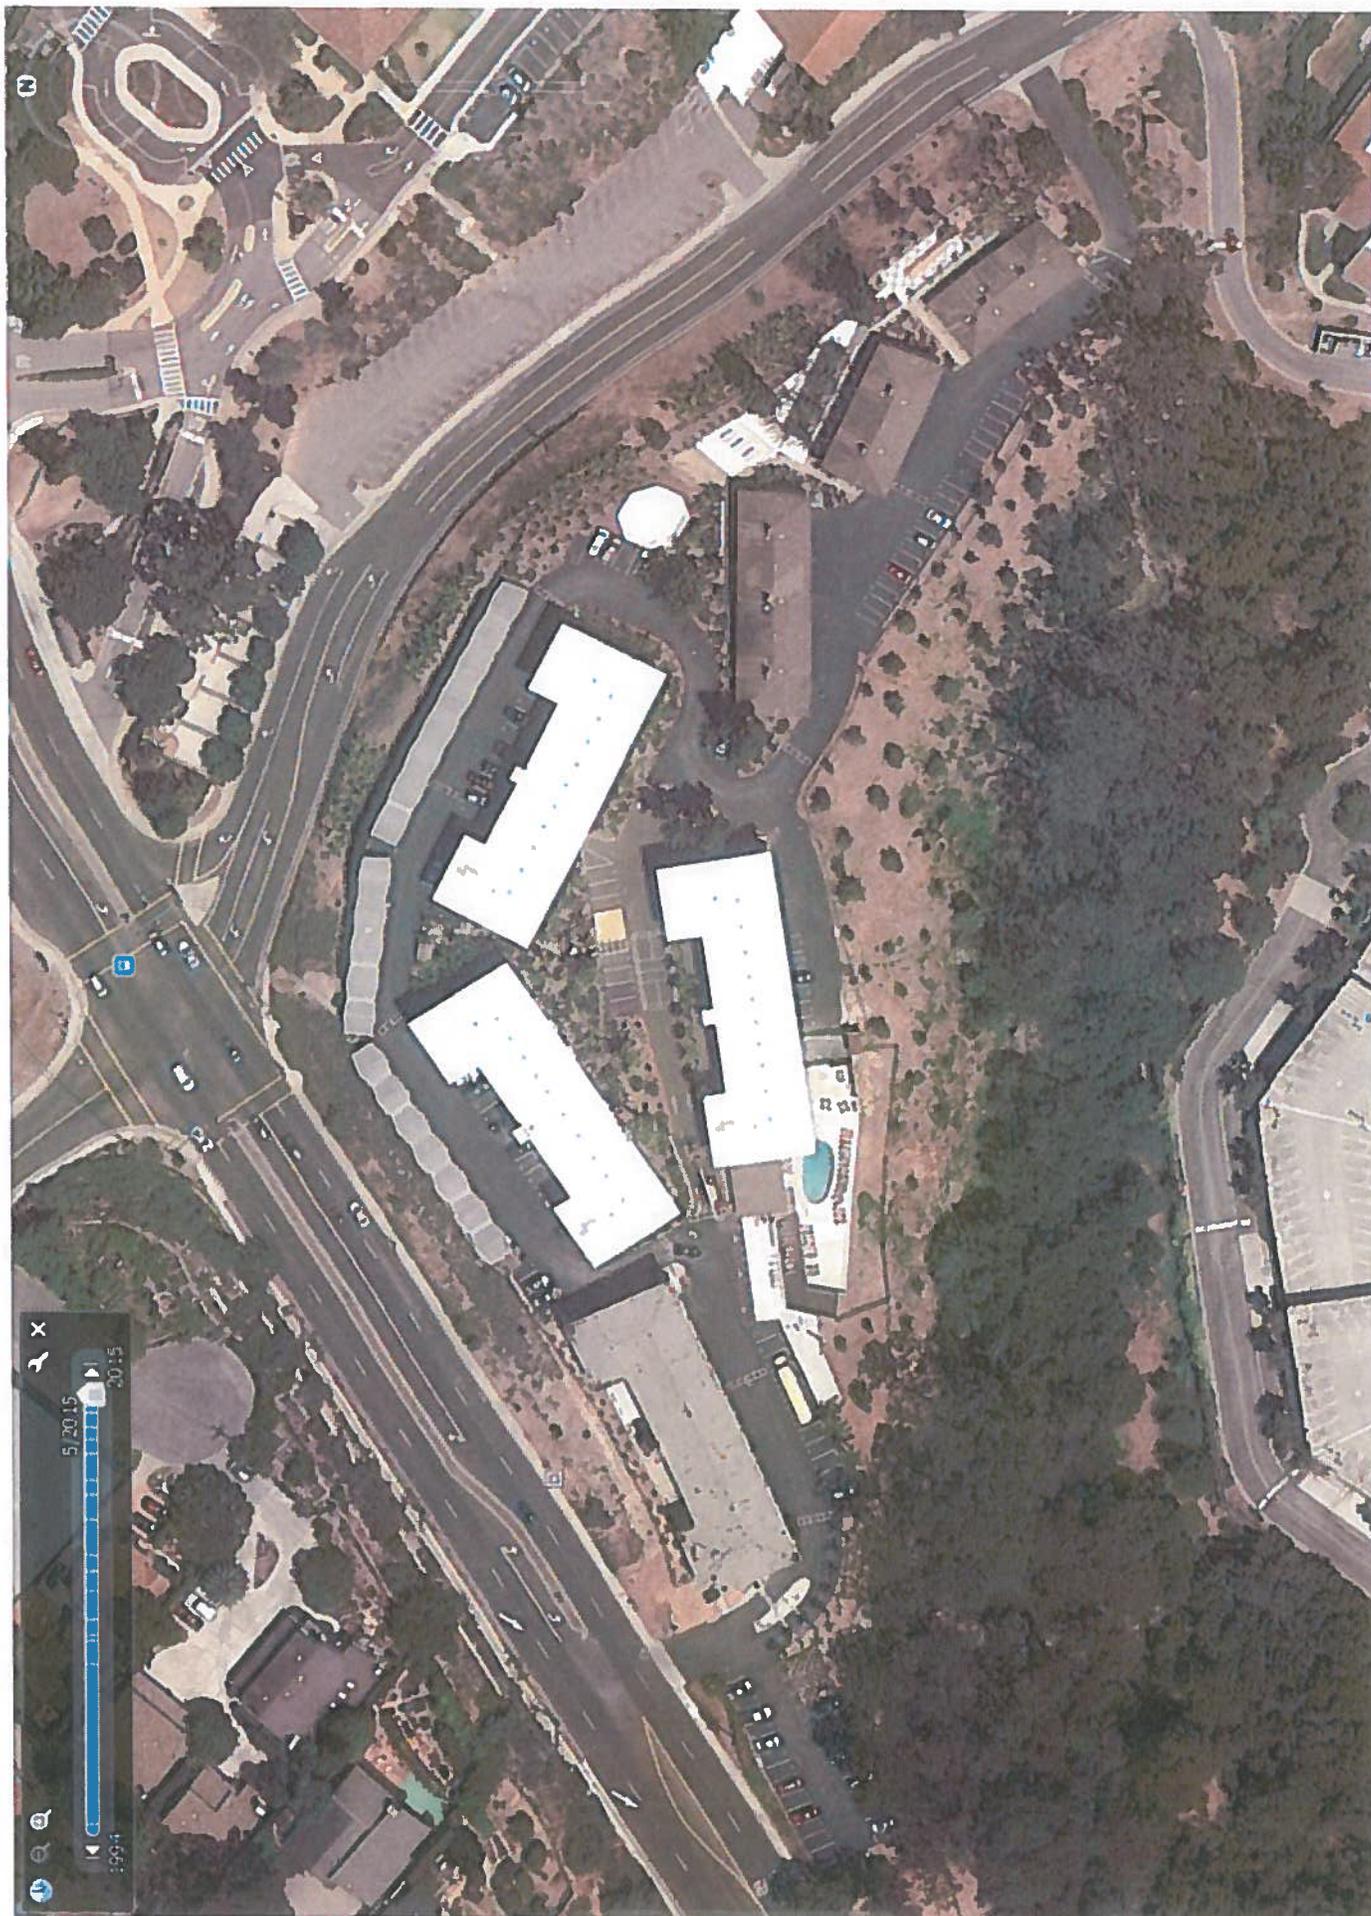
Google Earth May 2015 - After Work Was Done

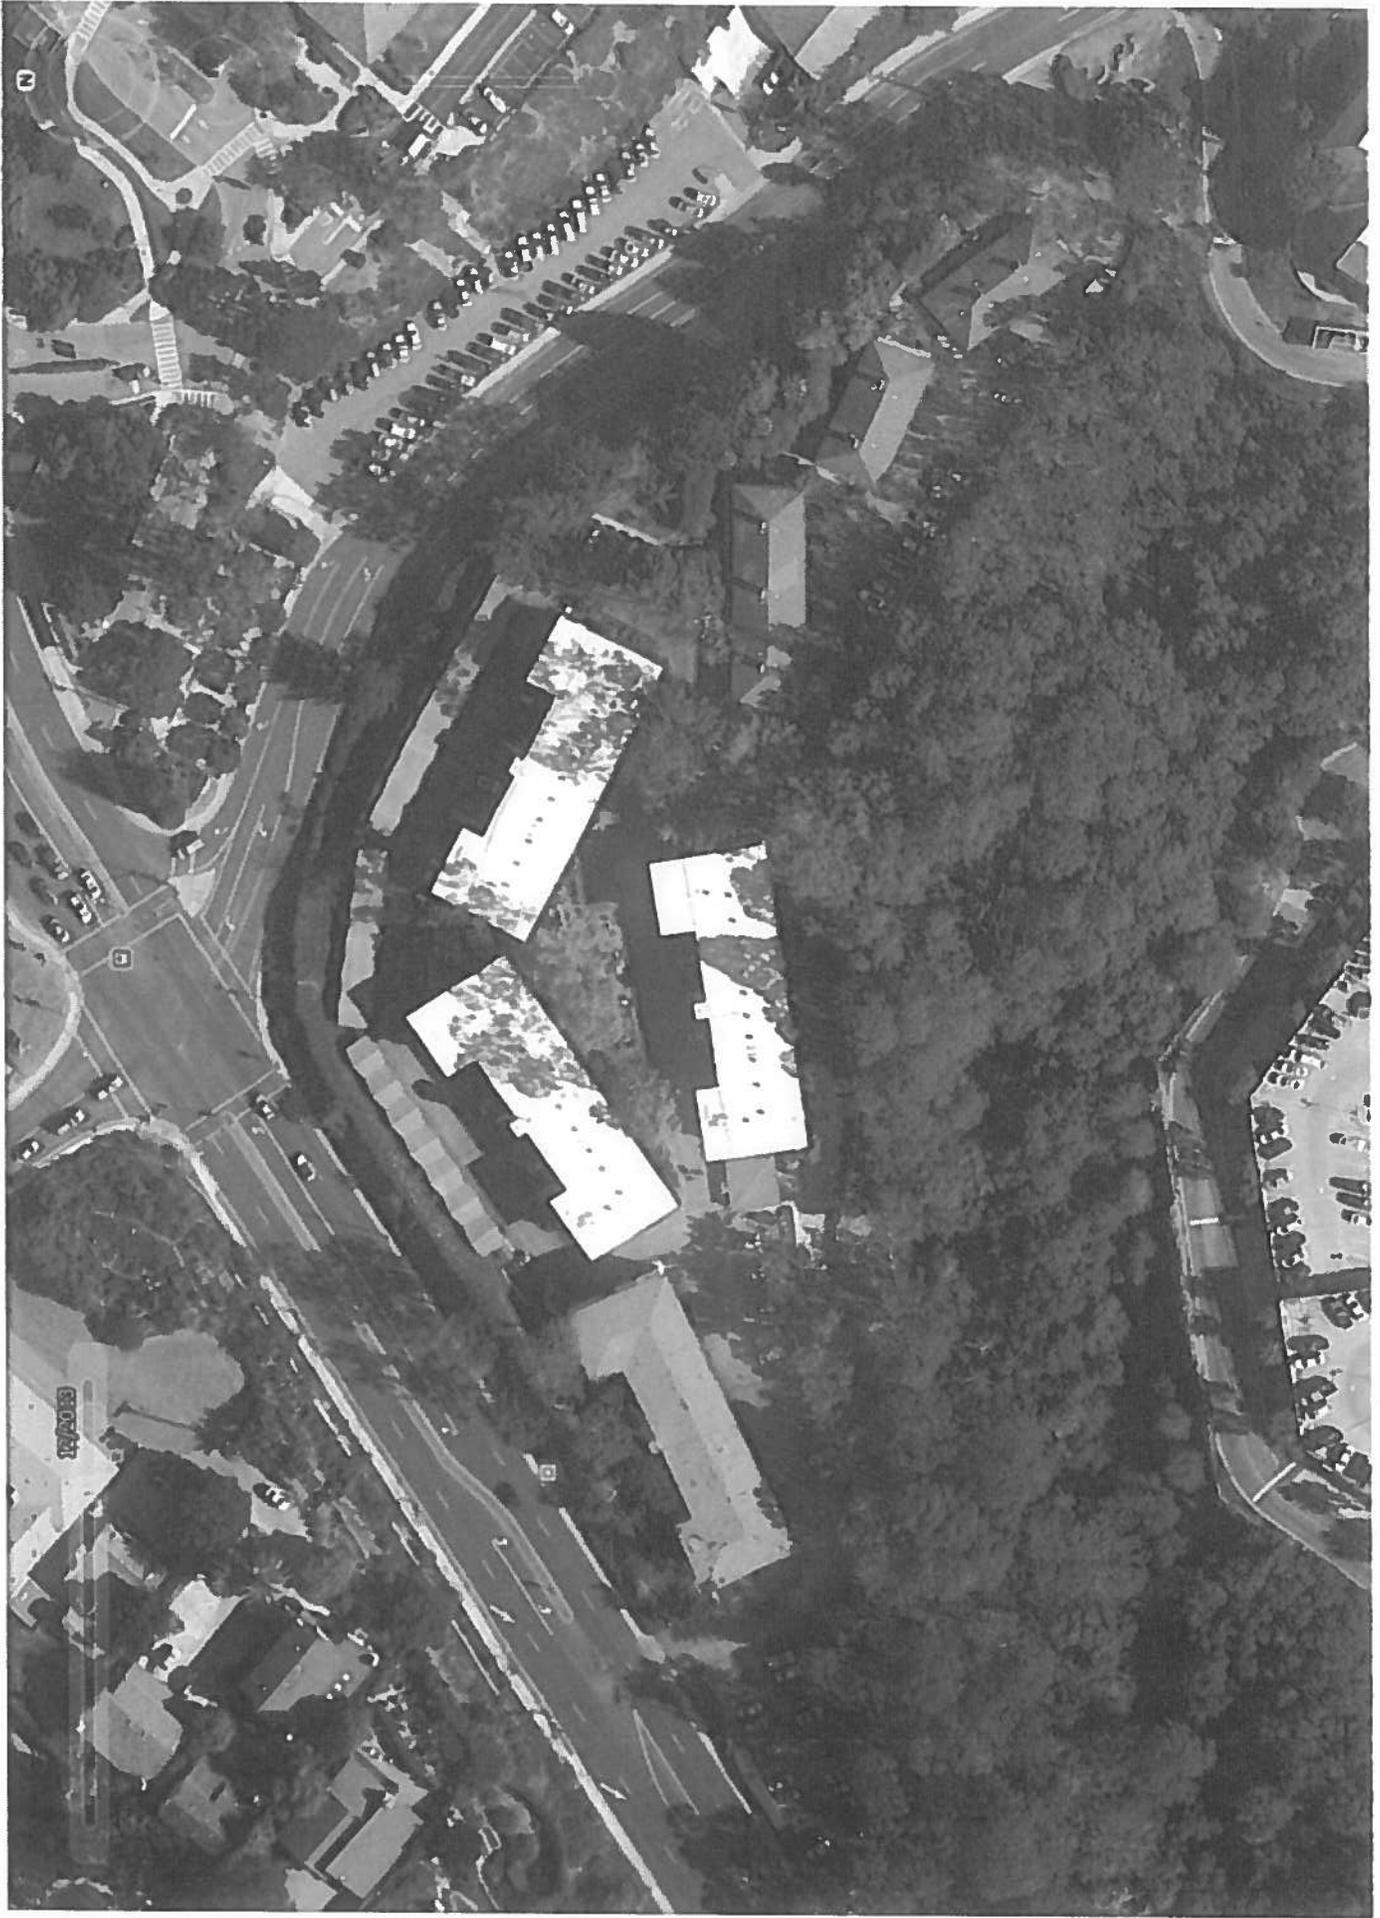
Google Earth December 2013 - Prior to Work

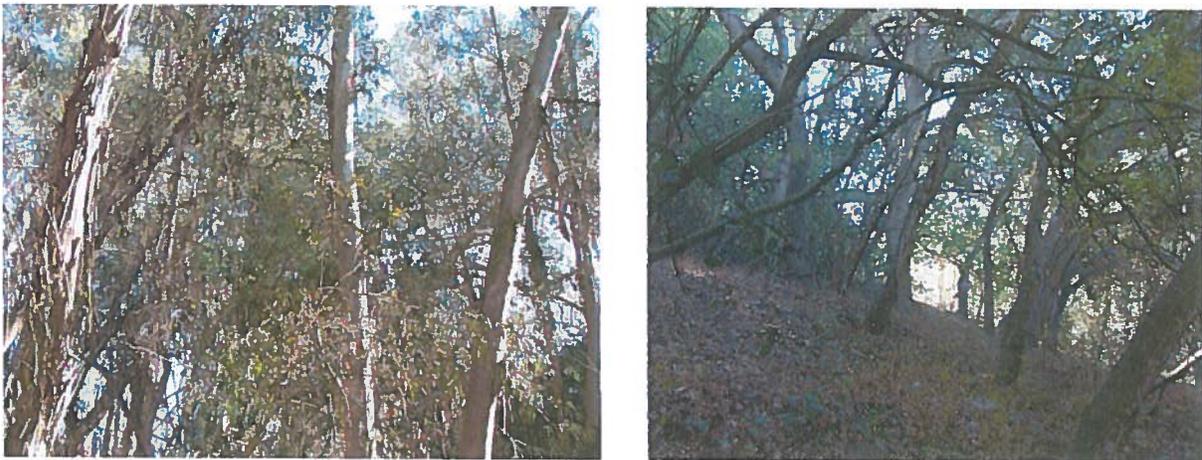
Fig. 2. Architecture of blue gum eucalyptus woodland (left) on south-facing slope versus coast live oak woodland (right) on north-facing slope of Honda Valley. Photos were taken at same point in drainage. Differences in microclimate between these communities are obvious. Hundreds of monarchs were observed in clusters or cruising, nearing, and/or drinking in eucalyptus woodland, but few were seen in adjacent coast live oak woodland. 17 November 2014.

Eucalyptus Woodland. This woodland is dominated by dense, mixed-age stands of blue gum (*Eucalyptus globulus*). Canopy cover and canopy height varies with age and density of trees. Maximum canopy height here is 70-80 feet. A unique characteristic of mixed-age blue gum stands is elevated structural heterogeneity at all canopy heights caused by a combination of “pole” trees (2-6 inches in diameter) densely distributed around mature trees (6-36+ inches in diameter) coupled with continuous limb, bark, and leaf drop. The result is a significantly more complex leaf, branch, and stick/bark litter architecture relative to native woodlands (Fig. 2 and photos in Appendix 1). Such mixed-age stands of eucalyptus create and maintain microclimatic conditions that monarch butterflies seem to favor when aggregating and they provide a nectar source for adults during the winter aggregation period when native nectar sources are absent (Fig. 3).

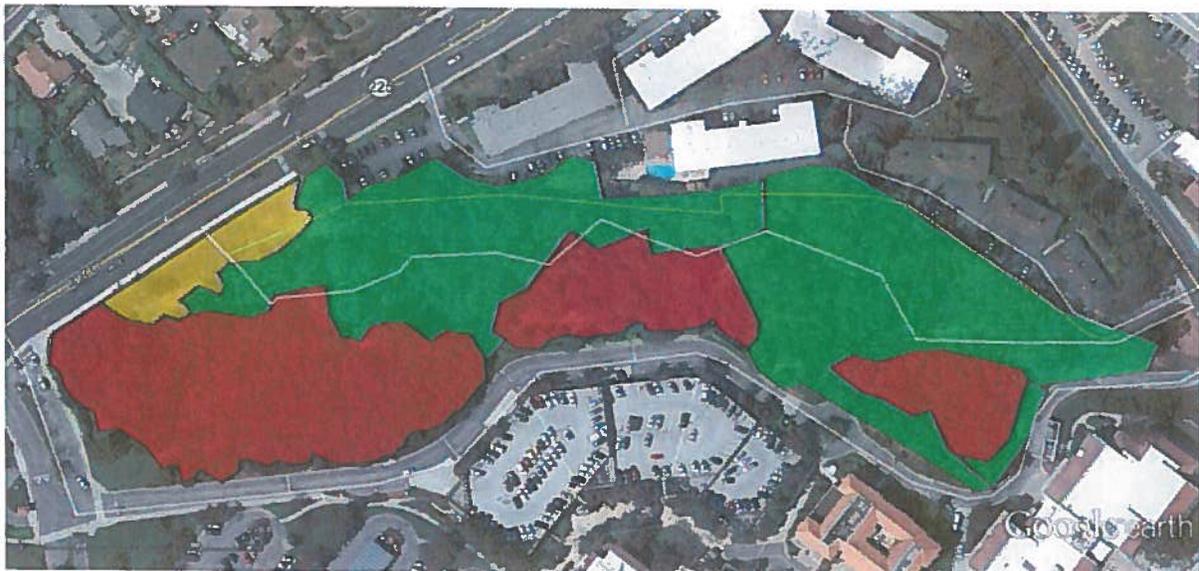
Figure 3. Approximate distribution of primary plant communities in subject reach of Honda Valley: eucalyptus woodland (green), coast live oak woodland (red), and coastal sage scrub (yellow). Unmarked trees in southern portion are ornamental species planted as landscaping. White line approximates southern boundary of subject property; green line show existing chain-link fence on subject property. Imagery dated 17 April 2013.

Coastal Sage Scrub. Coastal sage scrub vegetation is present on the south-facing slope of the creek near Cliff Drive and west of the westernmost parking lot (Fig. 3), and is characterized by absence of tree canopy and a dense woody shrub structure. Species present include: California sagebrush (*Artemisia californica*), California buckwheat (*Eriogonum fasciculatum*), coyote bush (*Baccharis pilularis*), Douglas' nightshade (*Solanum douglasii*), California blackberry (*Rubus ursinus*), poison oak, and tree tobacco (*Nicotiana glauca*).

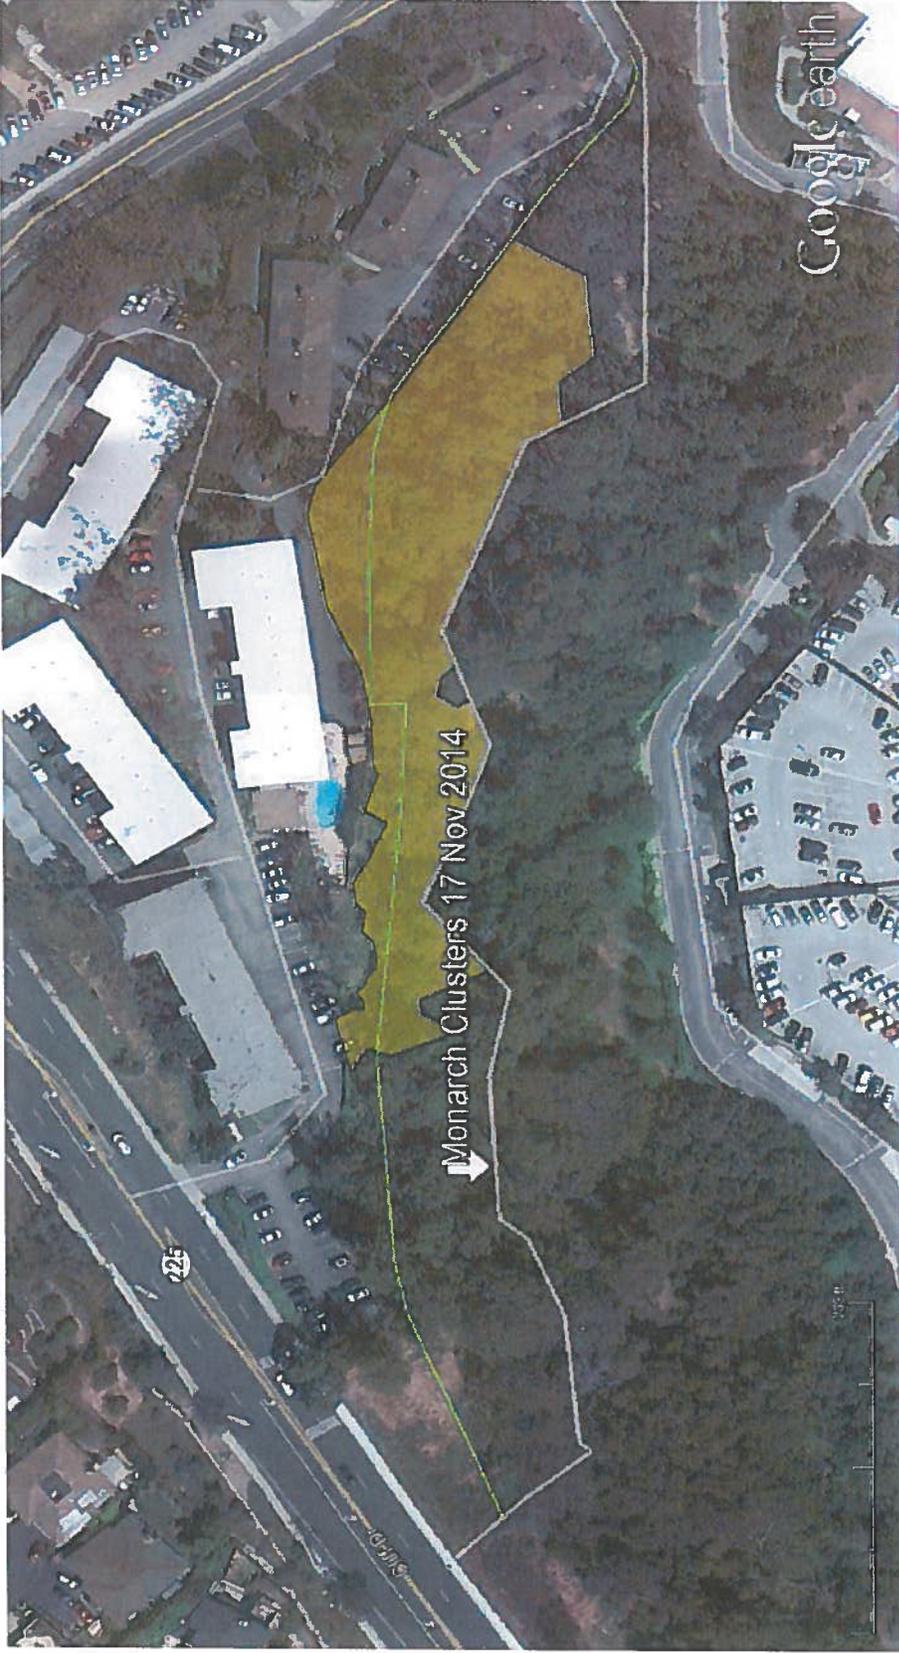
Figure 4. Recent (2014) eucalyptus tree removal (yellow polygon); monarch clusters (total of 750+ butterflies) observed during site visit for this document on 17 November 2014 are shown by white arrow. Southern property boundary is shown by white line; chain-link fence is shown by green line. All boundaries are approximate. Imagery dated 17 April 2013.

Each of these plant communities is heavily infested with non-native, ornamental species that either have been intentionally planted as landscaping or have escaped cultivation (e.g., periwinkle (*Vinca* sp.), jade plant (*Crassula* sp.), Canary Island palm (*Phoenix canariensis*), and Mexican fan palm (*Washingtonia robusta*). Tree removal activities occurred primarily in eucalyptus woodland (Fig. 4).

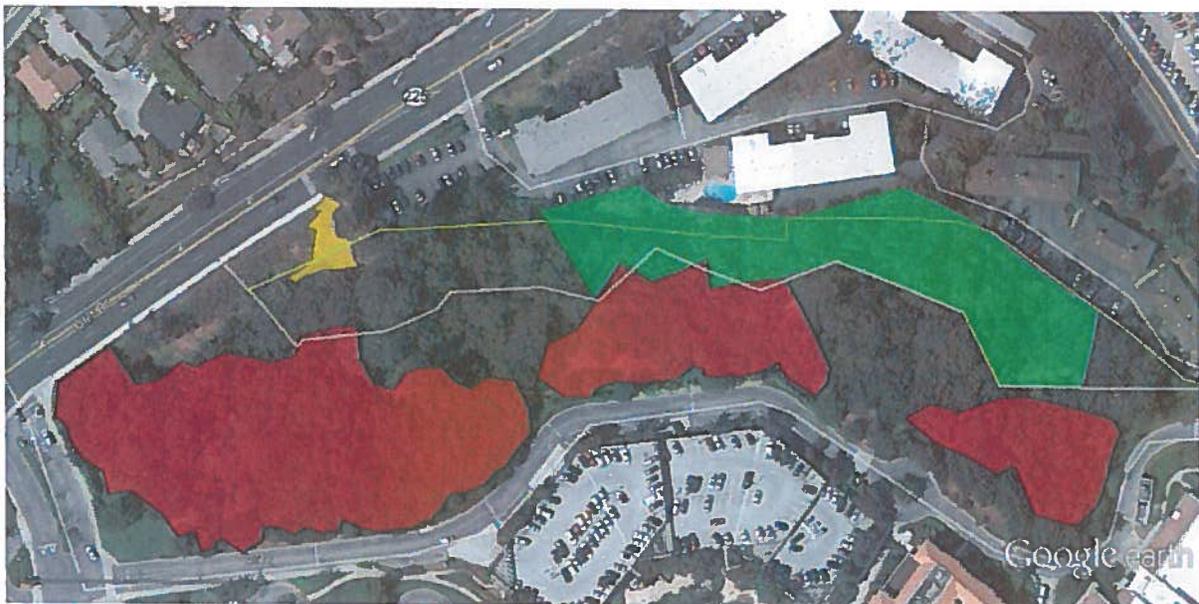
Figure 5. Candidate restoration/enhancements site proposed herein: green polygon -- Table 2 species; yellow polygon -- Table 3 species. Red polygons show approximate areas of coast live oak woodland; unmarked trees are mostly blue gum eucalyptus. The white line shows approximate location of property boundary between Harbor Heights apartment complex and Santa Barbara City College; yellow line shows chain-link fence on Harbor Heights property. Imagery dated 17 April 2013.

In addition to the top-of-bank and south-facing slope, the grassy area west of the westernmost parking lot on the subject property is an ideal candidate site for additional enhancement of coastal sage scrub as monarch habitat. The species and counts listed in Table 3 should be planted in the yellow polygon area in Fig. 5.

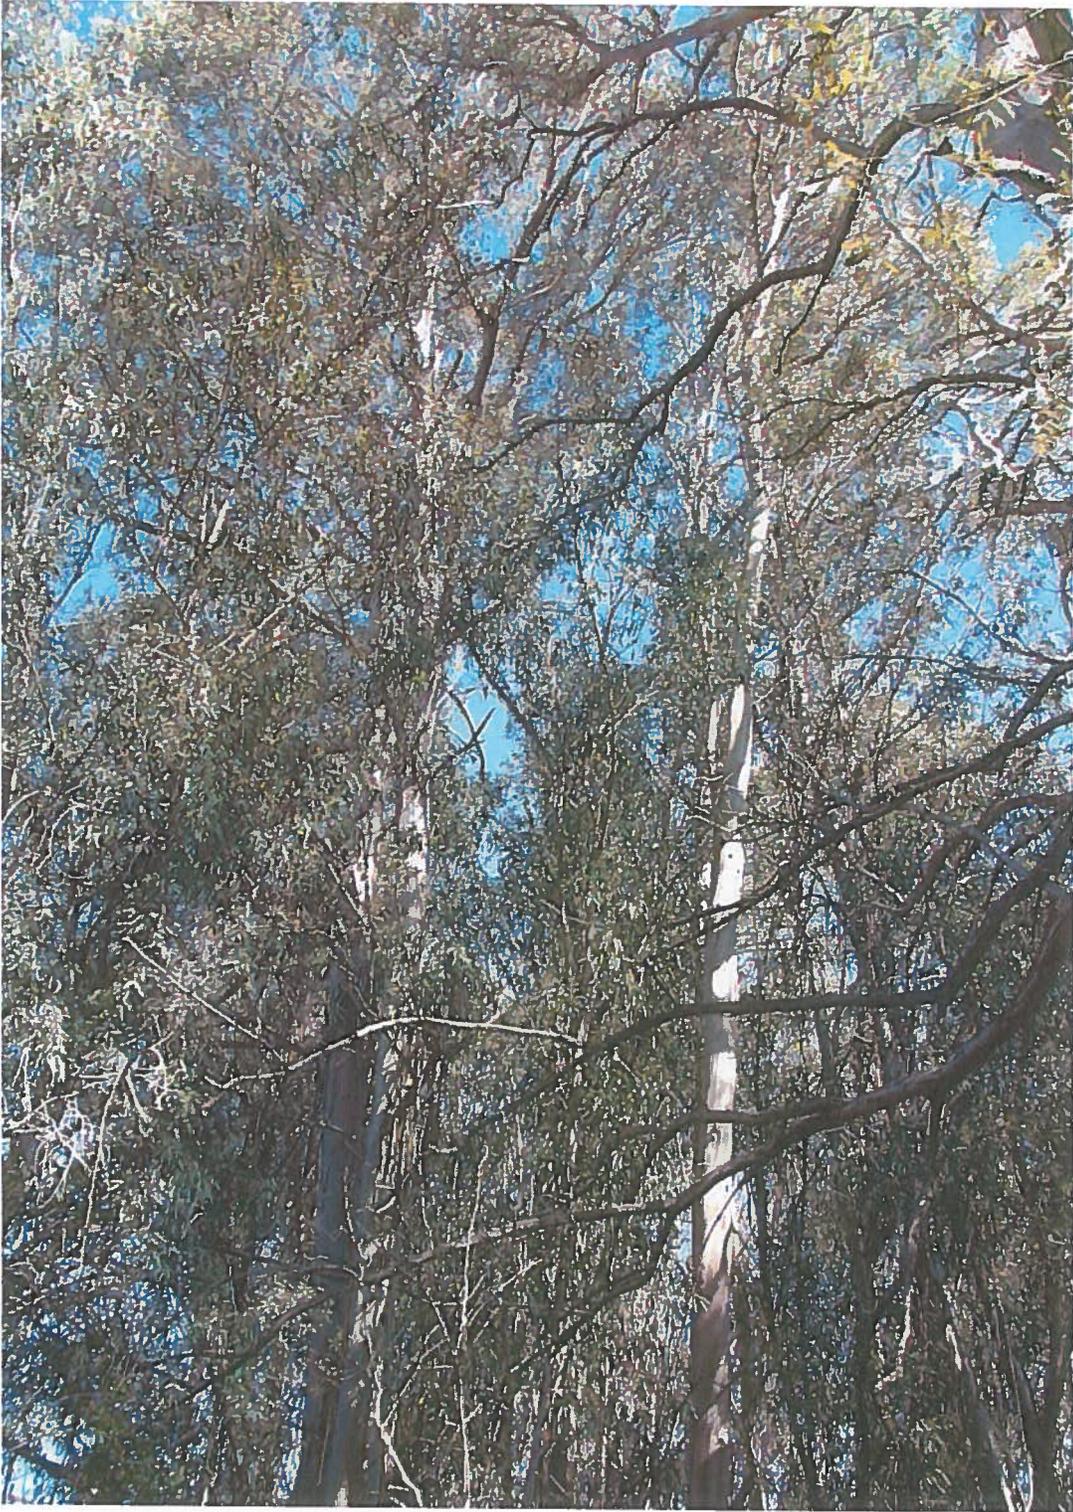
Intact eucalyptus woodland in western portion of Honda Valley on subject property used by monarchs as aggregation sites. Note structure of canopy and understory provided by this mixed-age stand of trees.

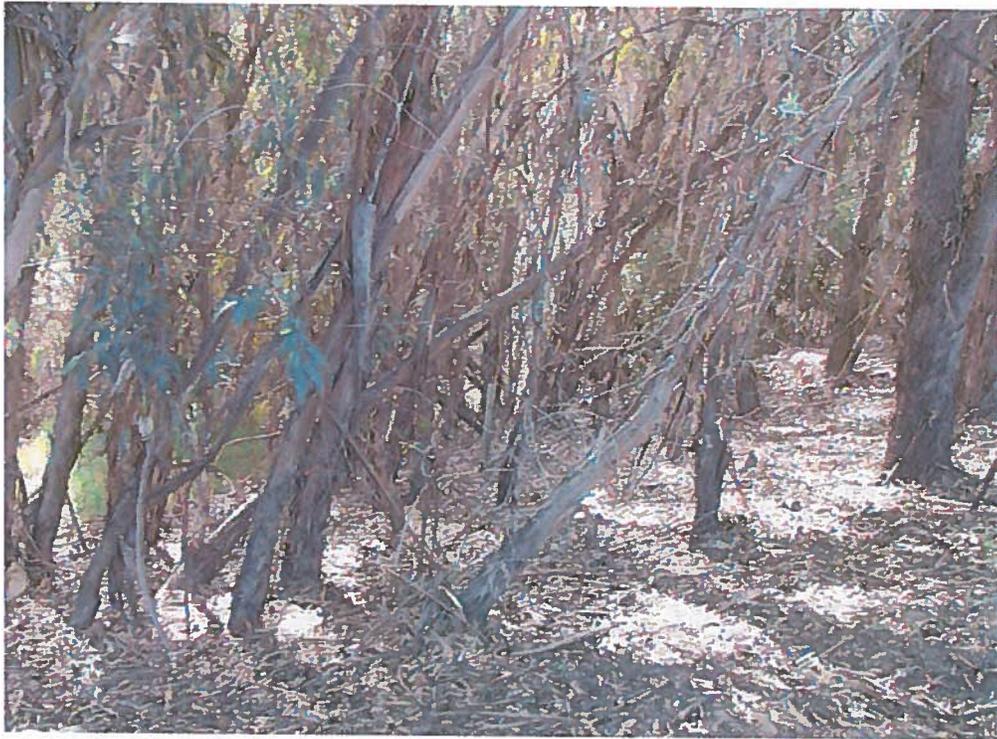
Structure of understory in undisturbed eucalyptus woodland used by monarchs.

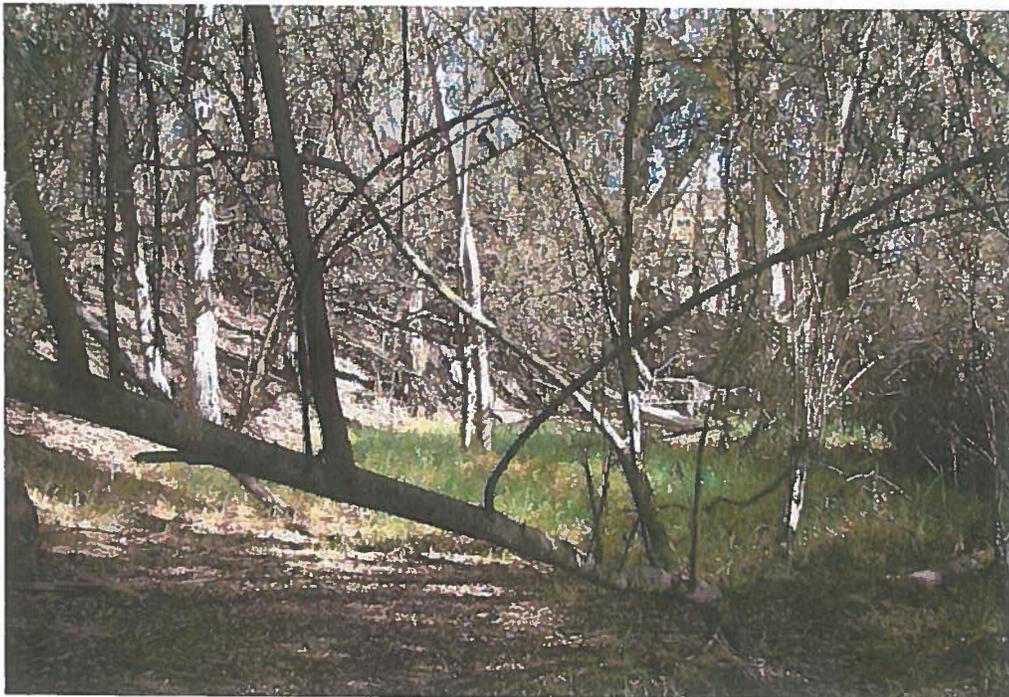
Eucalyptus woodland around monarch clusters reported herein. Note structure provided by downed trees, saplings, and ground cover.

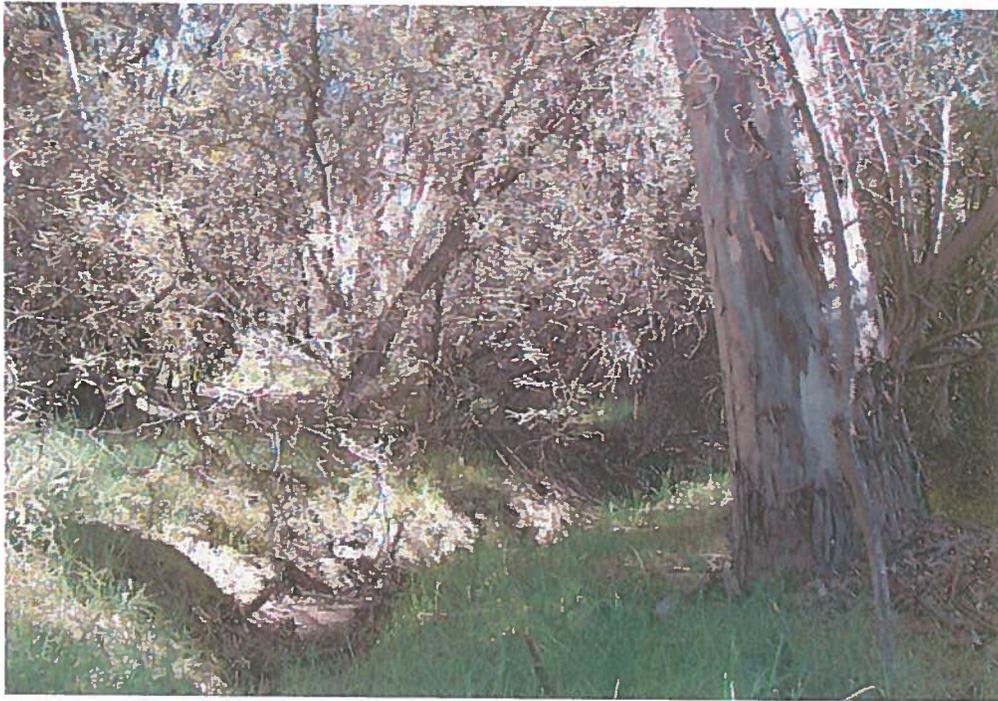
Mixed eucalyptus woodland-willow woodland along invert of Honda Valley Creek. Note structure provided by arroyo willow (*Salix lasiolepis*) (left) and toyon (*Heteromeles arbutifolia*) (right), in addition to eucalyptus.

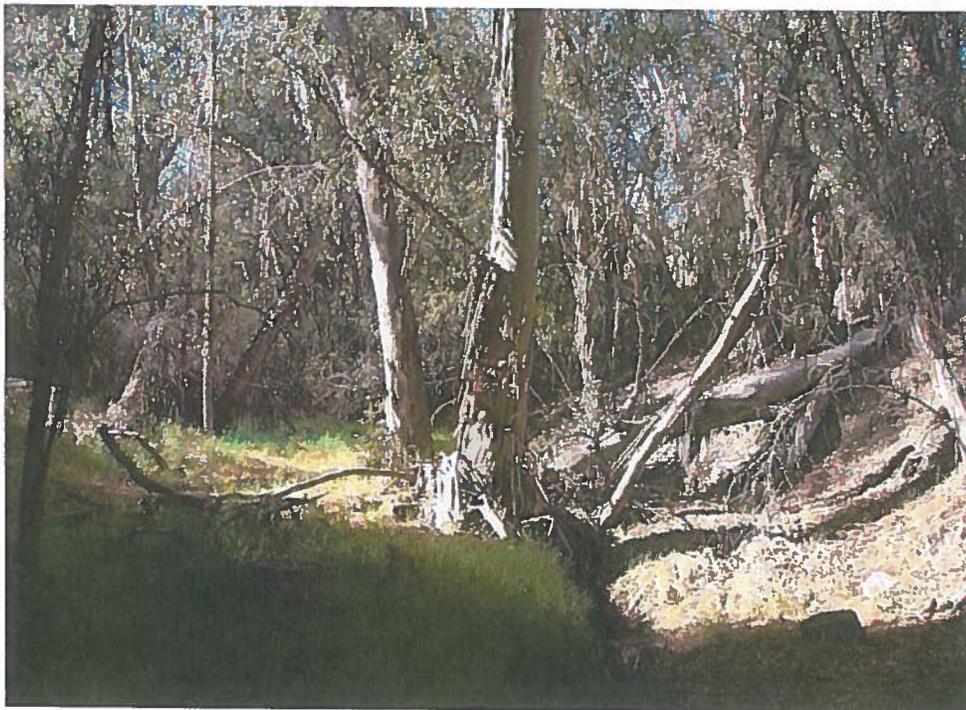
Eucalyptus woodland around monarch clusters reported herein, showing elements preferred by monarchs: partial sun, dense vertical structure formed by living vegetation and dead woody debris, mixed-age stand, ground cover, and a water source.

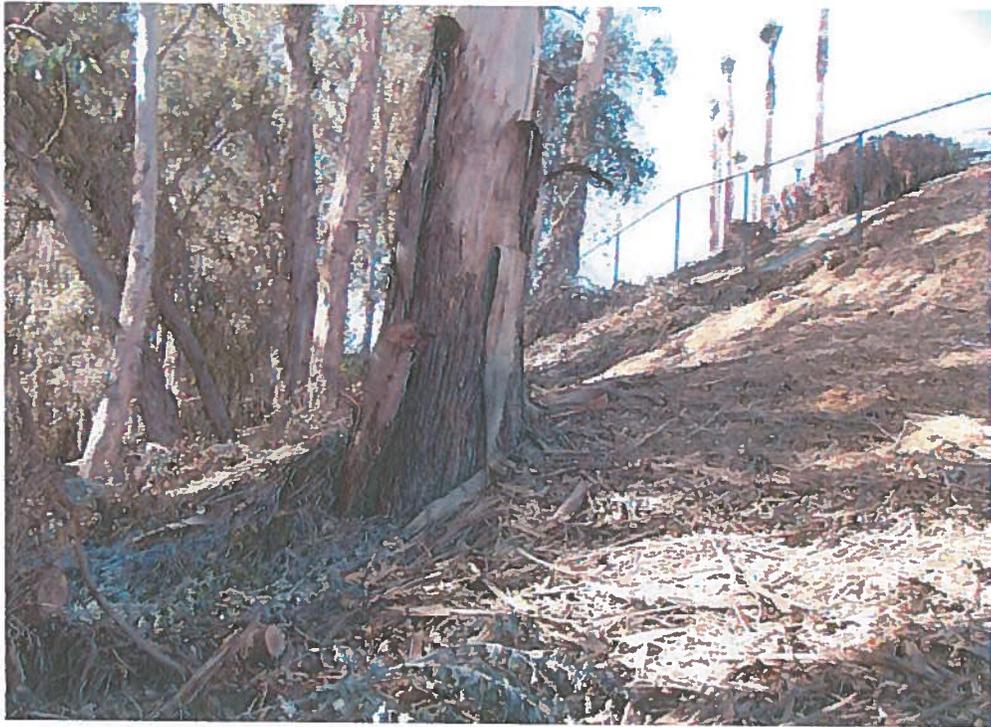
Western limit of eucalyptus tree and understory vegetation removal on subject property. Note differences in understory and ground cover between cleared and uncleared areas.

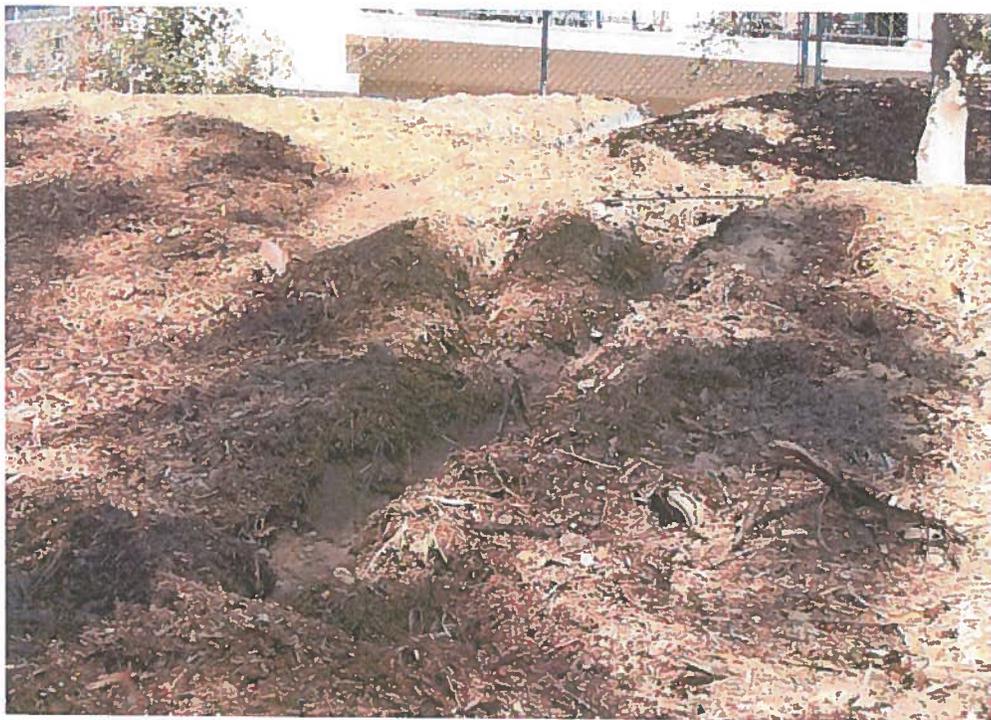
Typical condition of slopes cleared of eucalyptus trees and woody debris. Note thick layer of mulch. Recently planted, boxed coast live oak is visible at upper right.

The cleared portion of the south-facing slope, which extends from the west end of the westernmost apartment building eastward to Loma Alta Drive, formerly supported a near closed-canopy of eucalyptus woodland mixed with a few coast live oaks (Fig. 4). The removed trees are present in aerial imagery dated 9 December 2013 and 17 April 2013 (Google Earth, 2014). Following tree removal and understory clearing, the owner planted 60 boxed coast live oaks ranging in size from 48-inch to 72-inch boxed specimens. The ground in the cleared areas was covered with a 3-5-inch thick layer of shredded wood mulch after tree removal (see photos in Appendix 1).

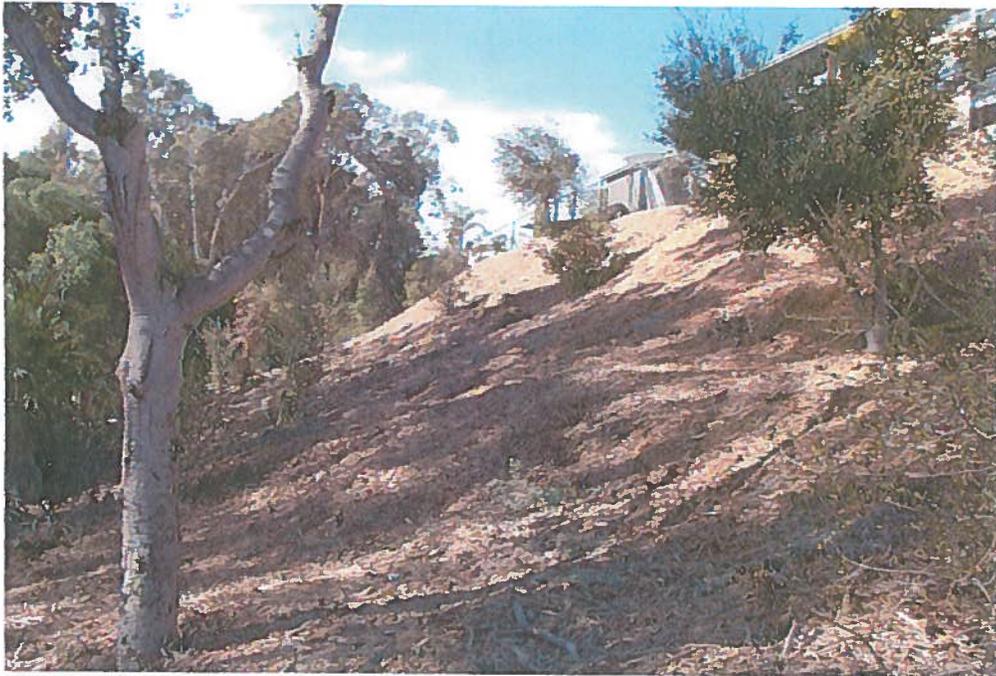
South-facing slope of Honda Valley Creek on subject property, looking west. Slopes in foreground have been cleared of eucalyptus trees and mulched. Coast live oaks have been retained (left foreground) and supplemented by planting boxed specimens. Eucalyptus woodland used by monarchs is seen in background.

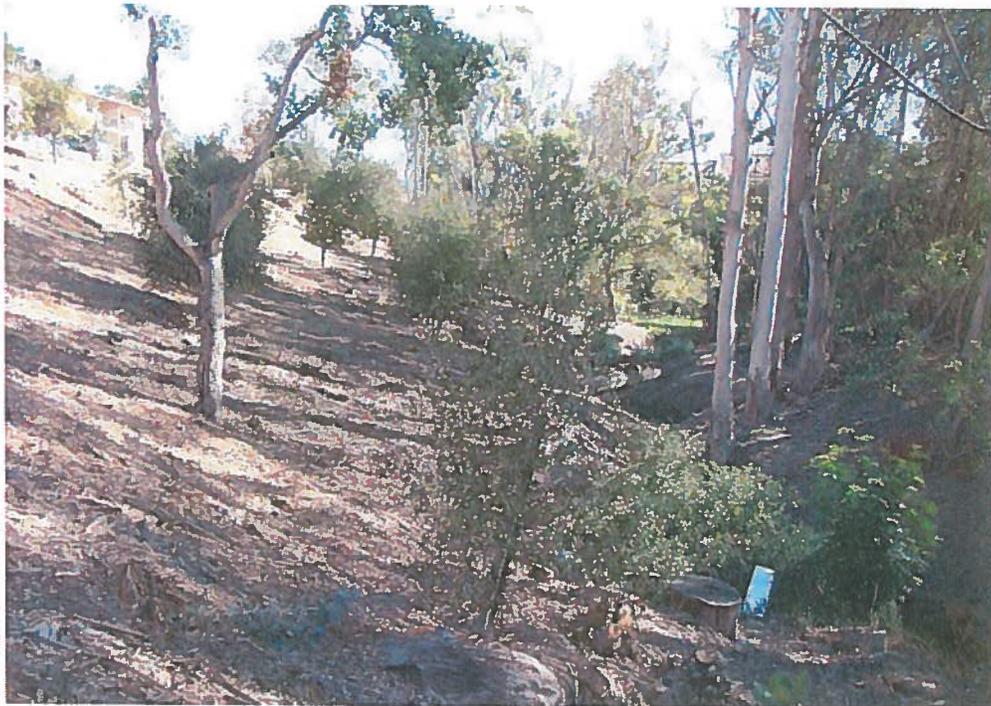
Same site as in previous photo, looking east. Invert of Honda Valley Creek is visible at right. Note coast live oaks planted on cleared slope. Eucalyptus trees and native (toyon, elderberry) and non-native shrub understorey occurs on SBCC property to right (south) of creek.
