City of Santa Barbara
Planning Division

SUBJECT: Continued Review of Coastal Development Permit and Zoning Modifications for 801 Cliff Drive

**HONDA VALLEY MONARCH BUTTERFLY
HABITAT RESTORATION AND MONITORING PLAN,
SANTA BARBARA, CALIFORNIA**

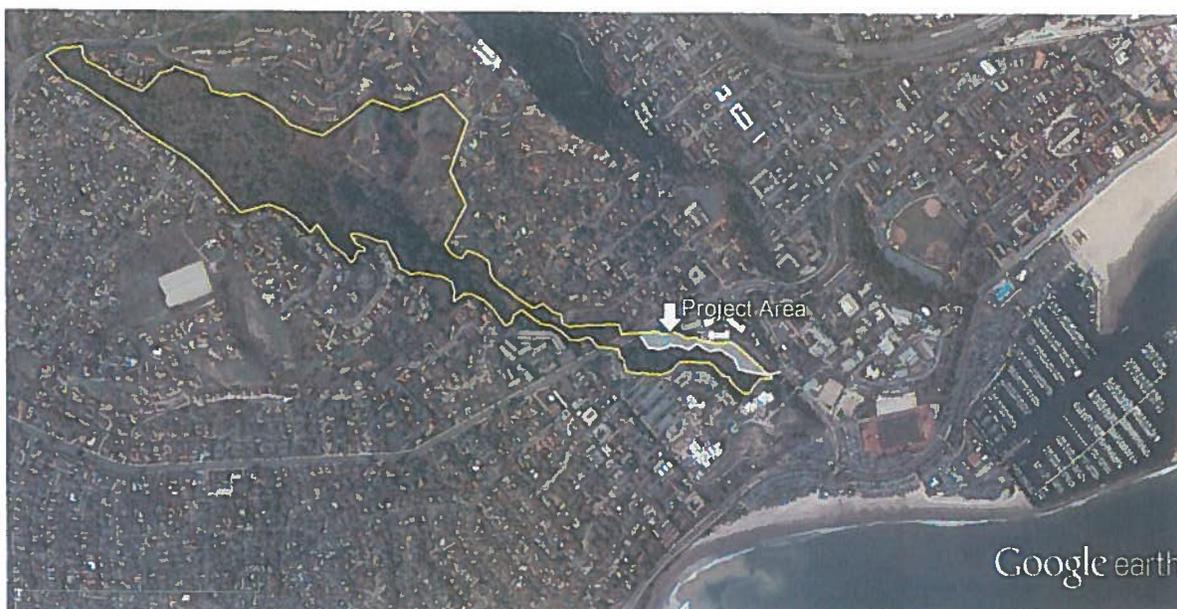
Figure 1. Existing open space in Honda Valley (yellow outline) in the City of Santa Barbara. The subject reach of the creek is located at the downstream (eastern) end of this feature (white overlay).

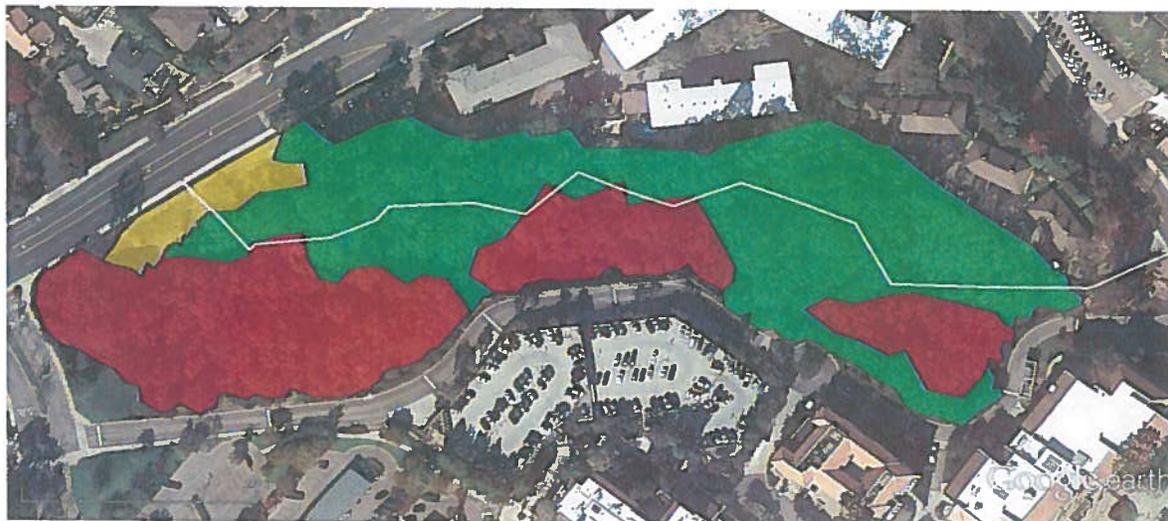
Figure 2. Primary plant communities in subject reach of Honda Valley prior to eucalyptus cutting in 2014: eucalyptus woodland (green), coast live oak woodland (red), and coastal sage scrub (yellow). Willow woodland is imbedded in other woodland types and cannot be mapped at this scale. The white line approximates the property boundary between the subject parcel to north and SBCC property to south. Removal of eucalyptus occurred in the central and northeastern portion of subject reach (see Fig. 5). Imagery dated 9 December 2013.

Four heavily disturbed plant communities are found within the subject reach of Honda Valley (Fig. 2). Plant community names follow terminology used in Sawyer et al. (2009):

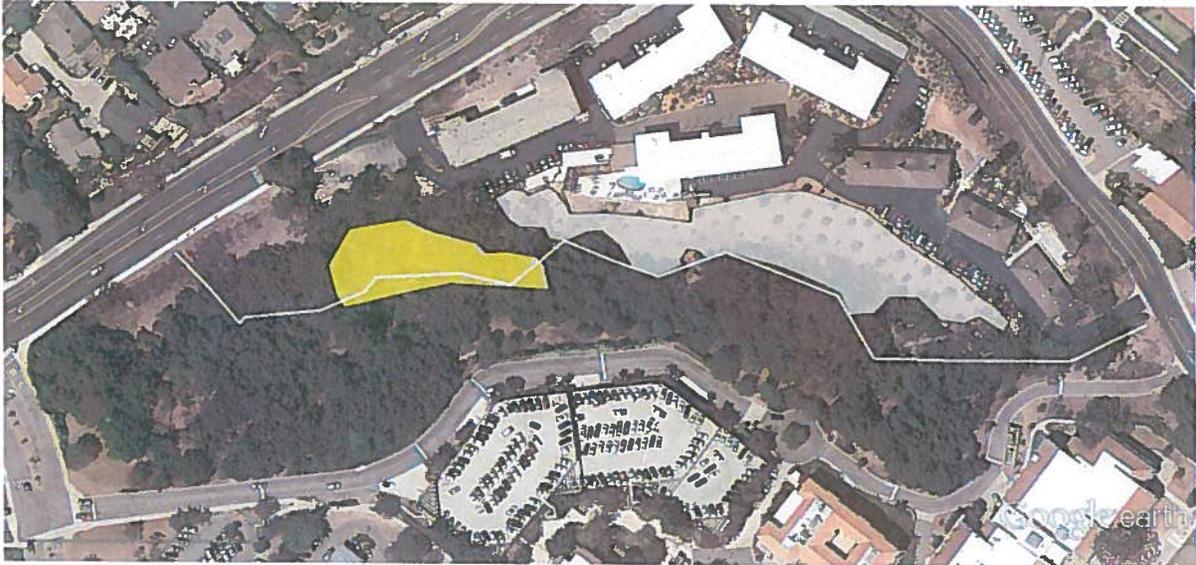
Figure 3. Approximate area of eucalyptus tree removal during spring/summer 2014 (white polygon). Yellow polygon shows approximate location of monarch clusters observed during fall/winter 2014 and fall/winter 2015/2016. White line shows property boundary between private property and SBCC. Imagery dated 27 August 2014, following removal of eucalyptus and planting of coast live oak trees.

woody debris (bark, fallen limbs, and leaf litter) as a fuel management strategy for fire safety (Fig. 3). The eucalyptus trees were replaced with sixty 48- to 72-inch boxed coast live oaks (*Quercus agrifolia*) and the affected slope was covered with a thick layer of mulch.

Eucalyptus groves are classified as “major vegetation” under the California Coastal Act so removal of eucalyptus trees is considered “development” under the Act (Section 30240 – Environmentally Sensitive Habitat Areas [ESHA]) (Bell et al., 1993; Sawyer et al., 2009; California Coastal Act, 1976; City of Santa Barbara, 2010). The owner received a Notice of Violation from the City of Santa Barbara for unpermitted tree removal, so no further work has occurred in the subject reach of Honda Valley to date. Monarch aggregations in fall/winter 2014 and fall/winter 2015/2016 were observed in undisturbed portions of the eucalyptus woodland west of the area where eucalyptus trees were removed (Fig. 3).

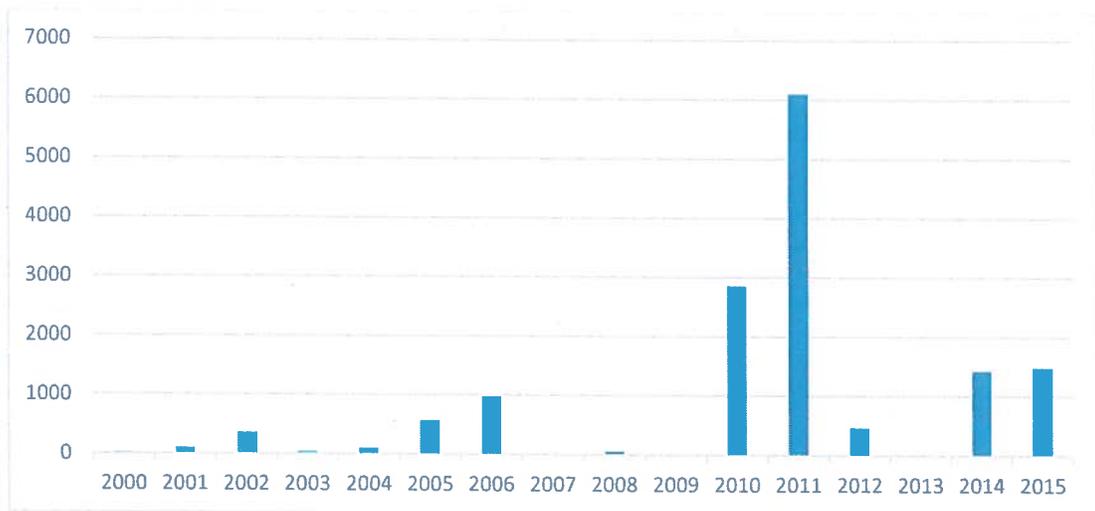
Figure 4. Honda Valley monarch counts, 2000-2015 (Xerces Society Thanksgiving Count data). Years with no observations (2007, 2009, and 2013) had no surveys. Average population per year is 1,147 individuals.

Since 2000, the Xerces Society for Invertebrate Conservation has sponsored monarch counts in the Honda Valley site as part of their regional annual Thanksgiving count of monarch populations. These surveys reveal widely varying numbers of butterflies from year to year between 2000 and 2015 (range: < 100 to over 6,000 individuals). The late November 2015 count found a total of 1,475 individuals at the site, similar to the 2014 Thanksgiving count (Fig. 4). Note that both counts were made after eucalyptus tree removal in summer 2014.

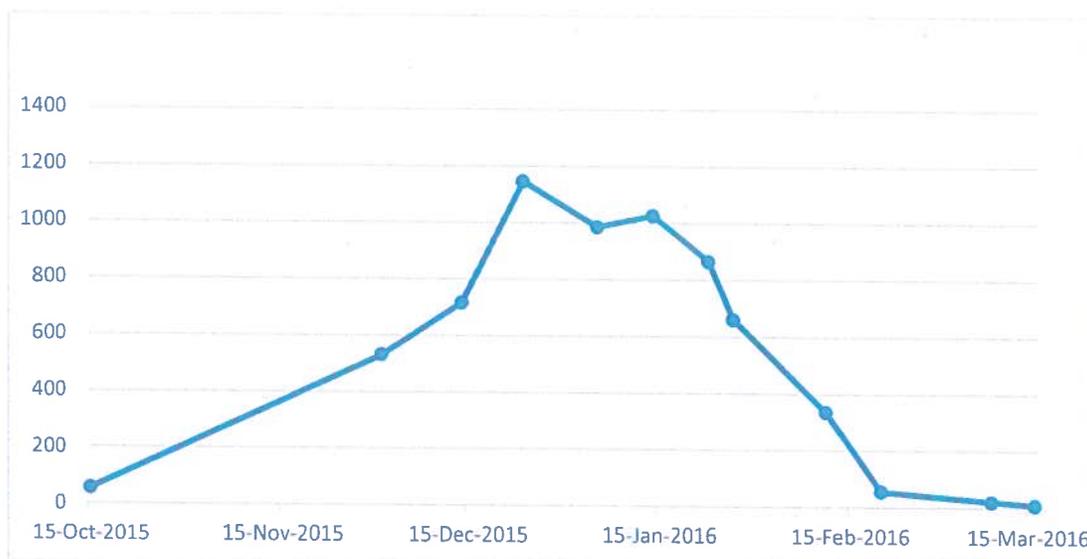
Figure 5. Variation in monarch numbers at the Honda Valley overwintering site from October 2015 to March 2016. The phenology of arrival, aggregation, and dispersal here is typical of aggregation sites elsewhere in California.

Hunt & Associates (2016) conducted a series of monarch counts between October 2015 and mid-March 2016 at the Honda Valley site in order to characterize monarch arrival and dispersal during one overwintering cycle. Monarchs arrived at the site in October 2015, reached a maximum of about 1,200 individuals in mid- to late December 2015, and were all but gone by mid-March 2016 (Fig. 5). This maximum is slightly lower than that observed in late November 2015 during the Xerces Society count. Clusters of monarchs were observed 18-25 feet above ground in partial shade on 6-inch diameter eucalyptus trees along the bottom of the creek west of where eucalyptus trees were removed in 2014.
