HISTORIC LANDMARKS COMMISSION  
HISTORIC SIGNIFICANCE REPORT  
Prepared by Nicole Hernandez, MFA, City Architectural Historian  
January 2021

# 225 STATE STREET SANTA BARBARA, CALIFORNIA

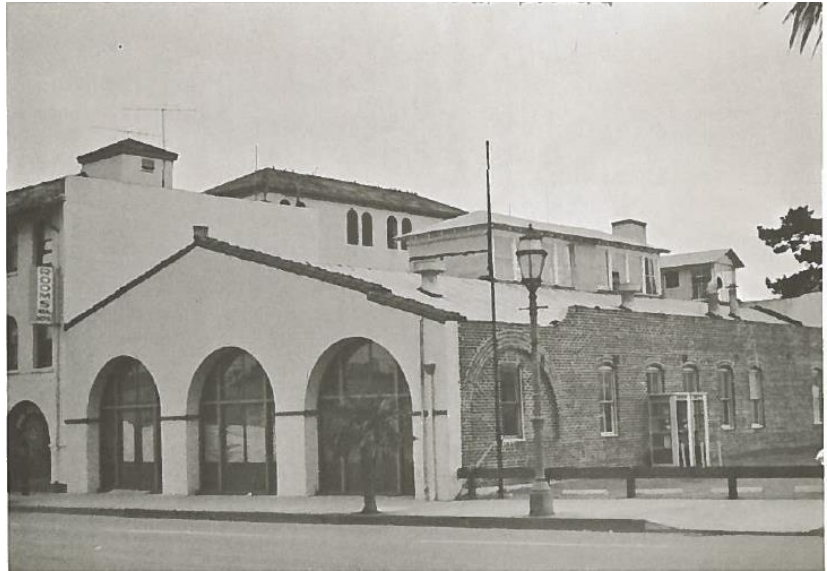
1977 Drawings of the building directing stucco removal from brick

**Historic Integrity:** The large openings on State Street remain, but the windows themselves are not original, nor do the existing windows match those in the 1977 drawings. The 1977 drawing illustrates the large opening on the north elevation facing the parking lot as enclosed with brick and a double-hung window as existing. The façade has also been stripped of the stucco façade of the 1925 building. Designed as a brick building with a stucco façade lined with terra-cotta coping in 1925. The 1977 renovation stripped the façade to expose the building as a vernacular commercial brick building. At the alteration to the brick façade may be a change that has acquired its own significance, the building can convey its 1977 appearance as a vernacular brick commercial building, but it does not convey its 1925 appearance.
