HISTORIC LANDMARKS COMMISSION  
 HISTORIC SIGNIFICANCE REPORT  
 Prepared by Nicole Hernandez, MFA, City Architectural Historian  
 January 2021

225 STATE STREET  
 SANTA BARBARA, CALIFORNIA

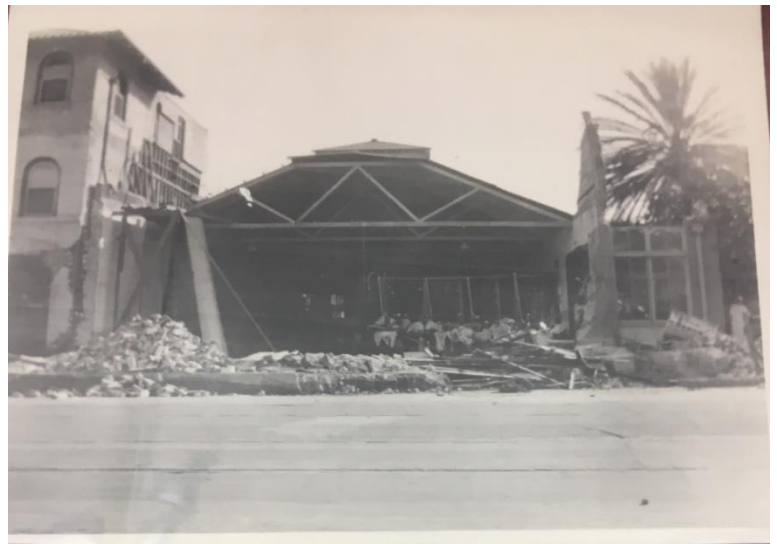
View of building after 1925 Earthquake.

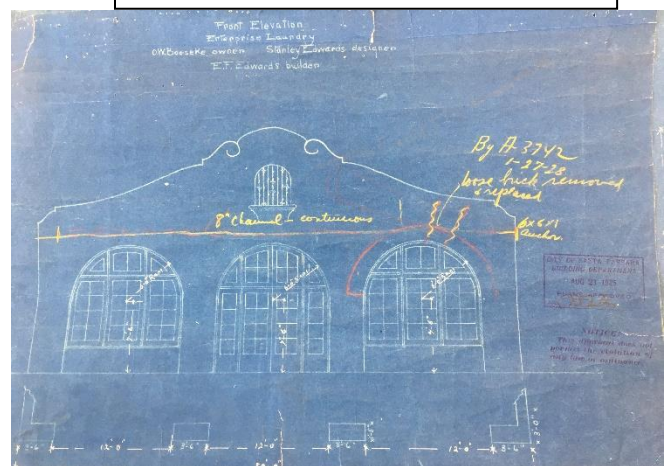
225 State Street original drawings dated August 21, 1925

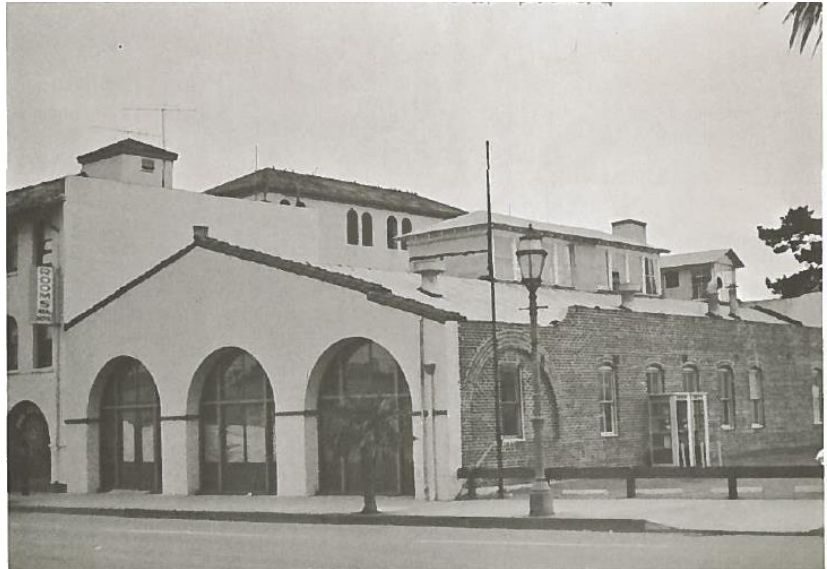
1977 Drawings of the building directing stucco removal from brick

**Historic Integrity:** The large openings on State Street remain, but the windows themselves are not original, nor do the existing windows match those in the 1977 drawings. The 1977 drawing illustrates the large opening on the north elevation facing the parking lot as enclosed with brick and a double-hung window as existing. The façade has also been stripped of the stucco façade of the 1925 building. Designed as a brick building with a stucco façade lined with terra-cotta coping in 1925. The 1977 renovation stripped the façade to expose the building as a vernacular commercial brick building. At the alteration to the brick façade may be a change that has acquired its own significance, the building can convey its 1977 appearance as a vernacular brick commercial building, but it does not convey its 1925 appearance.
