**REVISED BIOLOGICAL ASSESSMENT OF
PROPOSED MONTECITO COUNTRY CLUB AND
GOLF COURSE RENOVATION,
SANTA BARBARA, CALIFORNIA**

3 April 2009

**Revised Biological Assessment of
Proposed Montecito Country Club and Golf Course Renovation,
Santa Barbara, California**

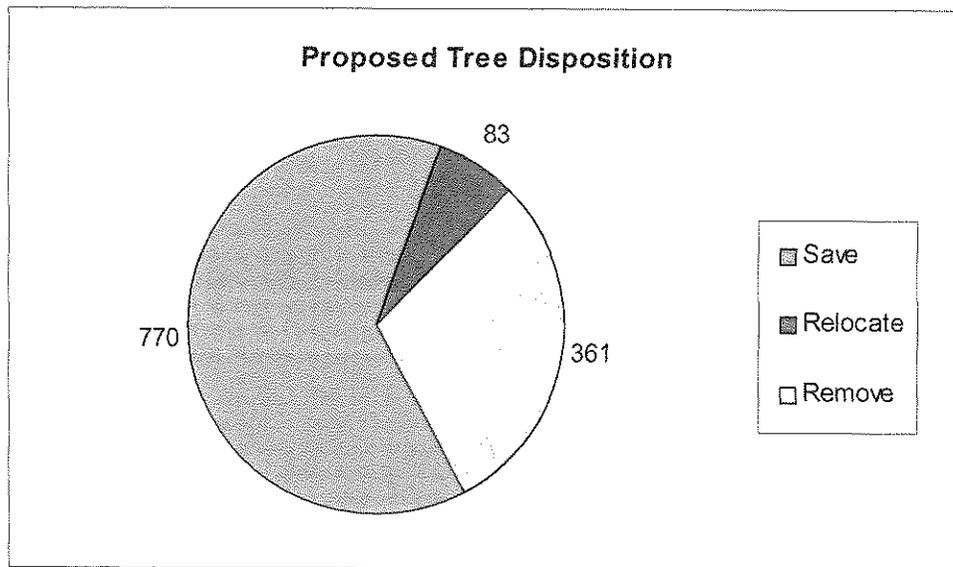
Figure 9. Proposed Disposition of Existing Trees.

Figure 9 summarizes the disposition of existing trees (McPherson, 2009). Approximately 63% (n = 770) of the existing trees on-site will be saved, 30% (n = 361) will be removed, and 7% (n = 83) of the trees will be relocated. Four of the 10 coast live oaks slated for removal are larger than 3 inches dbh, the City and County standard for mitigation. Eight coast live oaks, mostly small to medium-sized trees (3-18 inch dbh), will be relocated. About 12 Monterey cypress trees will be removed and most of these trees are medium-sized to very large trees (Table 2).

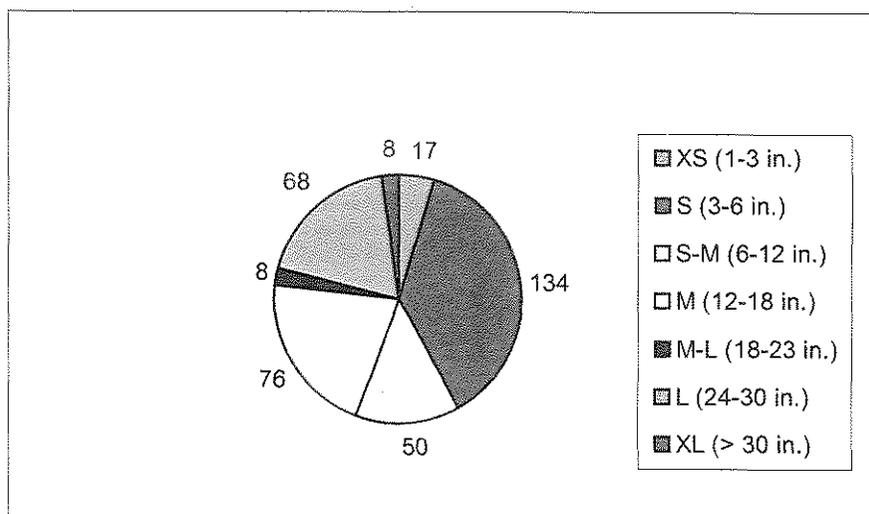
Figure 10. Sizes of Trees Proposed for Removal (dbh).

Figure 10 categorizes the size of the 361 trees to be removed. About 80% (n = 288) of these trees are ornamental species, i.e., not native to the United States (Table 2). Overall, about 56% (n = 201) of the 361 trees to be removed were classified by McPherson (2009) as small (XS to S-M); about 21% (n = 76) of the trees to be removed are large or very large (L to XL).

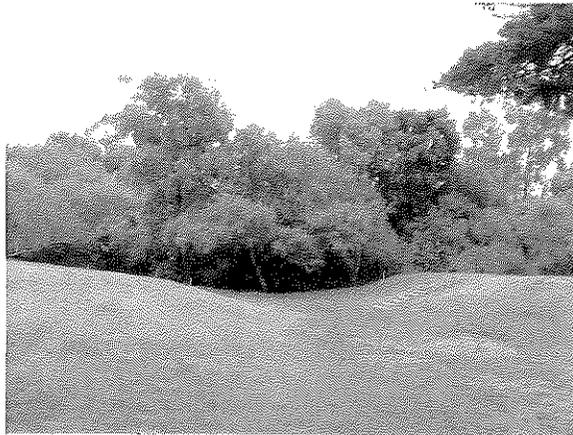
Photo 1. Eastern Drainage, looking east at riparian corridor. Golf course is in foreground. This is the typical transition from the golf course to the middle and eastern drainages. Riparian corridor composed mostly of non-native trees and shrubs, with a few coast live oaks. 10 April 2006.

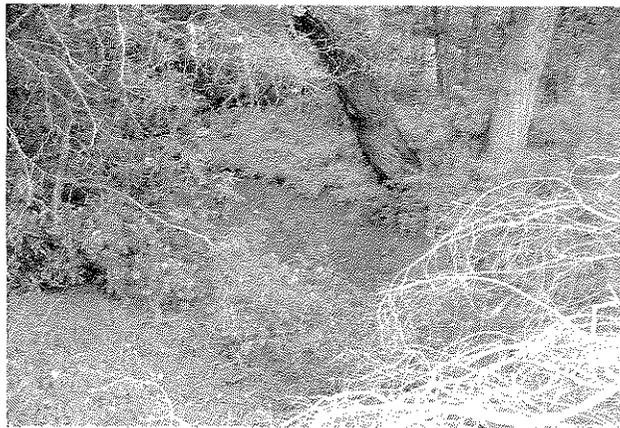
Photo 2. Eastern Drainage. Typical condition of bed and banks—note dry condition of streambed. Coast live oak in upper left; other trees and vegetation is non-native. 10 April 2006.

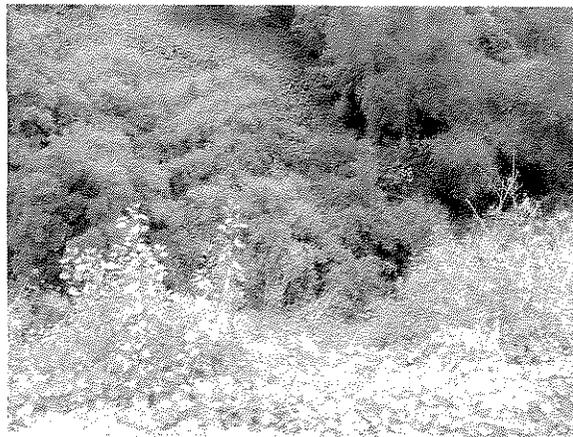
Photo 3. Middle Drainage, south of Golf Road. Note dense ground cover of mostly non-native, invasive vegetation. Riparian canopy is composed mostly of non-native species. 15 May 2006.

Mitigation: Remove invasive tree species from western, middle, and eastern drainages, as per recommendations of Habitat Restoration and Revegetation Plan included in Appendix 7. All trees proposed for planting should be native, locally-occurring species. Candidate species are: coast live oak (*Quercus agrifolia*), western sycamore (*Platanus racemosa*), white alder (*Alnus rhombifolia*), arroyo willow (*Salix lasiolepis*), California walnut (*Juglans californica*), black cottonwood (*Populus trichocarpa* var. *balsamifera*).

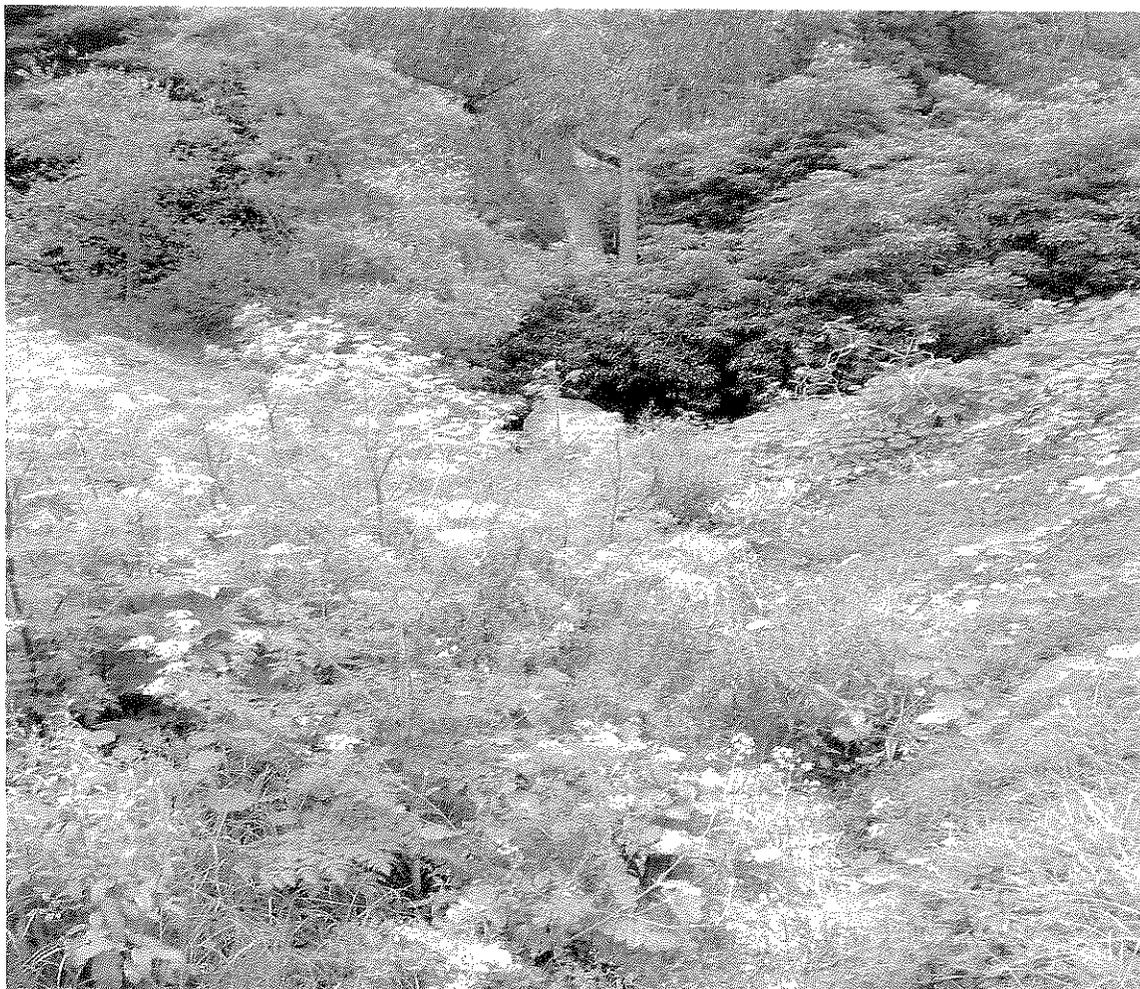
Photo 4. Middle Drainage, south of Golf Road. Shallow surface water present in foreground (less than six inches deep). Note narrow streambed and condition of banks. 15 May 2006.

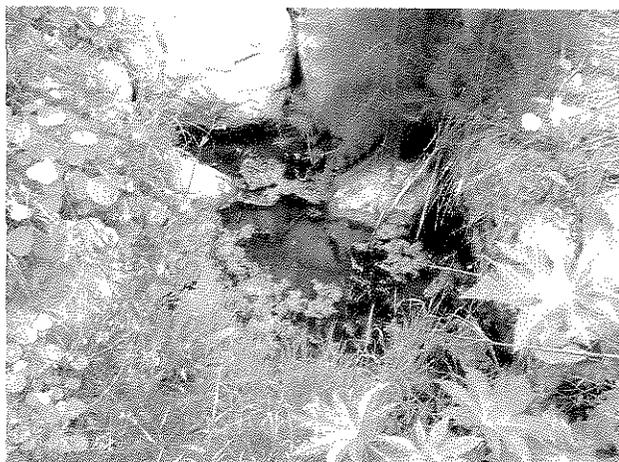
Photo 5. Western Drainage, adjacent to maintenance access pathway. This is the only pool found in the Western Drainage, following storm flows. Pool is about 10 feet x 6 feet x 15 inches deep. Drainage is conveyed through underground culverts downstream of this point. 4 April 2006.

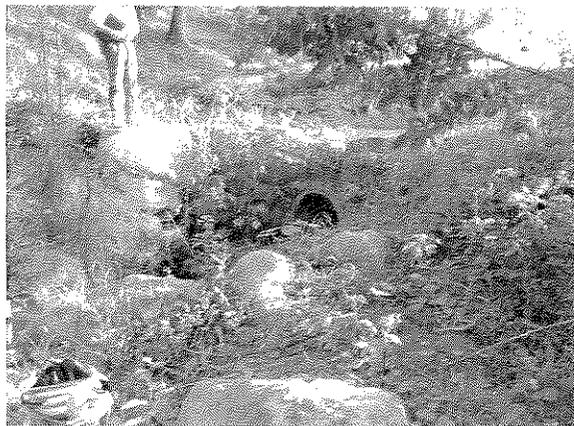
Photo 6. Western Drainage, taken at pool located at southern terminus of surface flow. 11 February 2006.

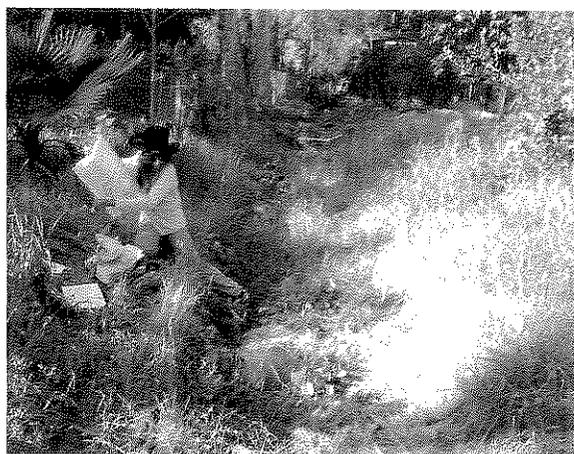
Photo 7. Western Drainage, looking NW as it enters golf course property from a residential area to the north. 11 February 2006.

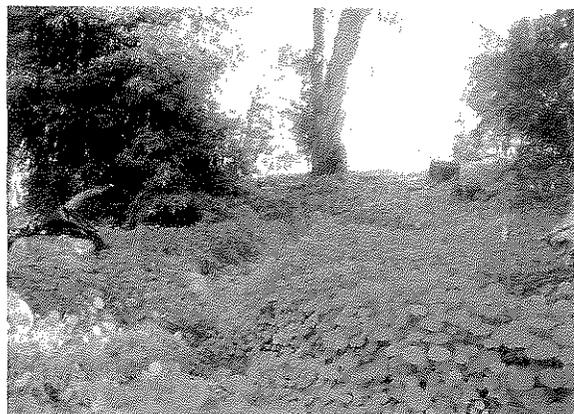
Photo 8: Western Drainage, looking SW at middle portion of aboveground reach showing channel modified from original course. Existing flows would be relocated as part of the project habitat restoration. 11 February 2006.
