**Bird Refuge Biological Resource Assessment  
and Tree Protection Plan**

**Santa Barbara Zoological Gardens**

**Santa Barbara, California**

**July 2003**

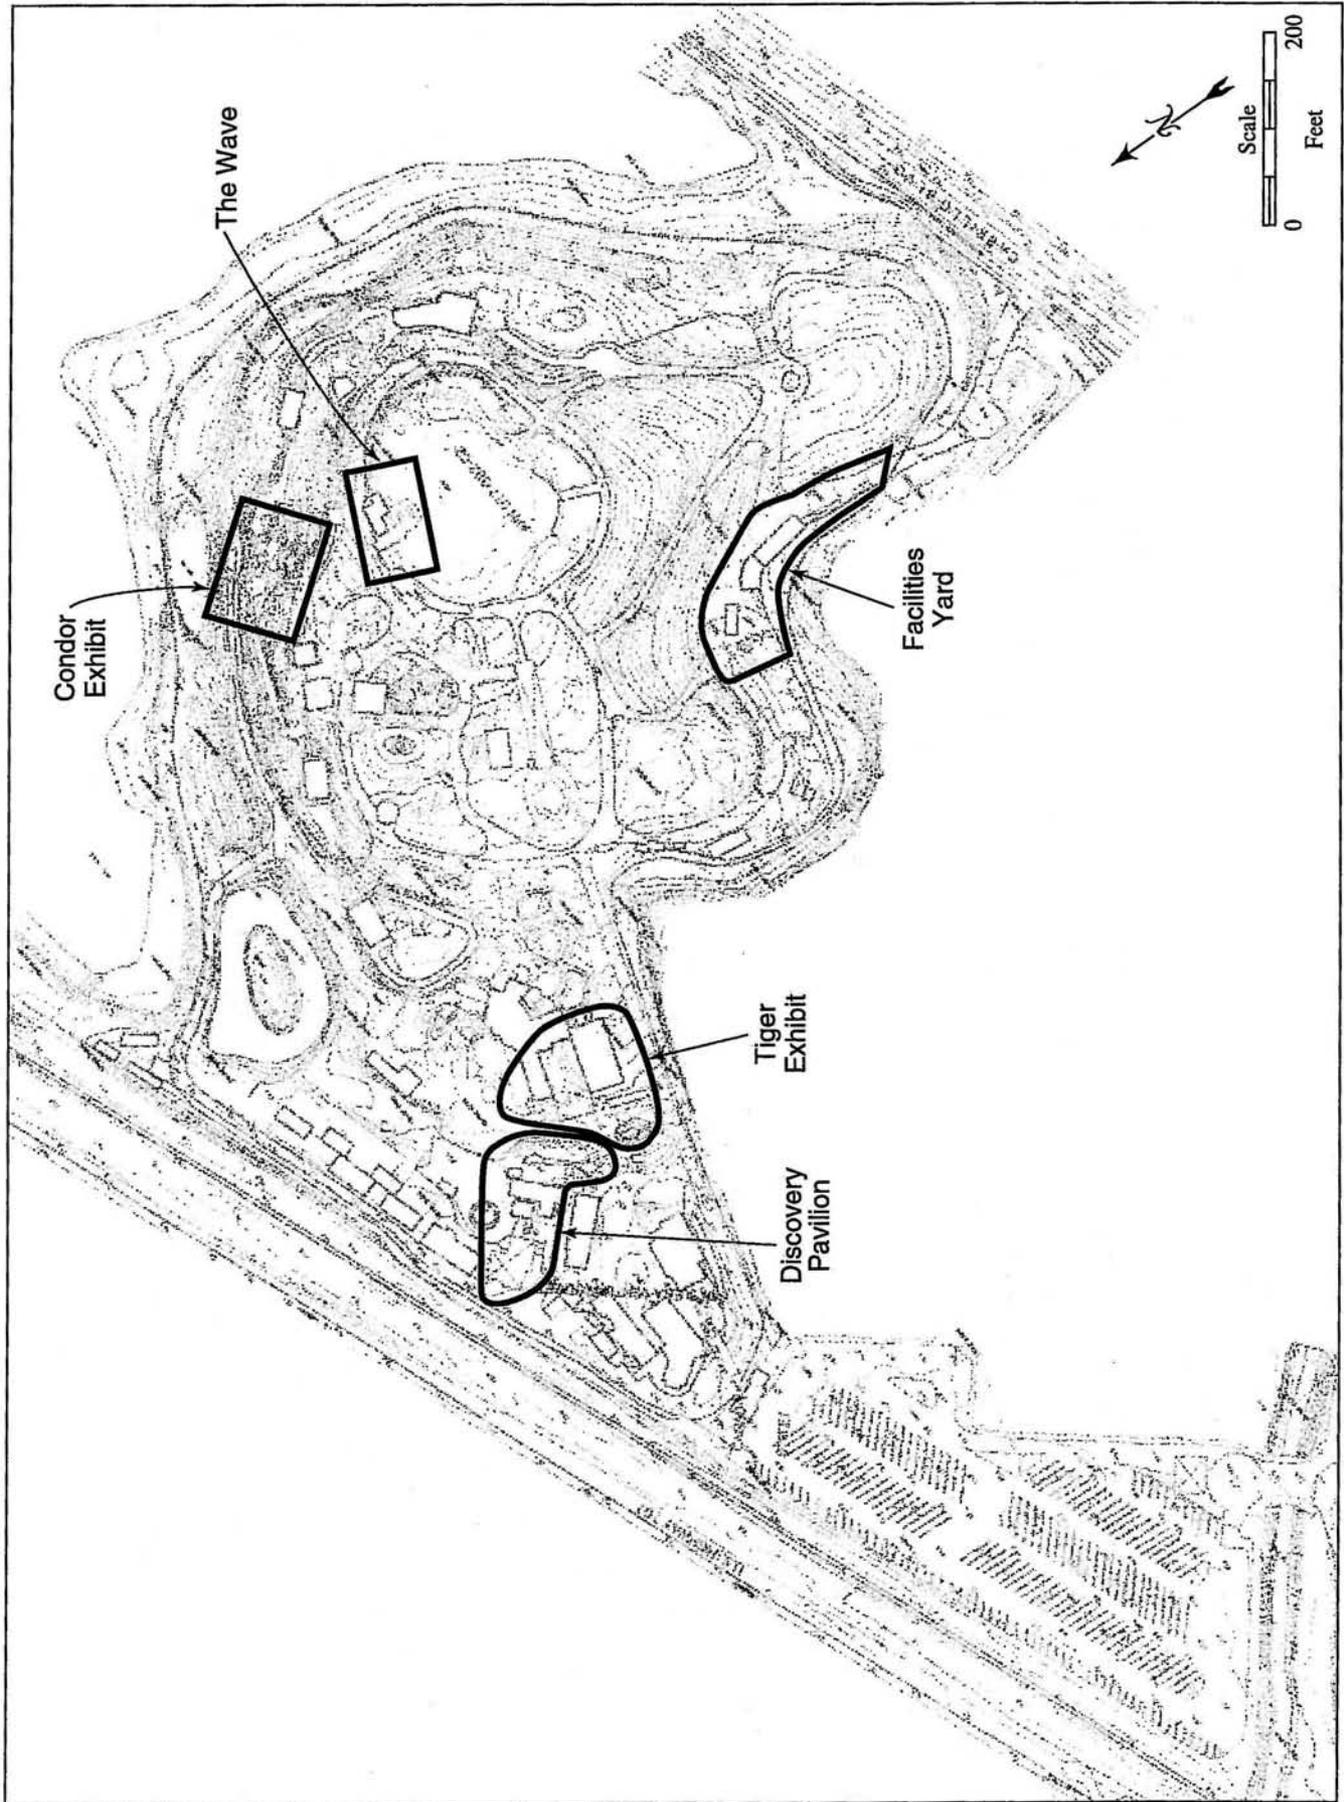
Figure 2. Santa Barbara Zoological Gardens Site Plan with General Locations of Proposed Projects

The following section includes a general description of the five different projects (Figure 2) currently proposed by the Santa Barbara Zoological Gardens.

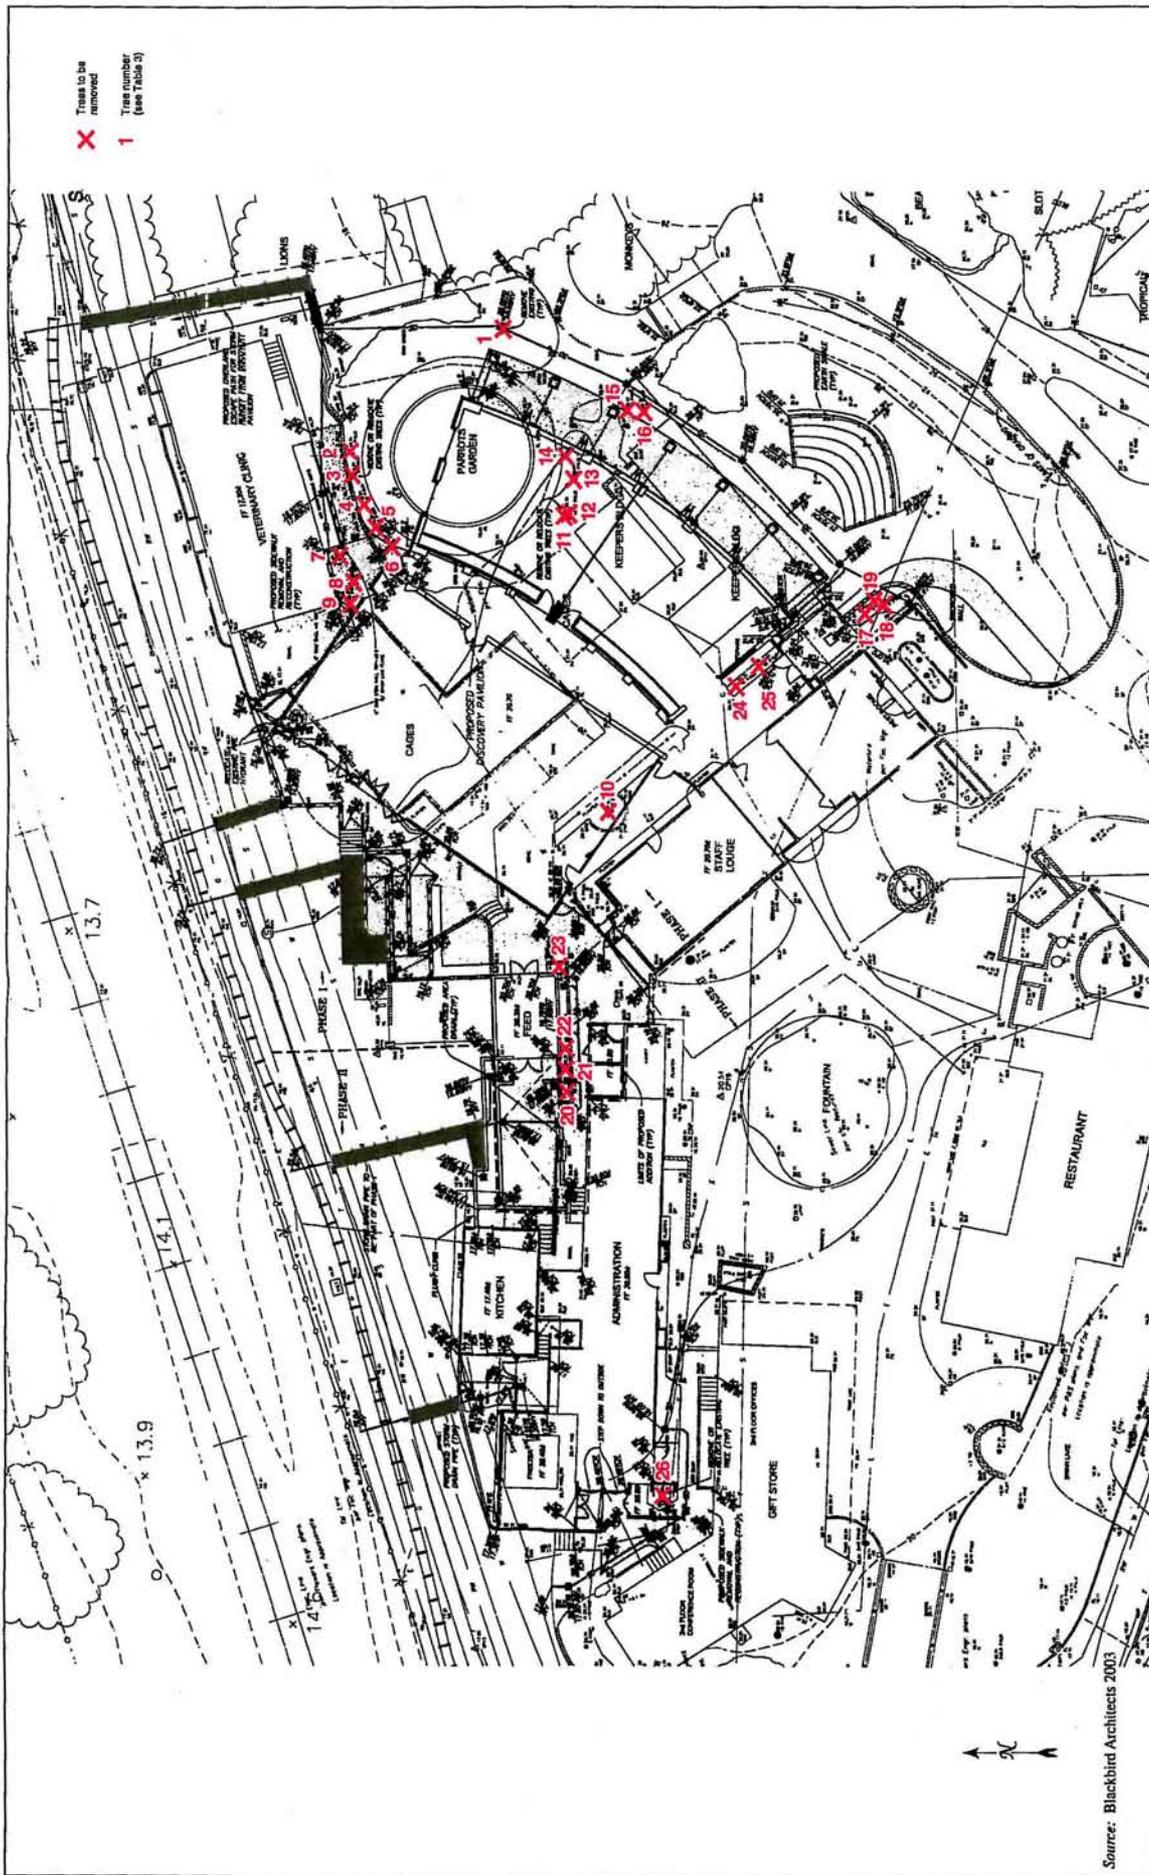
Figure 3a. Discovery Pavilion

The proposed Discovery Pavilion (Figure 3a) would be located near the main entrance, in an area currently occupied by existing office space, the parrot garden, the capybara exhibit, and off-exhibit birdcages. The proposed Gibbon Off-Exhibit building would replace an existing gibbon building in an off-exhibit area near the Gibbon Island. The proposed Gibbon Off-Exhibit Building would entail removing an existing gibbon building in an off-exhibit area near Gibbon Island and construction of a new, larger facility.

**Discovery Pavilion:** A total of 26 trees would be removed for construction of the Discovery Center including 20 palms of various sizes and types, three pines (*Pinus* sp.), one olive (*Olea europaea*), one Jacaranda (*Jacaranda mimosifolia*), and one Peruvian pepper (*Schinus molle*). All of the trees appear to be in good condition with the exception of the pepper tree. Removal of the Peruvian pepper tree is recommended as the tree appears to be declining in health and may become a safety hazard or source of infection to other trees, although the tree is in an isolated

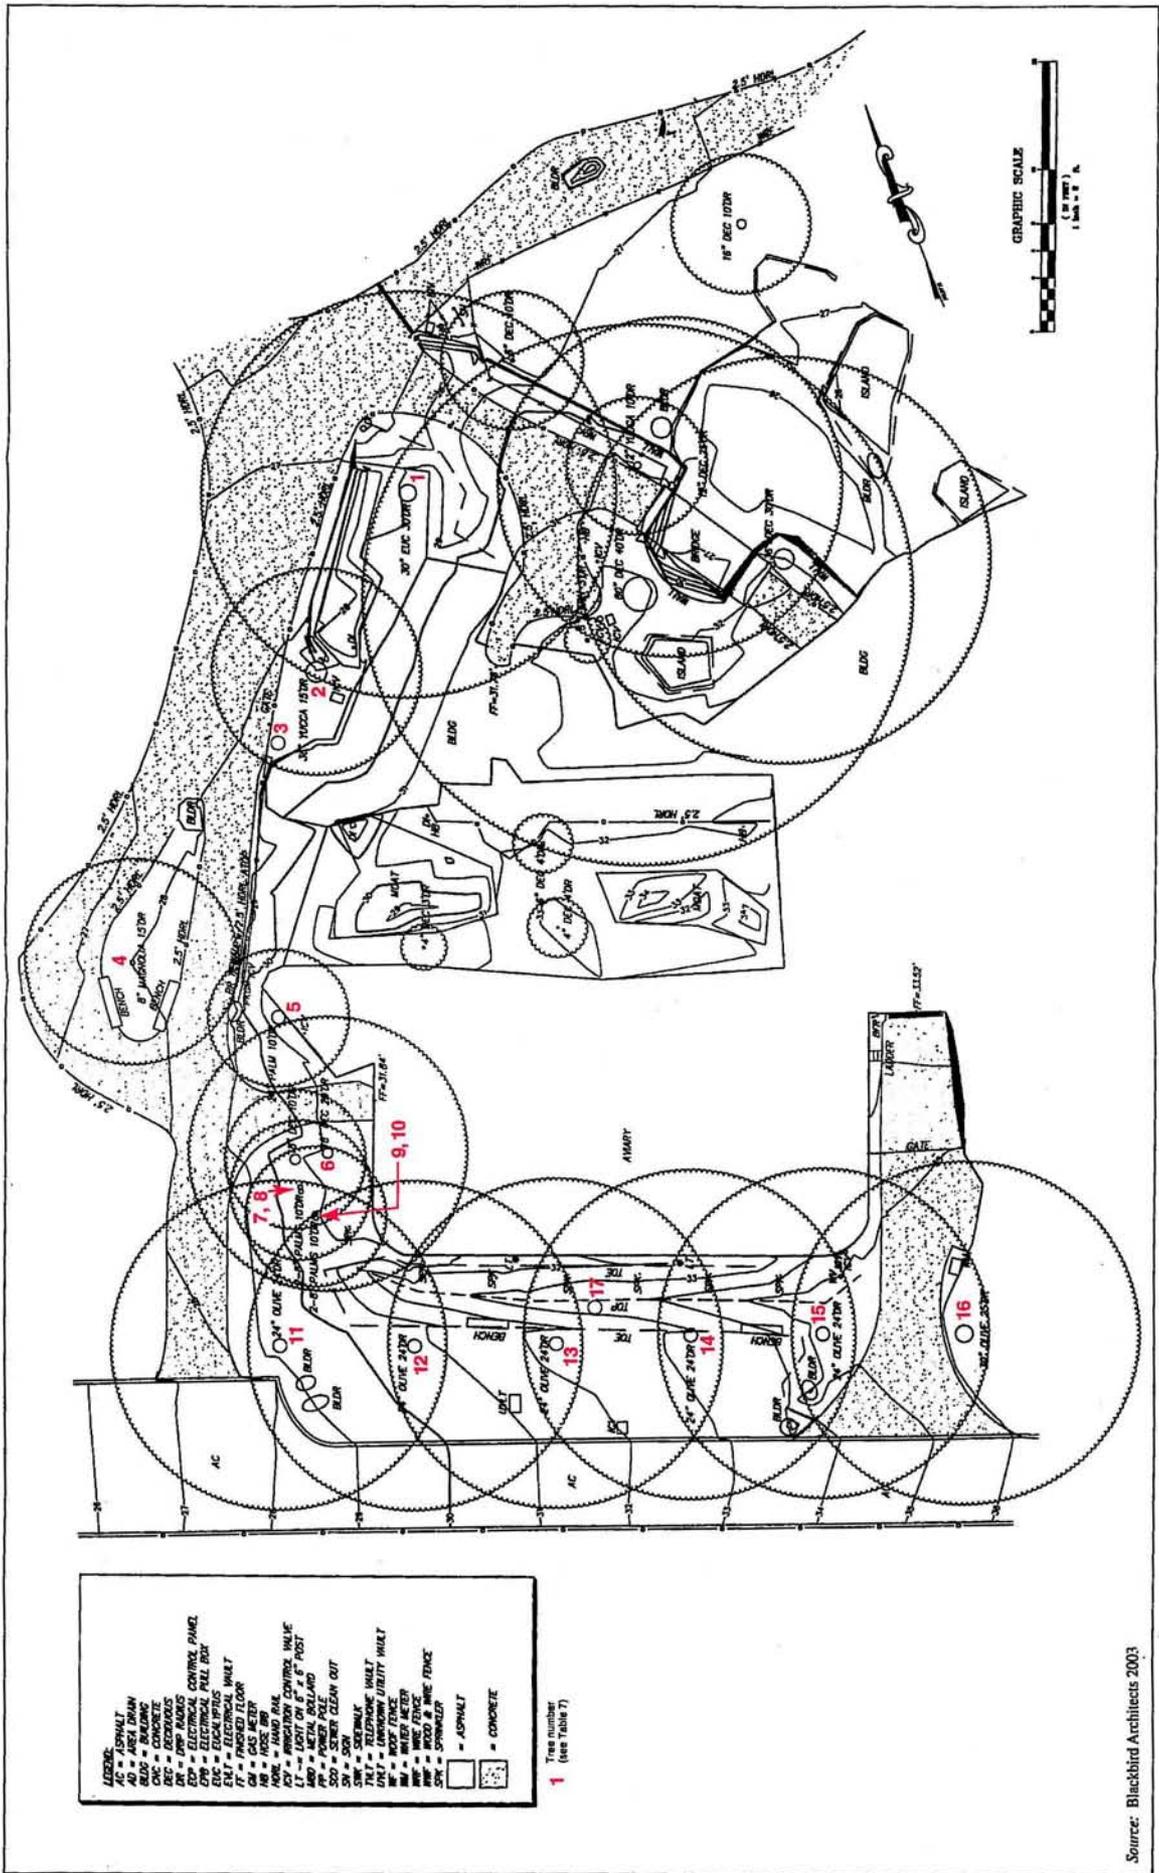
Figure 3e. Tiger Exhibit

The proposed Tiger exhibit (Figure 3e) would be located near the entrance to the zoo immediately adjacent to the new Discovery Pavilion facilities. The proposed project would include replacing the alligator pool, tropical bird aviary, and otter exhibits and removing several olive trees and other non-native vegetation along the entrance road near the entrance of the zoo, and the construction of a new fenced tiger viewing pen and facilities.

As proposed, the eucalyptus tree providing black-crowned night heron nesting habitat in the footprint of the proposed Tiger Facility would be removed. The loss of this tree would result in a permanent loss of breeding habitat for this species and would represent a loss of four or five active nests for this species. The U.S. Fish and Wildlife Service (USFWS) may consider the removal of any active nest as a violation of the Migratory Bird Treaty Act (MBTA). However, after the nestlings have left the nests, CDFG would prefer that trees would remain for those species that use a site year-after-year. The CDFG would not consider the loss of these nests as a violation of the MBTA (Morgan Wehtje, CDFG, personal communication July 2003). Impacts on individual birds would be reduced if construction activities, including tree removal and pruning were scheduled outside of the breeding season for this species; this species may begin nesting in late winter and could extend to the end of August. It is not known whether this species breeds in other trees in the area; however, other trees are apparently available in the immediate vicinity. Because the eucalyptus tree used by black-crowned night herons for nesting would be removed during the non-breeding season and there is other available nesting habitat within the zoo and Bird Refuge, impacts on black-crowned night herons would be adverse but not significant.

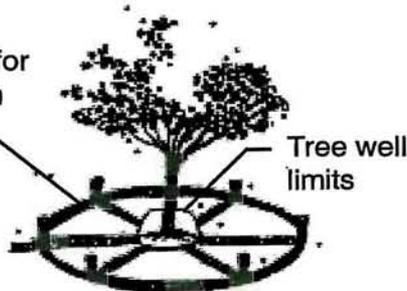
**Location of Radiating Pipes when Filling Around Existing Trees**  
Perspective View

Radiating pipes for supply of oxygen and nutrients

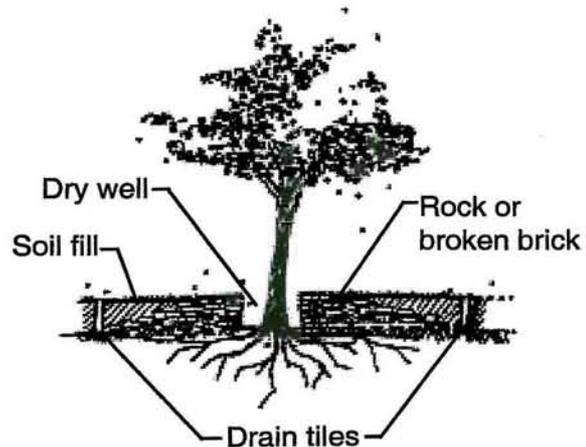
**Tree Well Section View**

Dry well  
Soil fill  
Rock or broken brick

"vertical tiles" that supply oxygen to the root system

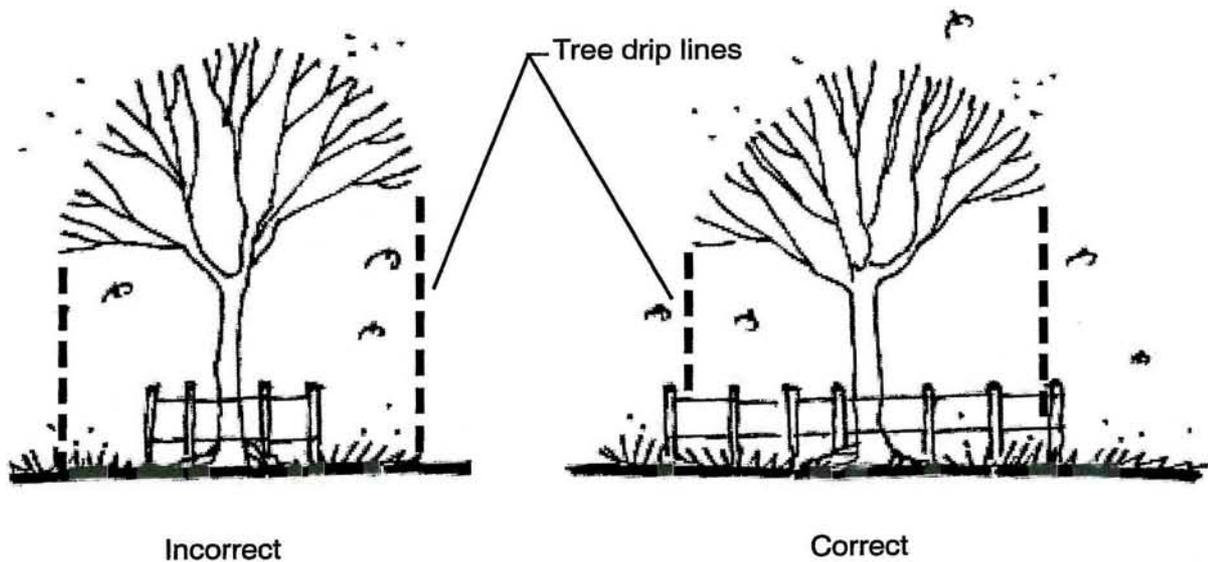
**Proper Fencing Around Existing Trees  
Elevation View**

Note: Barrier should be installed at the drip line of a tree's branches.

1. Leave critical areas (such as flood plains, steep slopes and wetlands) with desirable trees in their natural condition or only partially cleared.
2. Locate roadways, storage areas, and parking pads away from valuable tree stands. Follow natural contours, where feasible, to minimize cutting and filling in the vicinity of trees.
3. Select trees to be preserved before siting, roads, buildings, or other structures.
4. Minimize trenching in areas with trees. Place several utilities in the same trench.
5. Designate groups of trees and individual trees to be saved on the erosion and sedimentation control plan.
6. Do not excavate, traverse, or fill closer than the drip line, or perimeter of the canopy, of trees to be saved. See figure below for correct barrier placement.

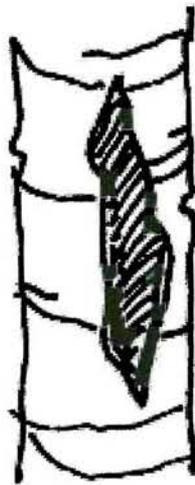
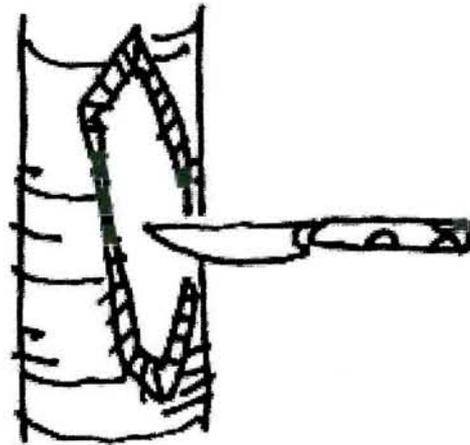
**Repairing Tree Bark Wounds  
Perspective View**

Tree wound

Trim and taper wound edge

Note: Trim bark wounds with a tapered cut, then apply tree paint.

1. Repair roots by cutting off the damaged areas and painting them with tree paint. Spread peat moss or moist topsoil over exposed roots.
2. Repair damage to bark by trimming around the damaged area, tapering the cut to provide drainage, and painting with tree paint. See figure below.
3. Cut off all damaged tree limbs above the tree collar at the trunk or main branch. Use three separate cuts to avoid peeling bark from healthy areas of the tree. See following figures.

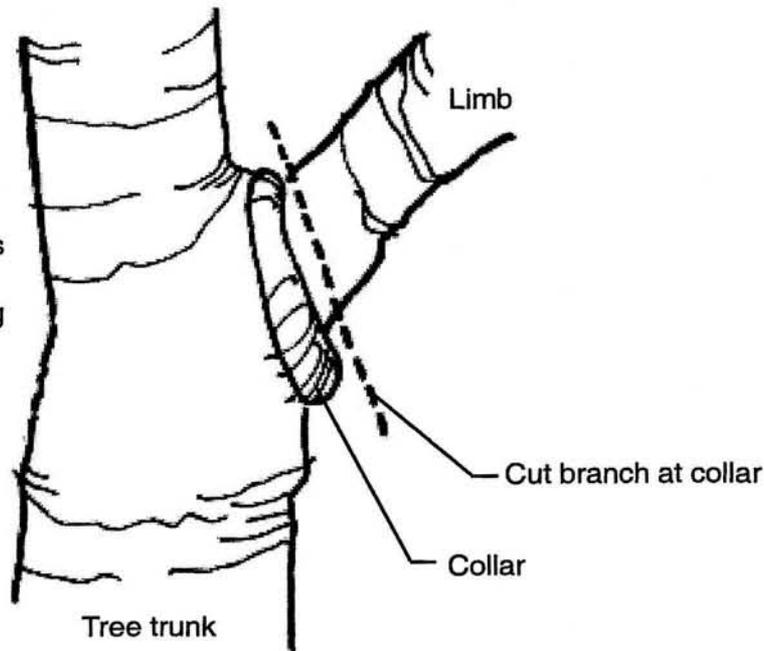
**Proper Pruning of Damaged Branches  
Perspective View**

Note: Prune damaged branches at collar; more than one cut may be needed to avoid peeling bark when a limb falls.
