# Santa Barbara Airport

August 24, 2023

Conditions and Further Use Analysis Study for the General Western Aero Hangars,  
Buildings 248 & 249.

LMA Architects

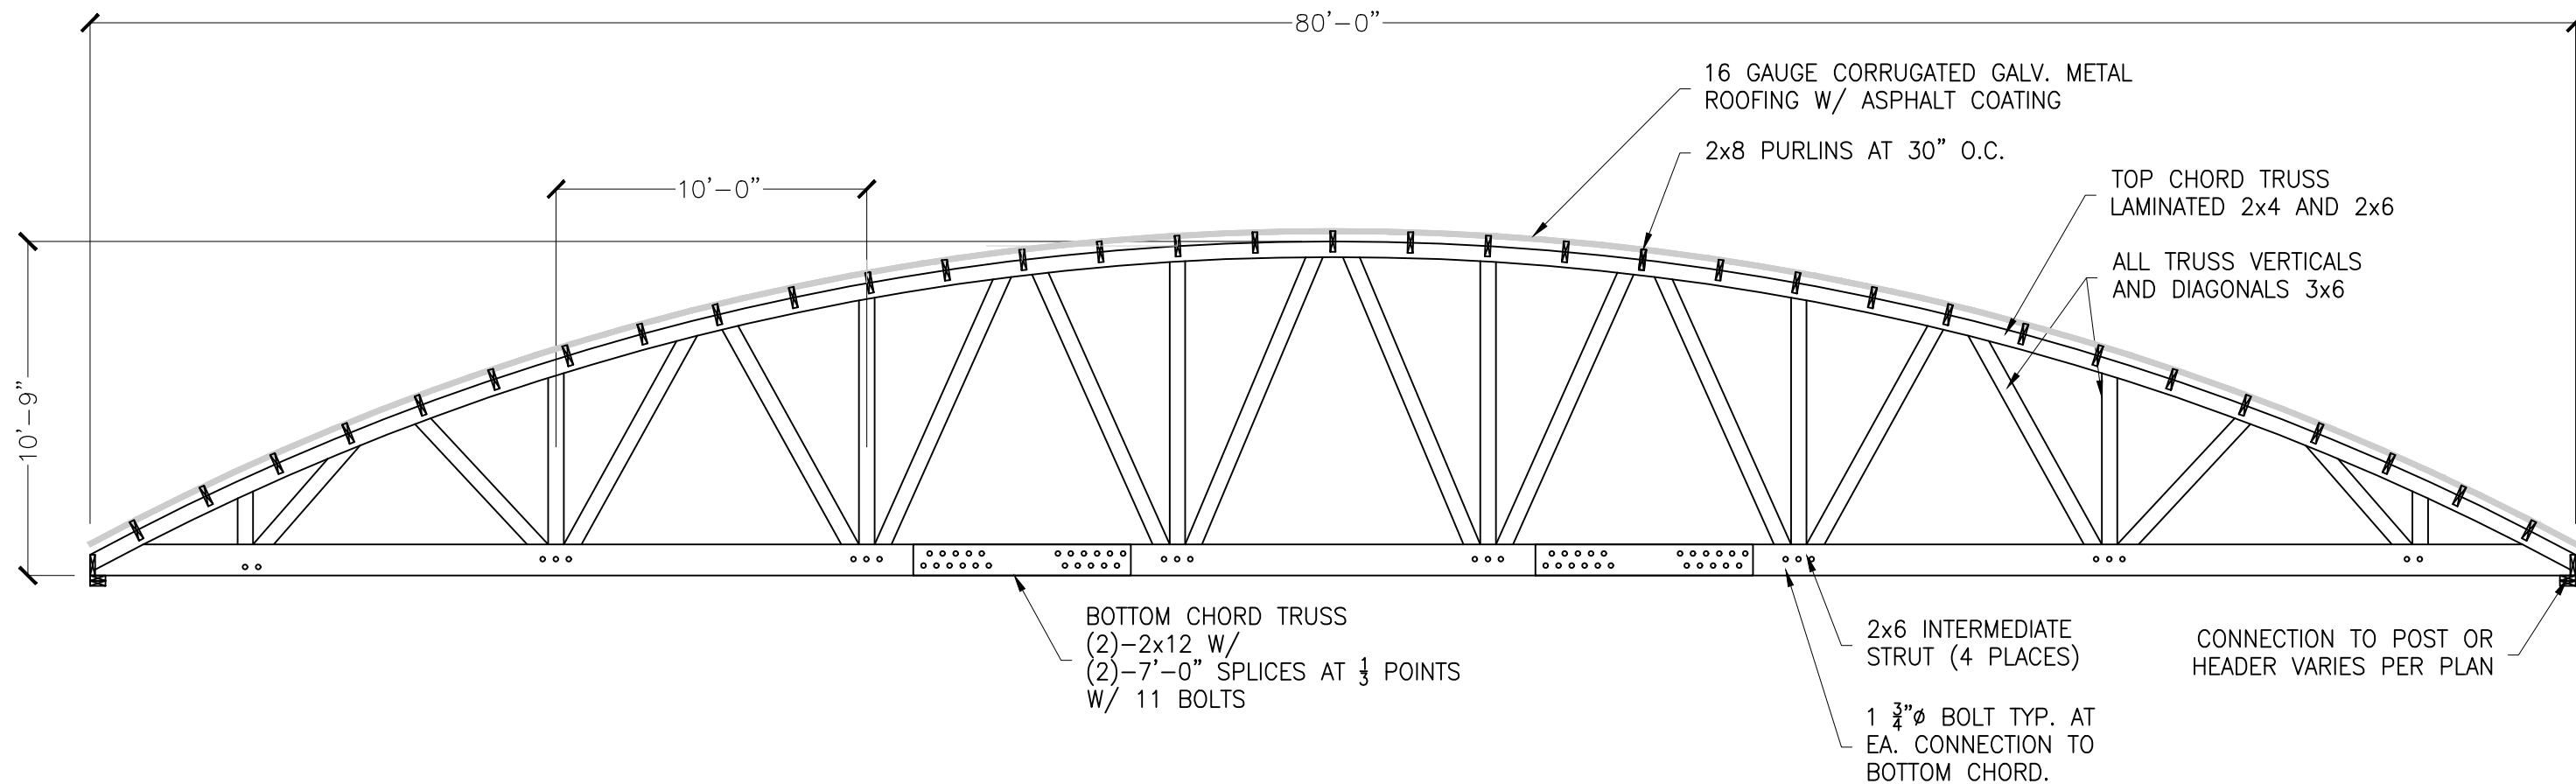
**1 BOWSTRING TRUSS ELEV.**  
N.T.S.

3. Bowstring Type Truss: The current truss spans approximately 80 feet. The gable truss at the door spans approximately 50 feet. The truss consists of (2)-2"x6" top chord, (2)-2"x12" bottom chord with two (2) splice connections, and 3"x6" web members. All web members are bolted to truss at top and bottom chords. On the easterly side (grid line 2 per figure 1) the truss sits on a header type structure comprised of (7)-2"x12" built up beam. On the westerly side (grid line 1 per figure 1) the truss sits on 8"x10" post. The post on northerly side (grid line C per figure 1) contains (2)-2"x6" kickers, and the other have been removed. For an elevation view of the truss, please see Appendix III. The gable truss at the door sits on approximately 15 feet long bearing walls on each end.
