Post/Hazeltine Associates

1.0 INTRODUCTION AND REGULATORY FRAMEWORK

This Historic Sites/Structures Letter evaluates a revision to the approved plans for a project for the Santa Barbara Museum of Art located at 1120 State Street (APN 039-232-021) and 1130 State Street (APN 039-232-020). Preliminary plans for the project were evaluated in a Revised Phase 1-2 HSSR that was reviewed and accepted by the Historic Landmarks Commission in May of 2014. Subsequent revisions to the plans were evaluated in a HSSR Letter Report prepared by Post/Hazeltine Associates dated March 3, 2015.

**Santa Barbara Museum of Art
 Phase 3**
 Building Renovation, Facility & Art Gallery Improvement Program
 1130 State Street
 Santa Barbara, CA 93101

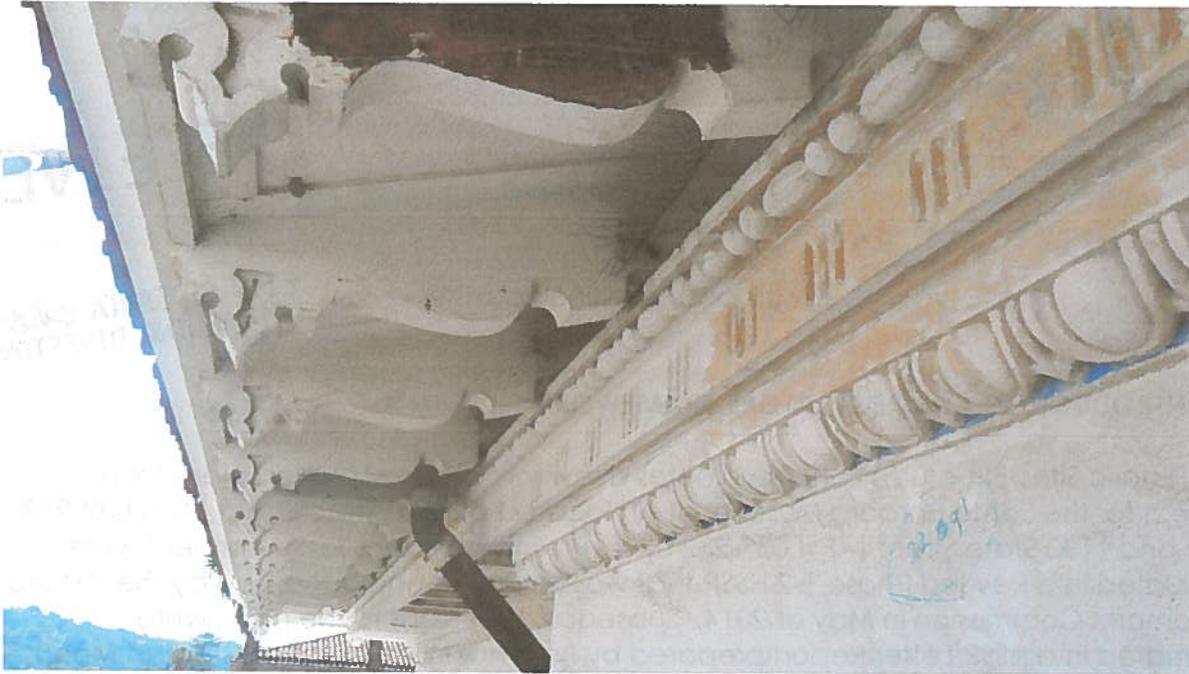
Figure 1 Detail of Cornice and Rafter Tails, South Elevation, looking west

The applicant proposes revisions to the plans reviewed and approved by HLC in 2015. The approved project included the removal of a 45-foot section of cornice and rafter tails located on the south elevation of the original post office wing (Figures 1 – 3, Appendix A, Sheet 2AD1.20). The removed section of cornice and rafter tails was approved for re-use in an interpretive display located either onsite, offsite at the Ridley

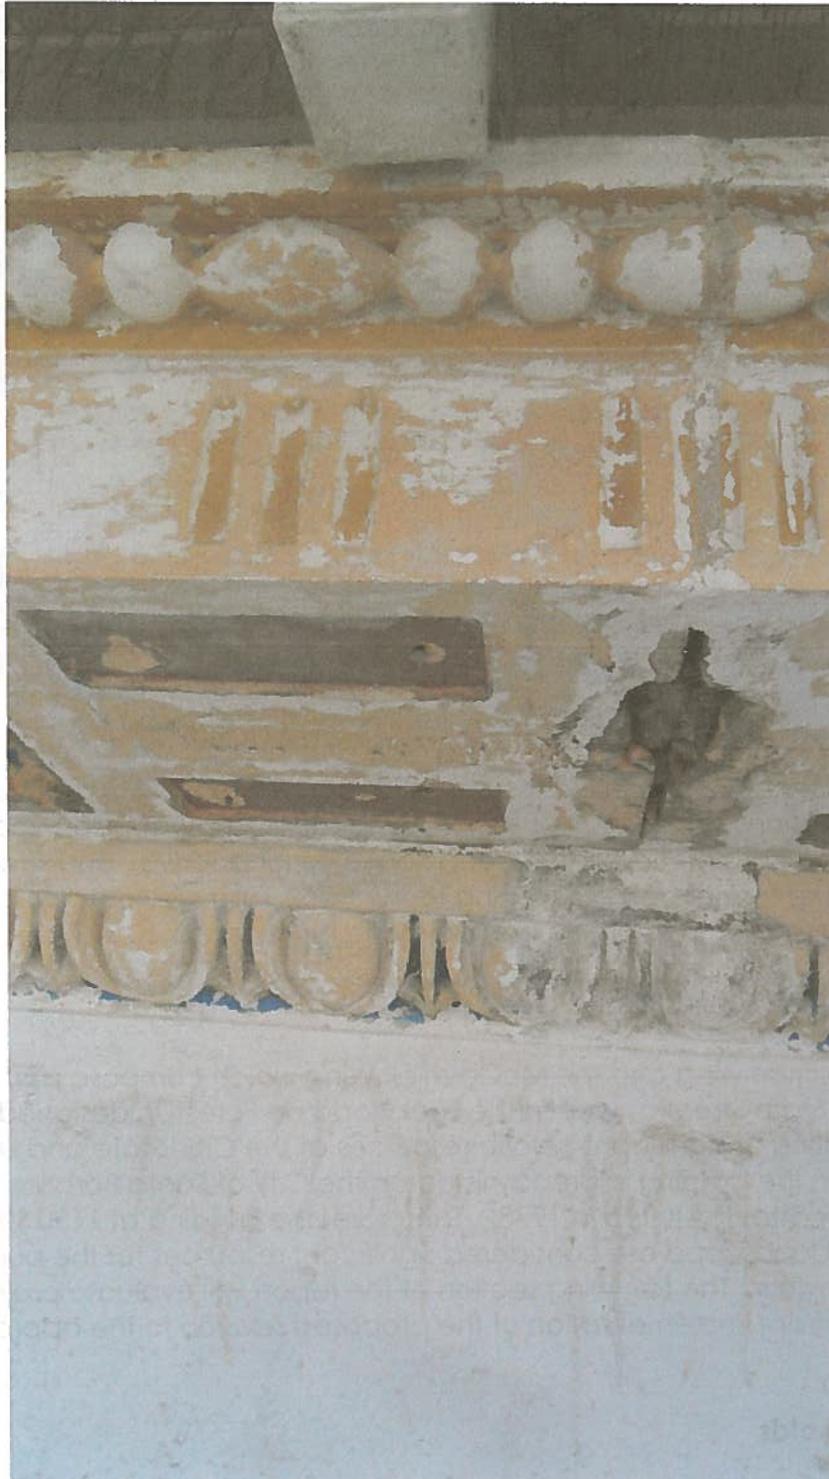
Figure 2, detail of cornice, south elevation, looking north

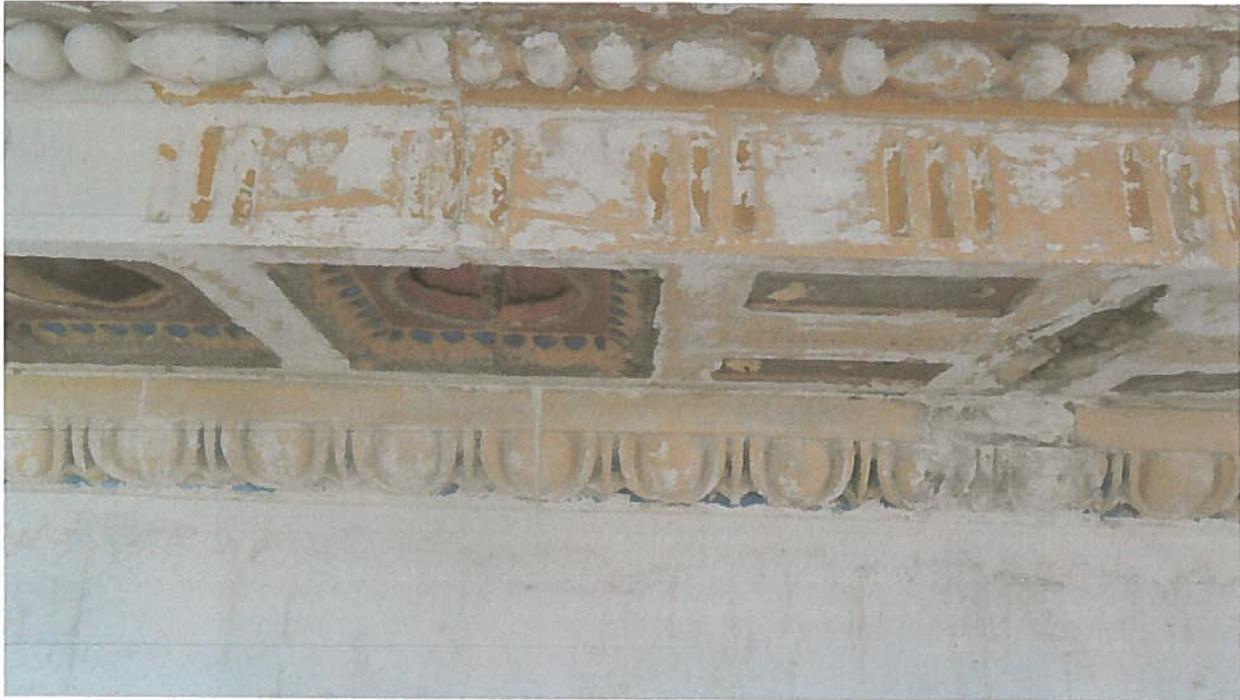
Figure 3, Detail of Cornice, south elevation, looking north

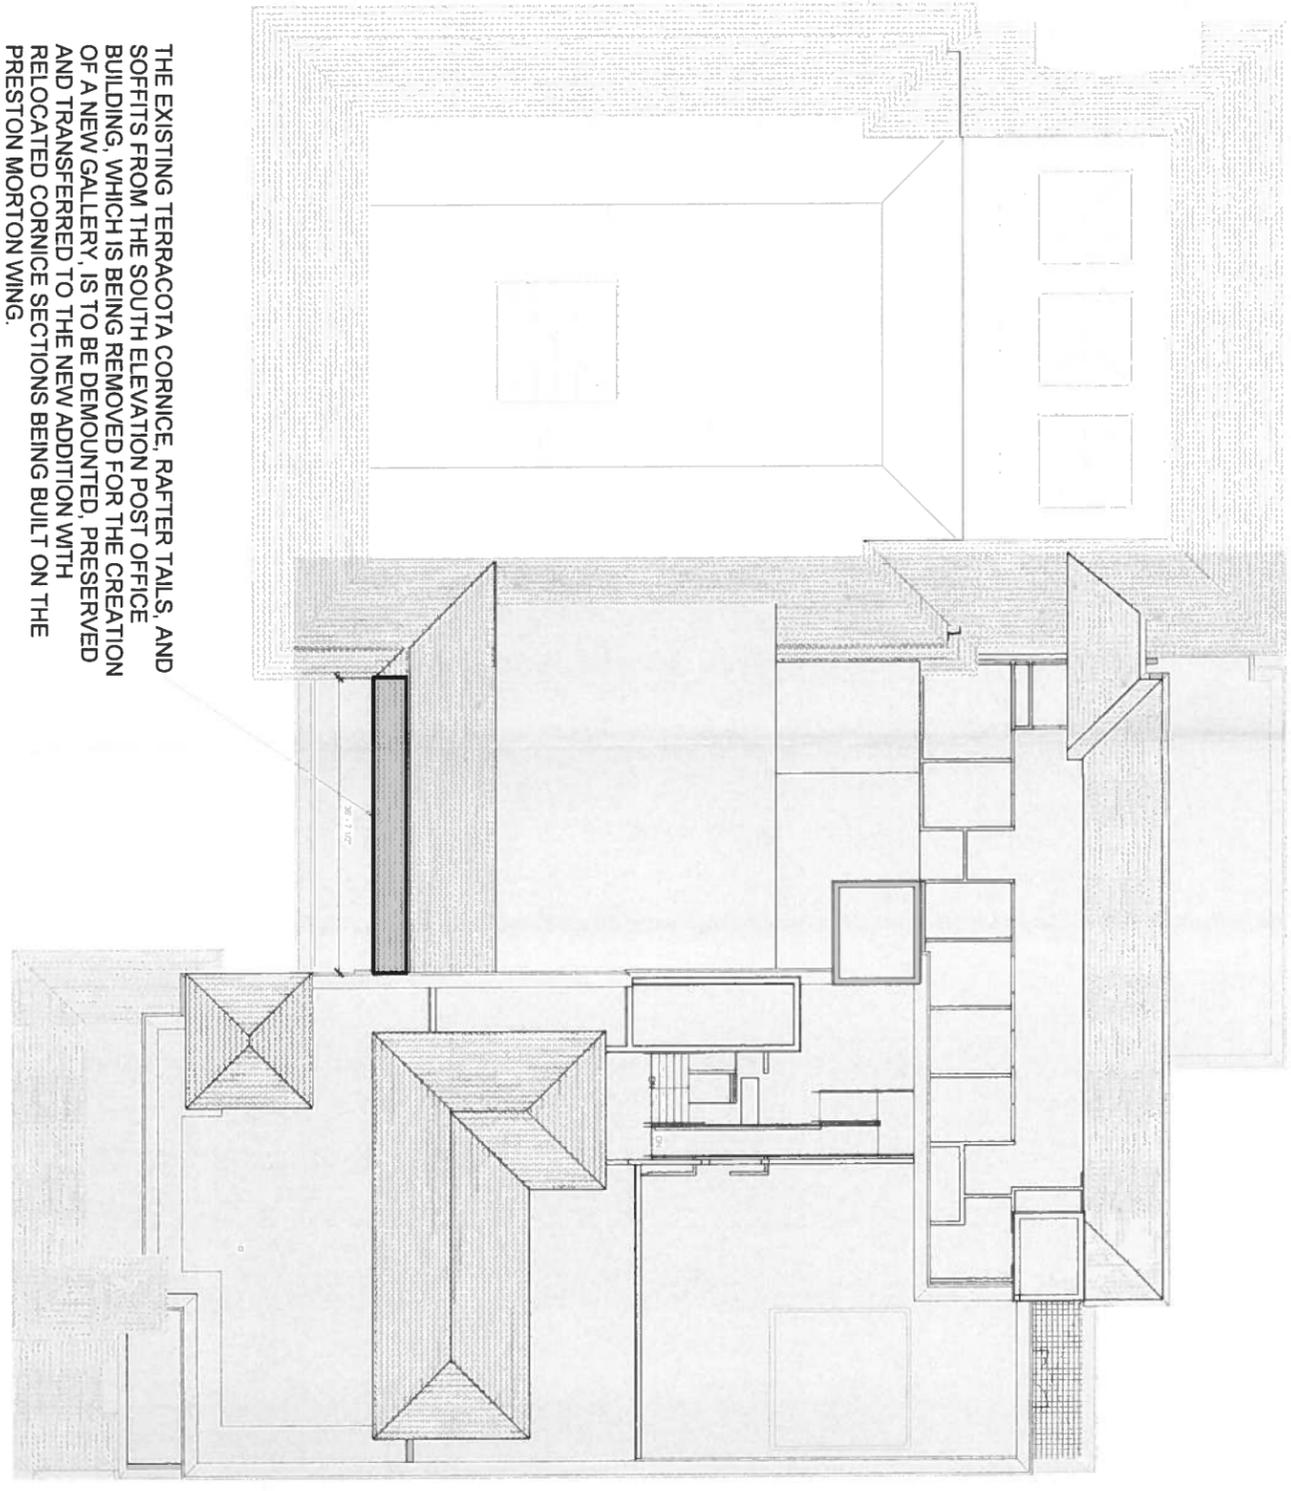
THE EXISTING TERRACOTA CORNICE, RAFTER TAILS, AND SOFFITS FROM THE SOUTH ELEVATION POST OFFICE BUILDING, WHICH IS BEING REMOVED FOR THE CREATION OF A NEW GALLERY, IS TO BE DEMOUNTED, PRESERVED AND TRANSFERRED TO THE NEW ADDITION WITH RELOCATED CORNICE SECTIONS BEING BUILT ON THE PRESTON MORTON WING.

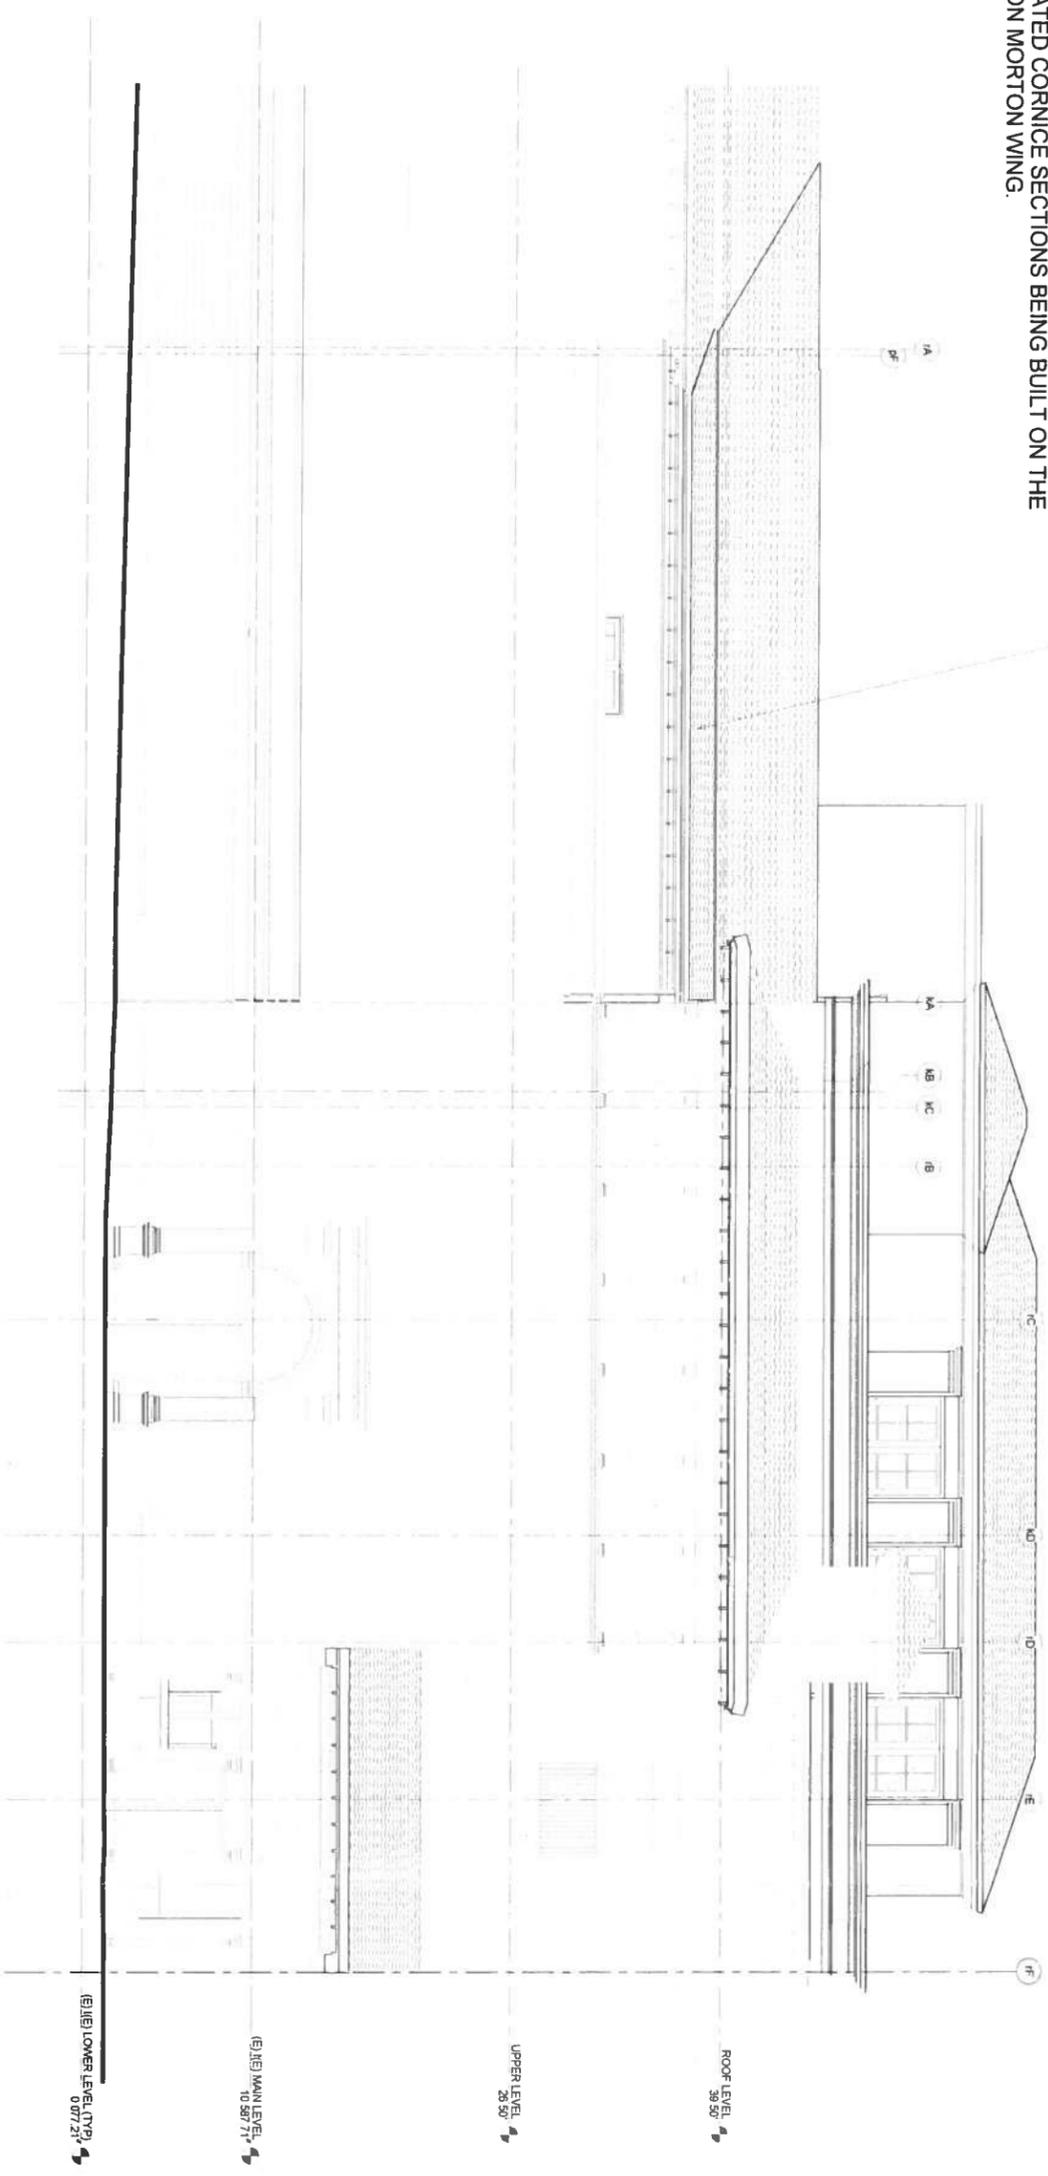
3A1.08

THE EXISTING TERRACOTA CORNICE, RAFTER TAILS, AND SOFFITS FROM THE SOUTH ELEVATION POST OFFICE BUILDING, WHICH IS BEING REMOVED FOR THE CREATION OF A NEW GALLERY, IS TO BE DEMOUNTED, PRESERVED AND TRANSFERRED TO THE NEW ADDITION WITH RELOCATED CORNICE SECTIONS BEING BUILT ON THE PRESTON MORTON WING.
