PHASE II ENVIRONMENTAL SITE ASSESSMENT AND REMEDIAL EXCAVATION REPORT

125 State Street
Santa Barbara, California

Rincon Consultants, Inc.
July 15, 2010

July 15, 2010
Project 08-25430

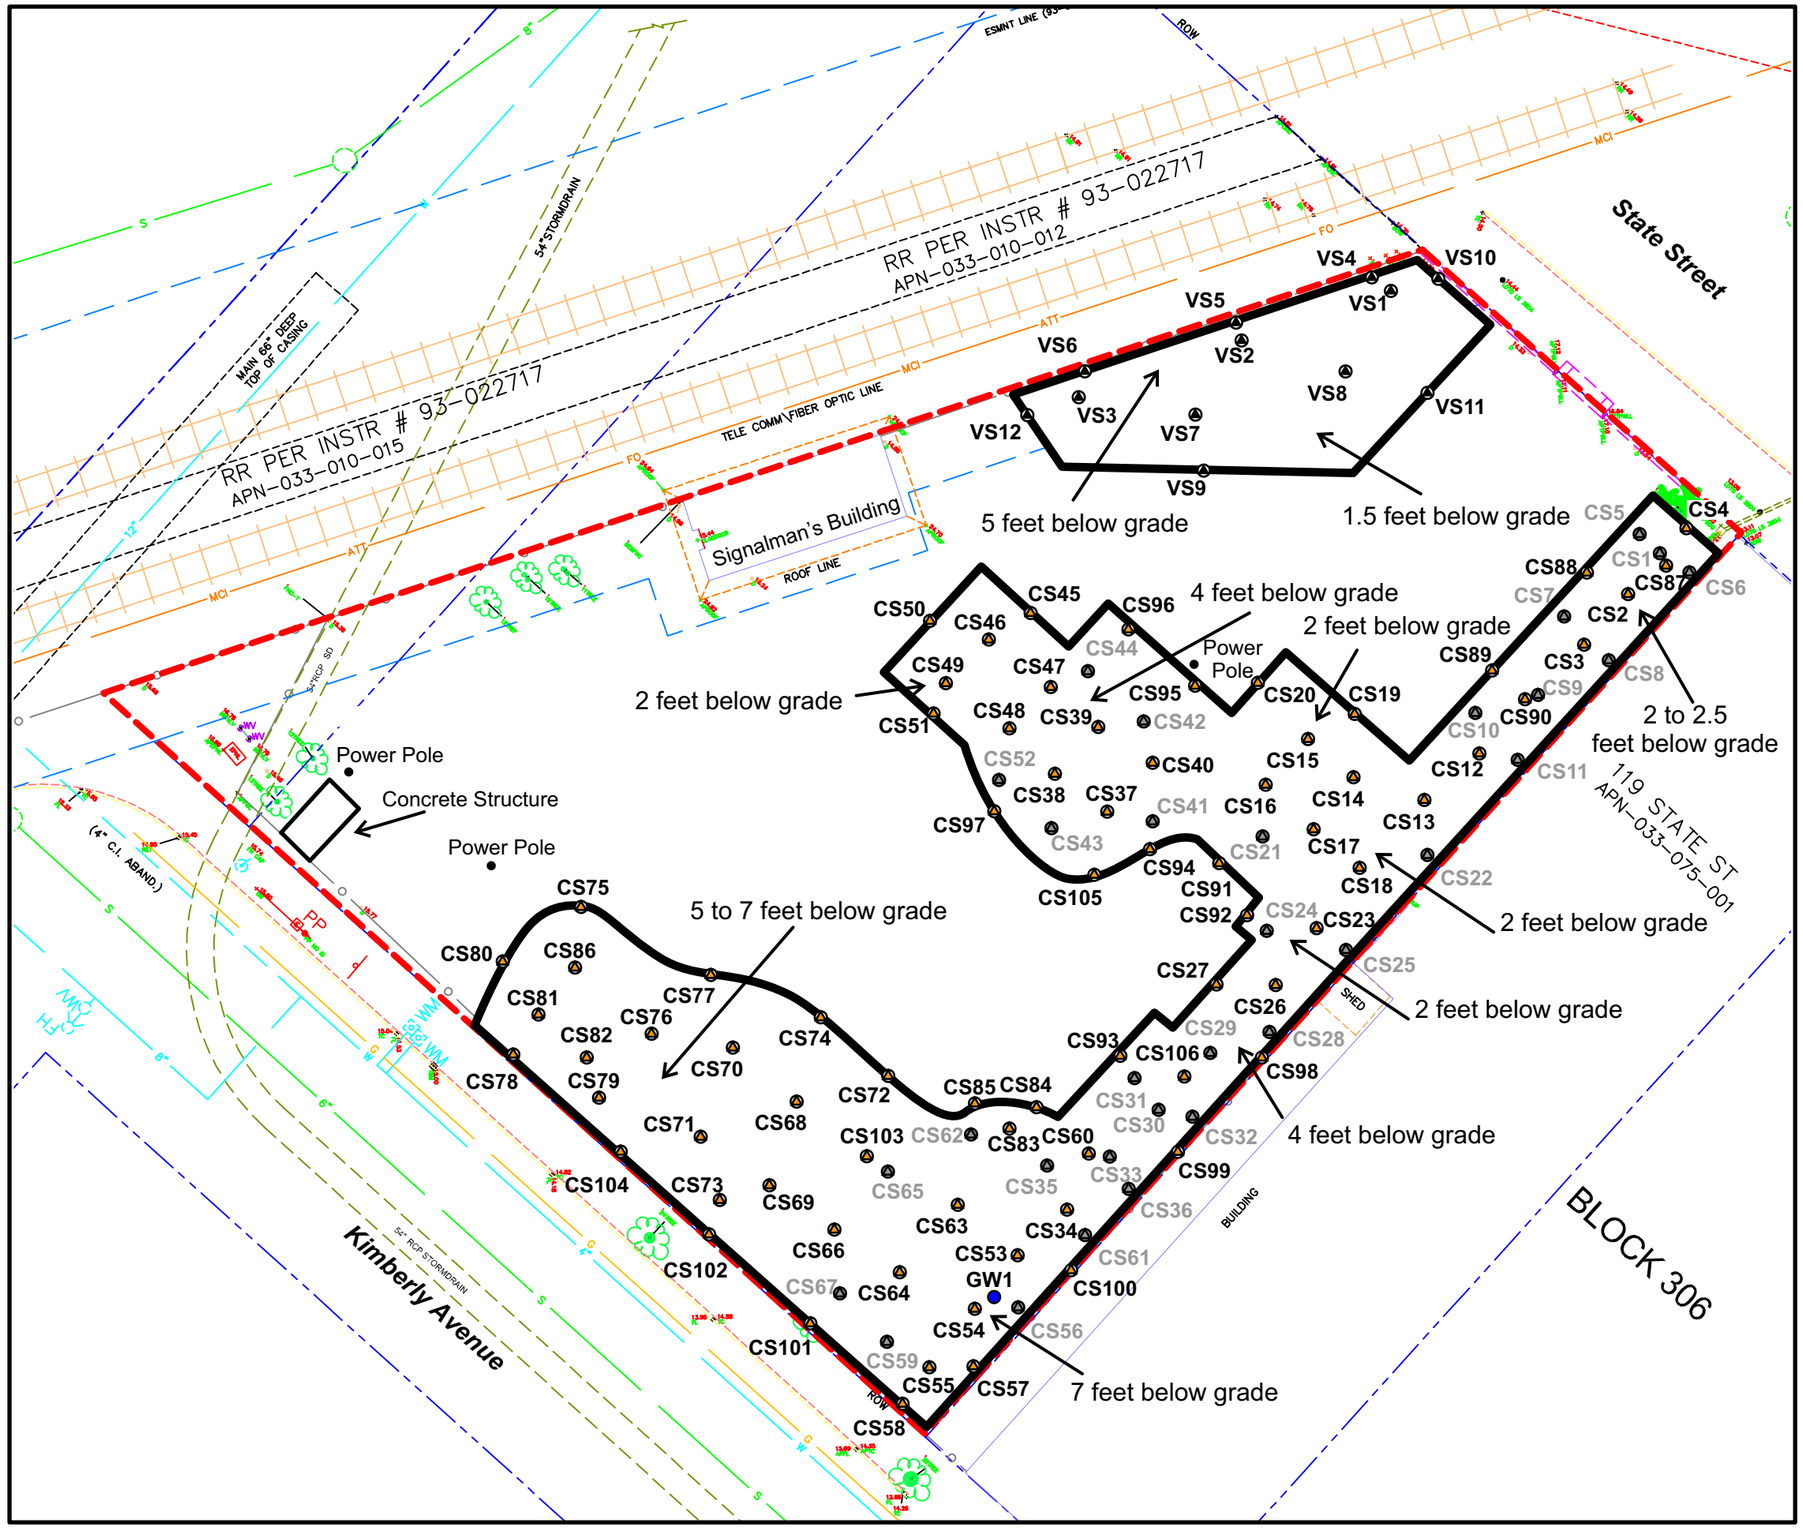
and CS11 was extended to the wall of the State Street Hotel structure. No confirmation soil samples were collected because the sidewall was the foundation of the State Street Hotel structure. Excavation sidewall confirmation samples CS84, CS85, and CS93 were collected from the extended excavation sidewall in the area of confirmation soil samples CS31 and CS35. Total lead was detected at concentrations of 9.1 mg/kg, 5.8 mg/kg, and 9.5 mg/kg in confirmation soil samples CS84, CS85, and CS93. The extended excavation area removed soil impacted by total lead concentrations exceeding cleanup goals (400 mg/kg) at the locations of confirmation soil samples CS8, CS11, CS31, and CS35. Figure 8 depicts the final excavation extent and the confirmation soil sample locations.

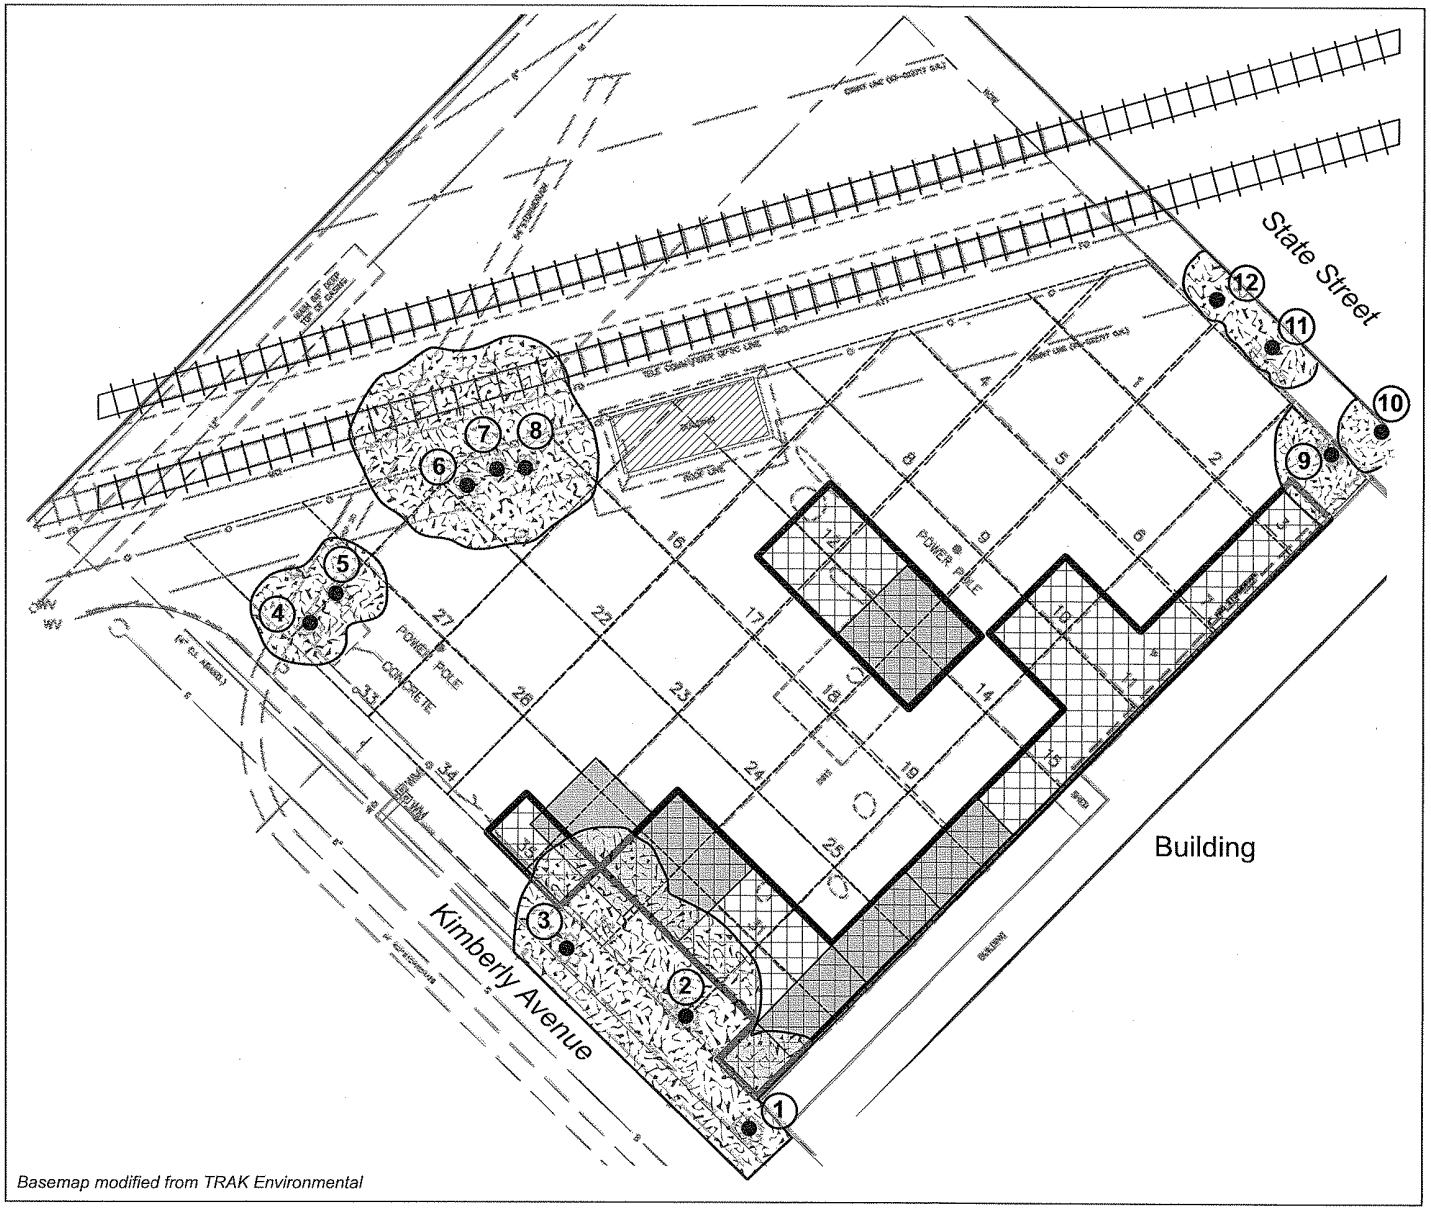
Figure 2

Seven (7) trees are on the site within the fence line and five (5) trees are outside the fence line associated with the city's sidewalks, all of which are non-native landscaping trees (Figure 2). Of these trees, nine (9) are expected to be subject to encroachment and possible long-term damage from grading unless tree protection measures are implemented.

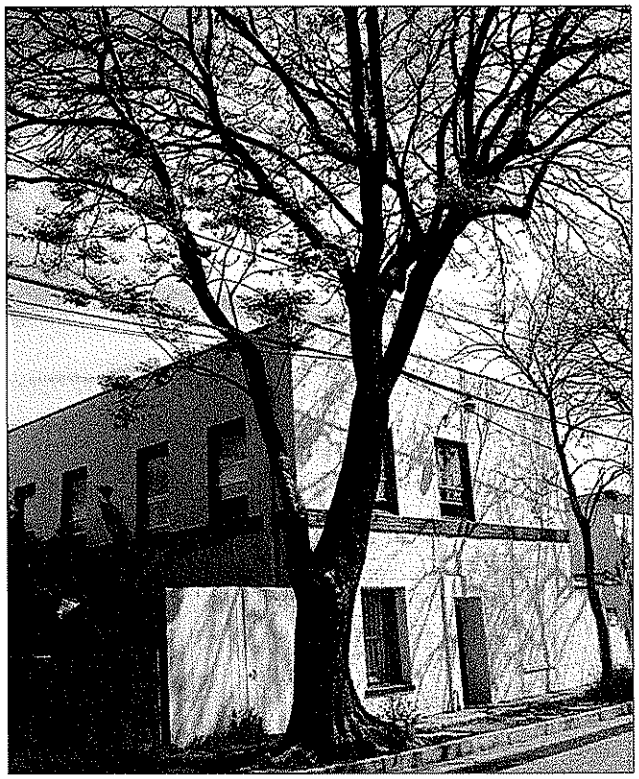
All of the trees found within and adjacent to the project site are biologically healthy with only minor structural damage. The majority of the damage is due to root crowding (Photo 8), expected reduced root support system caused by existing asphalted streets and minor mechanical damage to the trunks (Photo 7).

Photo 1. Tree #1, Jacaranda located on west end of project site.

Photo 8. Tree #1, jacaranda, with evidence of root crowding by curb and street gutter.

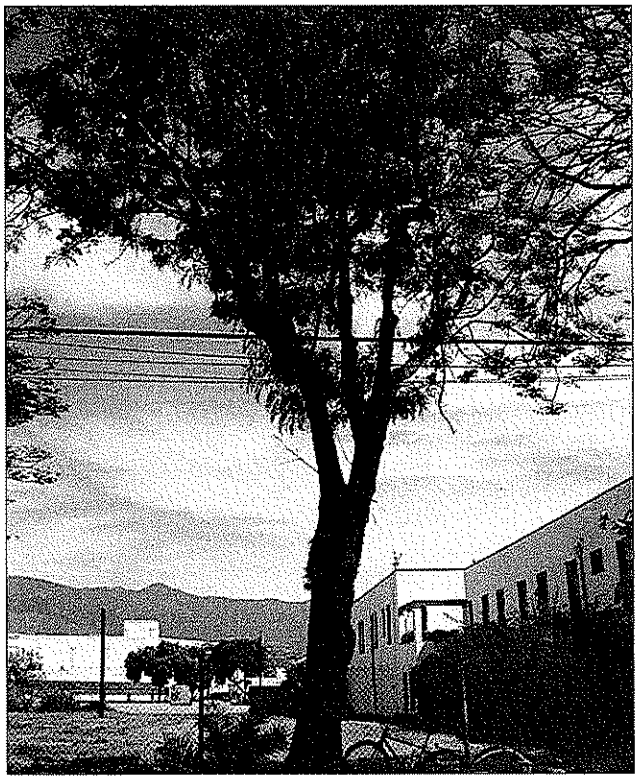
Photo 2. Tree #2 , bougainvillea goldenrain tree, located outside the western fenceline.

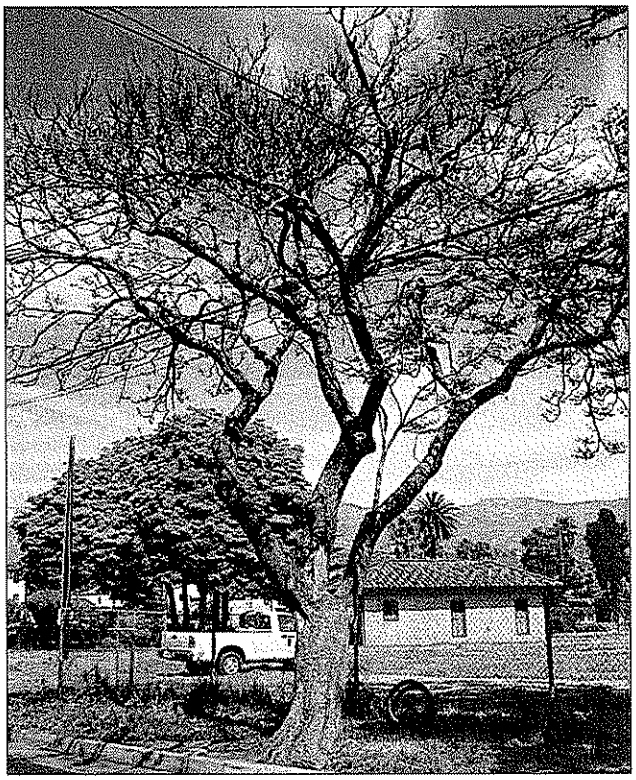
Photo 3. Tree #3, Jacaranda located on southwest corner of project site.

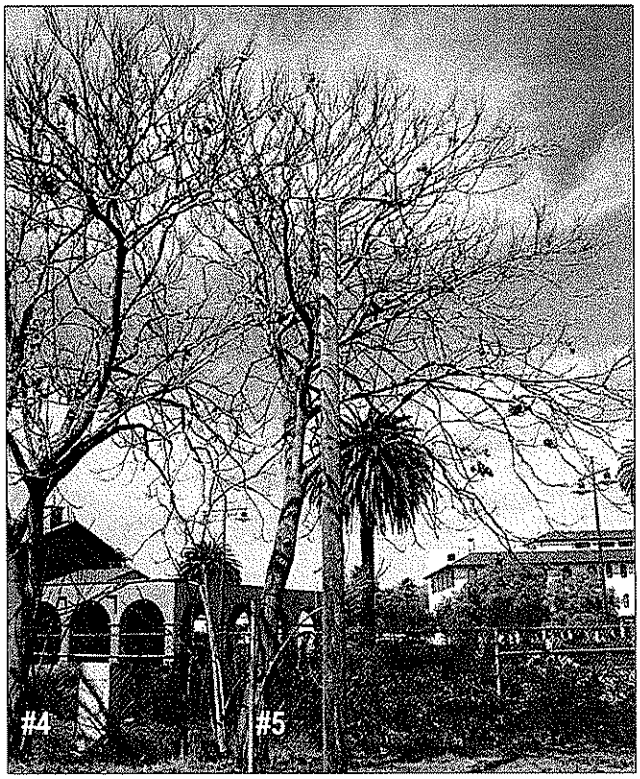
Photo 4. Trees #4 and #5, Jacaranda located on the west end of the project site, within the fencing.

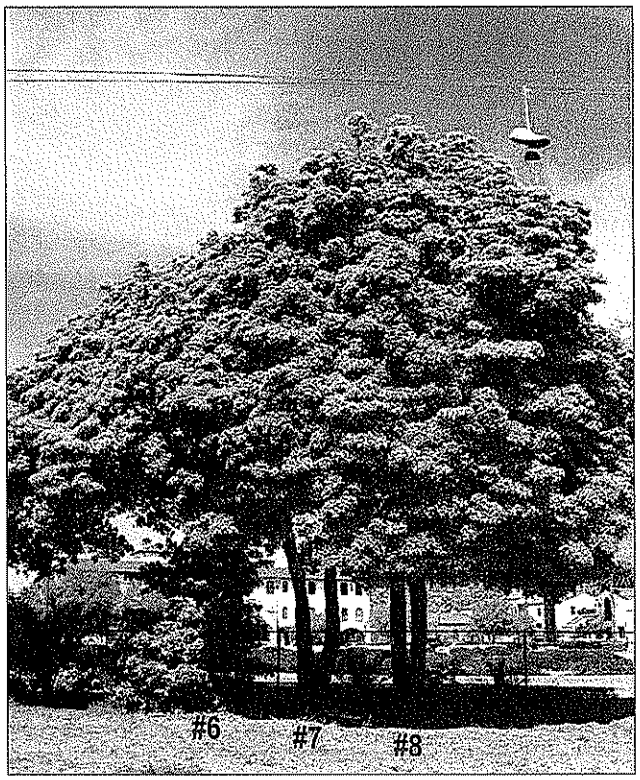
Photo 5. Pittosporum trees #6-8 located inside the northwest fenceline.

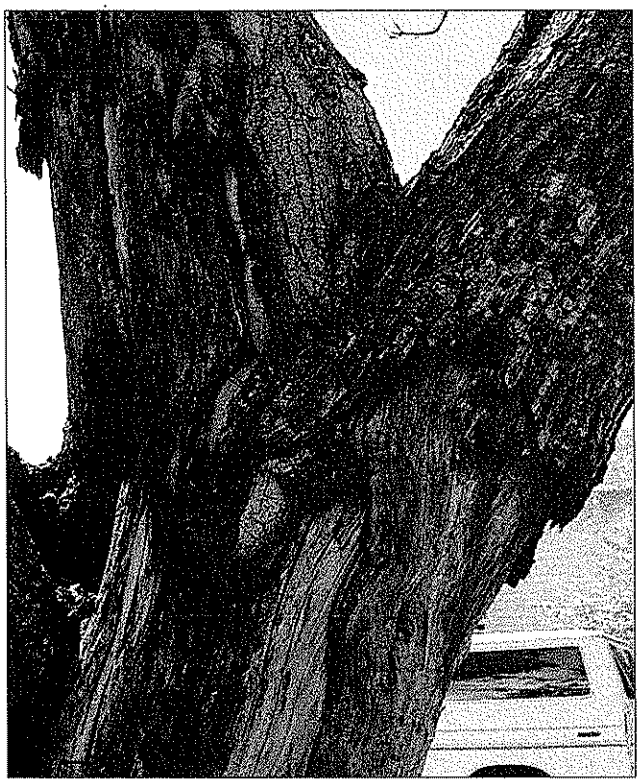
Photo 7. Tree #3, jacaranda, with minor mechanical trunk damage.
