PRESERVATION PLANNING ASSOCIATES

Re: Letter Addendum to Historic Structures/Sites Report for 113-117 West De la Guerra Street, APN 037-082-003, 037-082-027/Mixed Use A.U.D. Development

Findings of Significance for 113-117 West De la Guerra Street

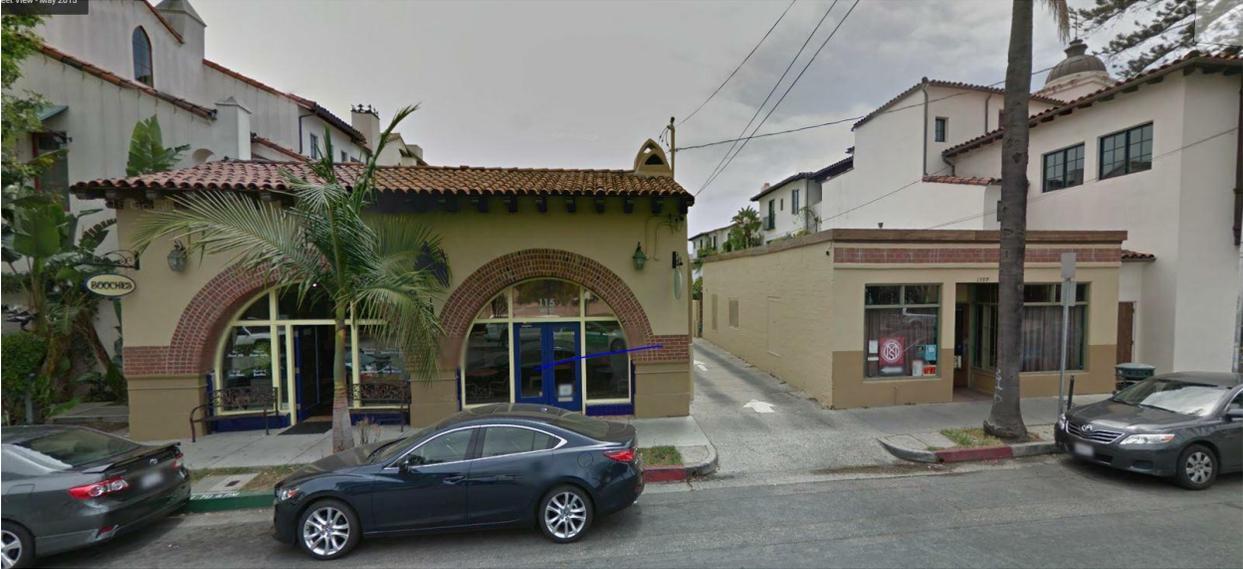
Plate 1. 113-115 and 117 West De la Guerra Street. Facing south. *Courtesy DMHA 2017*

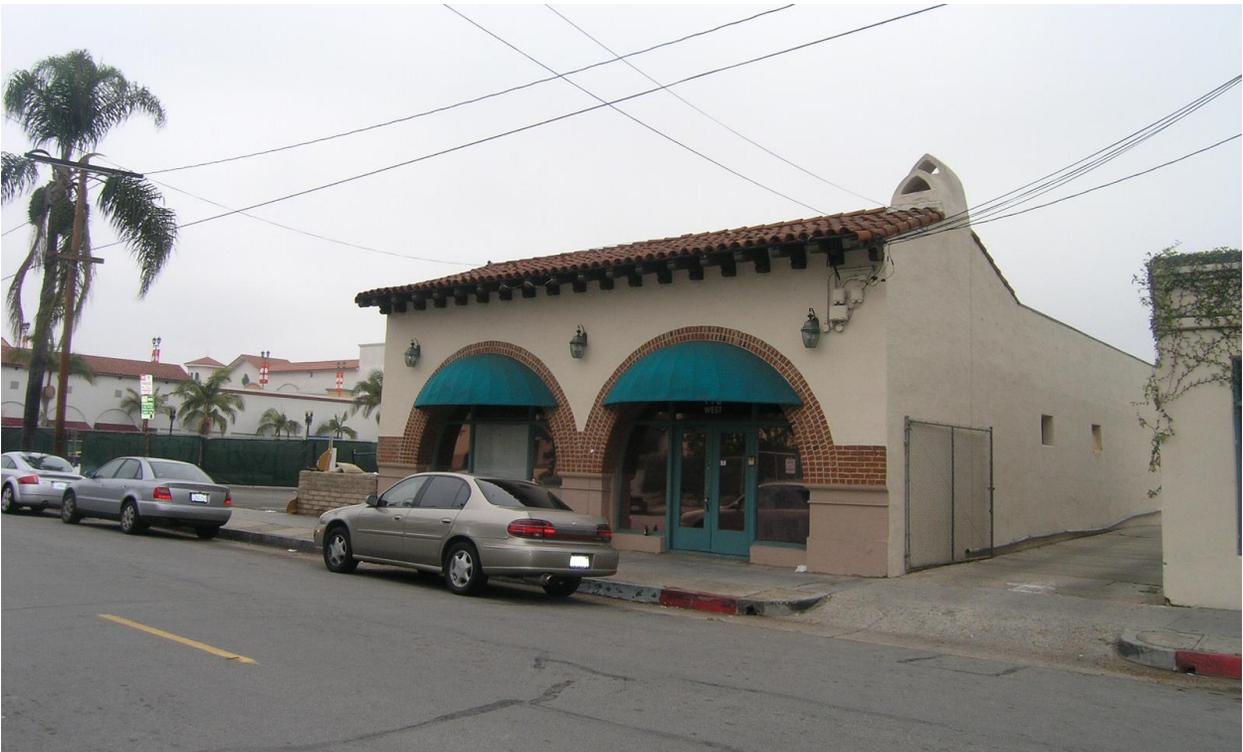
Plate 2. View of west wall of 113-115 West De la Guerra Street, showing smooth wall below chimney.
Facing southeast. A. C. Cole 2004

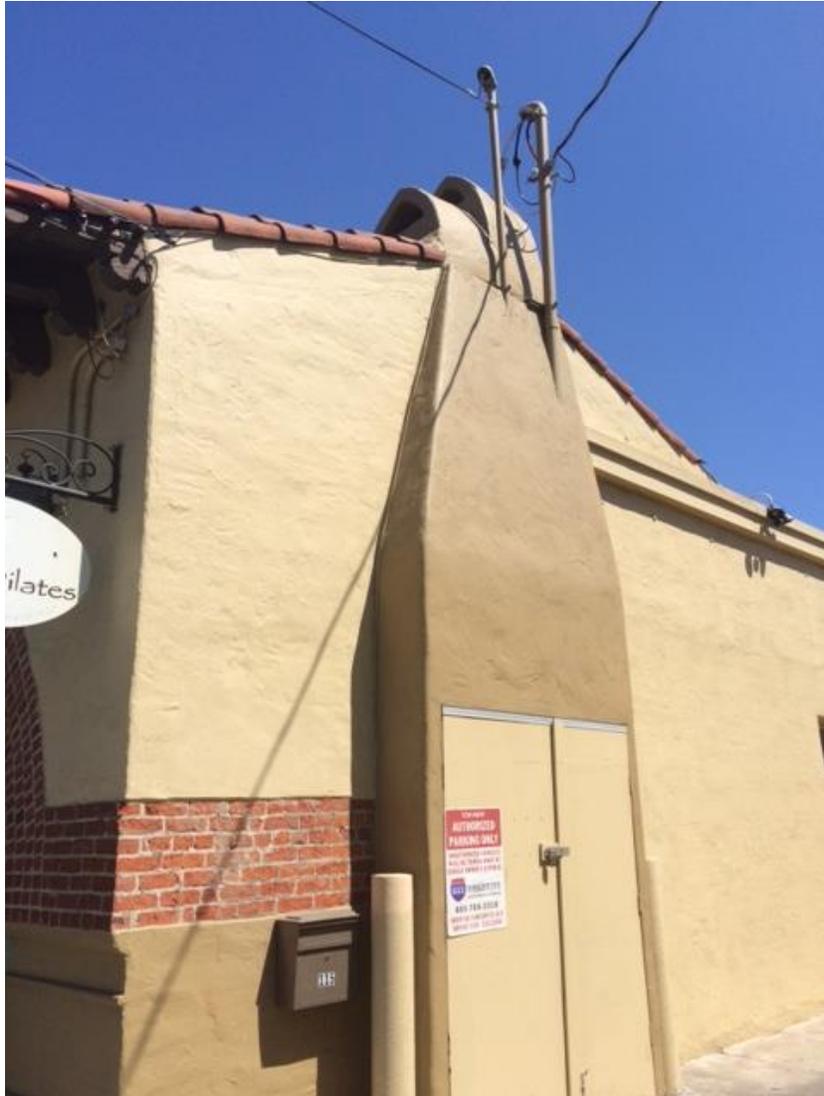
Plate 3. View of west wall of 115 West De la Guerra Street showing new utility bump-out. Facing southeast. A. C. Cole. September 2016

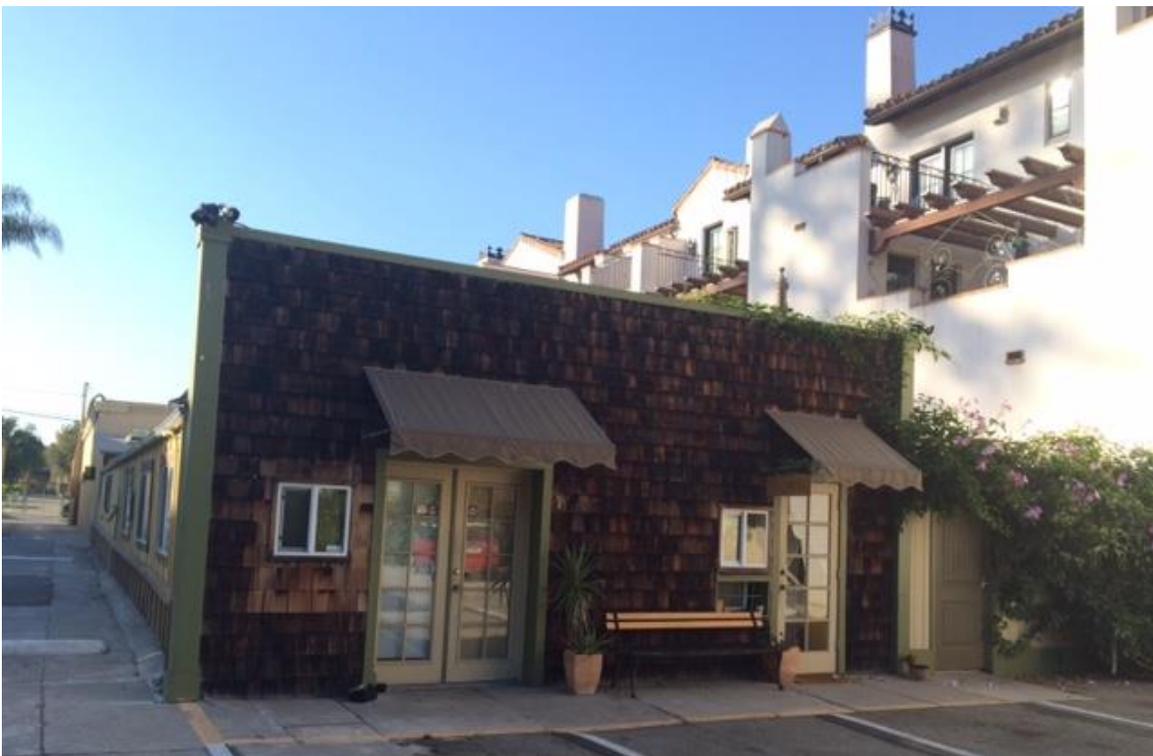
Plate 5. Rear of 113-115 West De la Guerra Street, with 105 West De la Guerra Street mixed use property at right. Facing northeast. A. C. Cole, September 2016

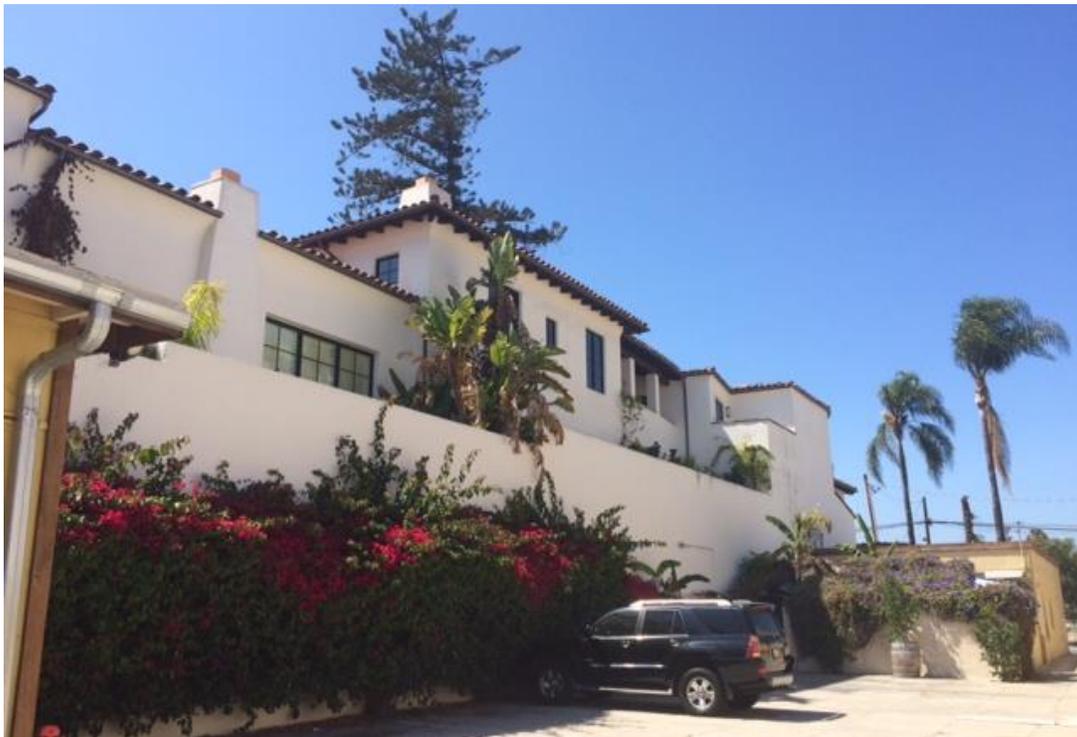
Plate 7. Rear of 117 West De la Guerra Street with 121 West De la Guerra Street
mixed use property at left. Facing northwest. *A. C. Cole, September 2016*

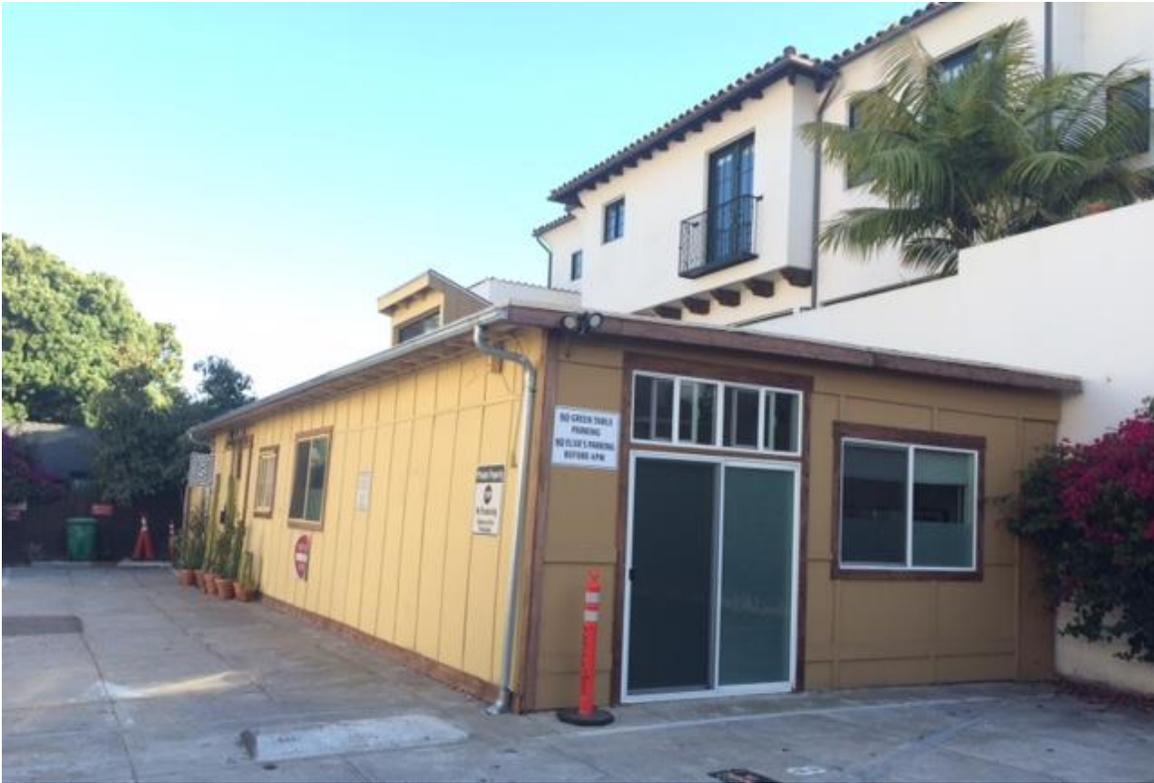
Plate 8. Modern building at rear of 117 West de la Guerra Street to be demolished.
Facing southwest. A. C. Cole, September 2016
