To: Members of the Historic Landmarks Commission
From: Alexandra C. Cole
Re: 428 Chapala Street review of the potential Structure of Merit
Date: November 21, 2017

I wish to comment on the proposed inclusion of the property at 428 Chapala Street on the List of Structures of Merit. It was declared potentially eligible as a Structure of Merit in an HSSR prepared in 2005 by Post/Hazeltine Associates. They concluded that the building retained sufficient integrity of design and workmanship, even though hidden behind modern additions, to be a Structure of Merit as a "rare surviving example of a circa-1870 brick and sandstone Italianate Style house". I wish to contest that evaluation.

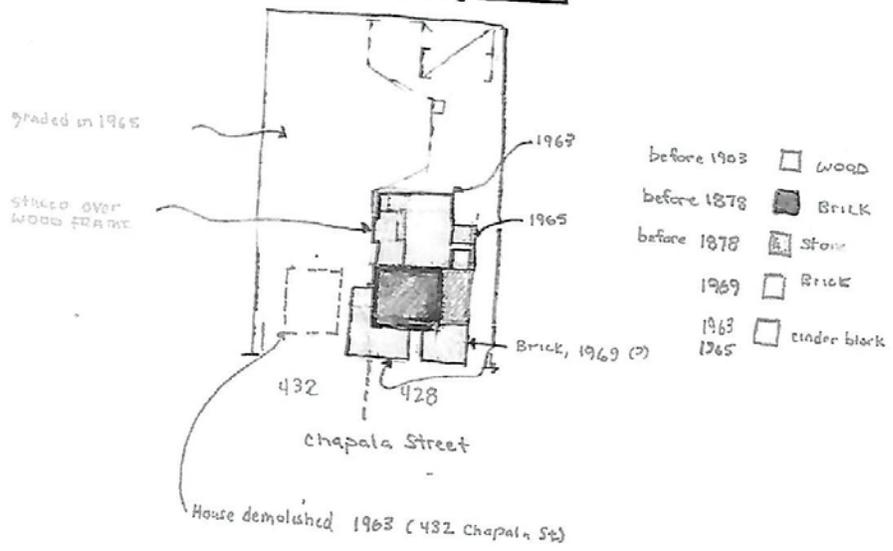
***Please note that this drawing is not to scale**

Ground Plan, Number 1
(depicting sequence of construction at 428 Chapala Street
from circa 1870 to 1969)
Information derived from City Planning Department's Street File for 428 Chapala
Street

Post/Hazeltine Diagram showing how the modern alterations
encapsulated the original house

Because the building was altered with two brick wings to the façade in 1966 which hid the original front of the house, the replacement of the original Victorian door and sandstone steps in 2004-2005, and the addition of concrete block additions at the rear, the building no longer retains the requisite integrity to be considered a Structure of Merit.
