City of Santa Barbara
Planning Division

SUBJECT: **Staff Evaluation of rear unit addition to a property that is designated a Structure of Merit.**

ADDRESS: **600 North Milpas Street**

PROJECT: Proposal to add a new patio/bar and interior dining room to the existing on-site parking lot. The patio will be surrounded by stucco walls. Project includes only stucco walls with a pedestrian gate on the Cota Street elevation. The rear elevation of the interior dining area is set off the historic resource to the north with linear windows on the rear elevation. Paint colors to mimic the patina adobe paint on the Miranda Studios.

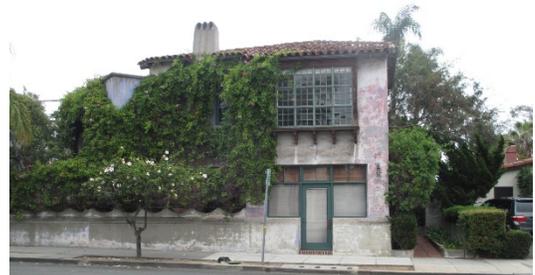
Patina adobe of the Lugo Adobe, Meridian Studios.

The project meets this guideline. The stucco walls of the enclosure will be treated with a patina adobe paint that mimics the paint on the Lugo Adobe, Meridian Studios that will differentiate the building from the Structure of Merit historic building in white, so as not to compete with it, yet using a traditional treatment found on a historic building. This treatment will differentiate the original building from the new building.

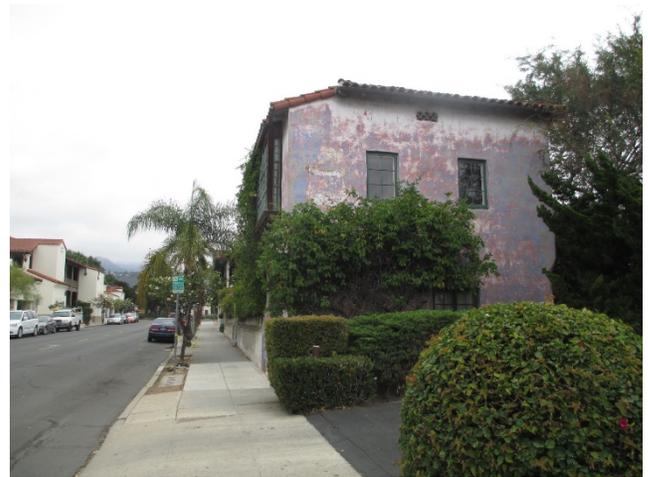
Windows: **The project does not meet the evaluation design criteria:** The new windows in the interior dining addition have long, linear patterns that are not similar to the rounded windows and casement windows of the original building.
