**SUBJECT: GEOLOGIC HAZARDS REPORT
EL ENCANTO HOTEL RENOVATIONS
1900 LASJEN ROAD, SANTA BARBARA, CALIFORNIA**

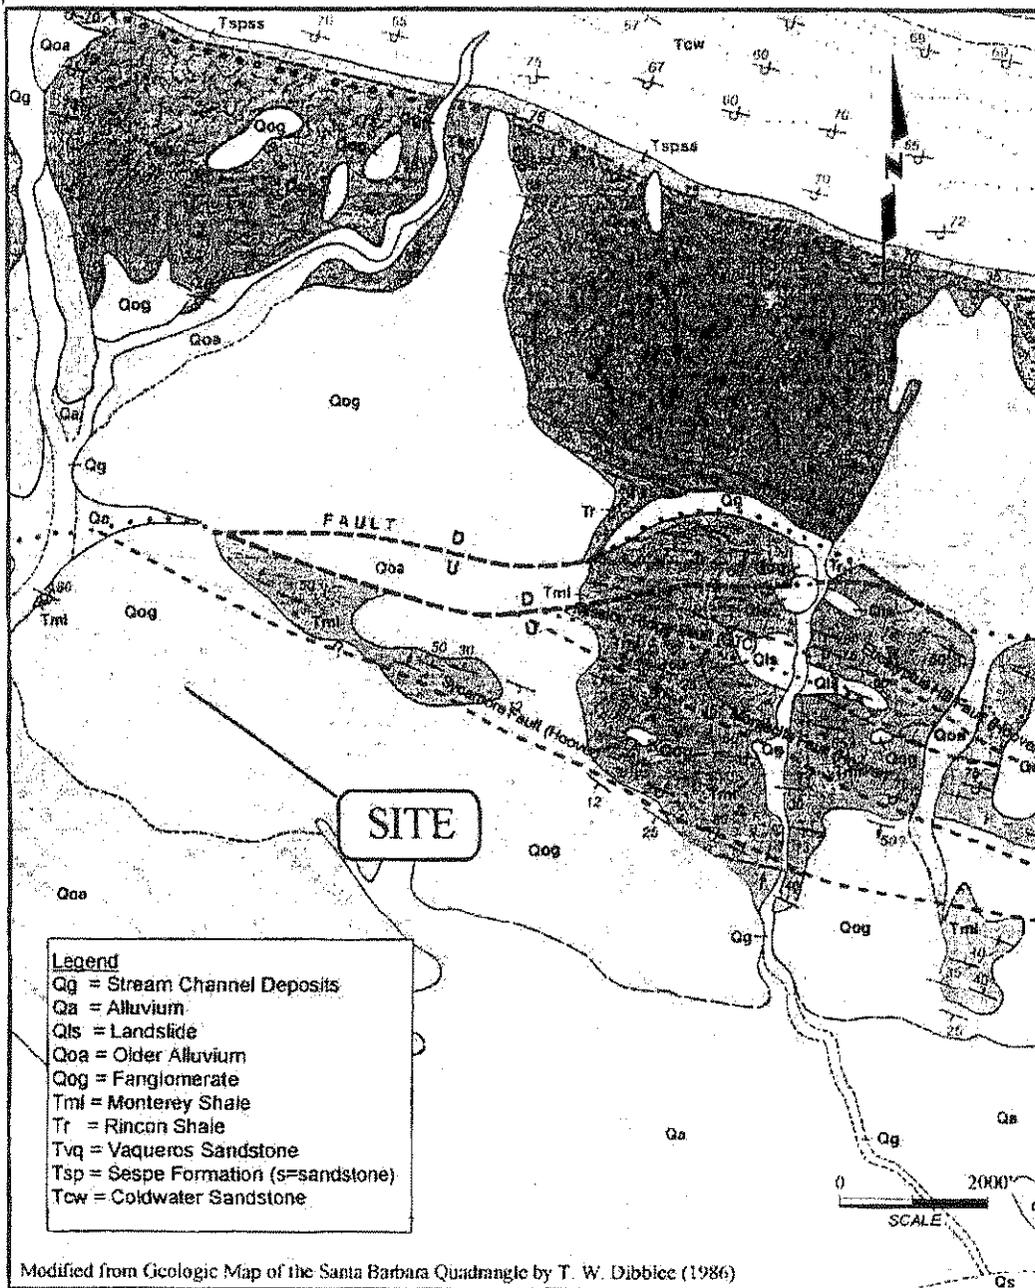
Modified from Geologic Map of the Santa Barbara Quadrangle by T. W. Dibblee (1986)
