PRELIMINARY GEOLOGIC INVESTIGATION

*Riviera Partners Apartment Project
915 E Anapamu Street
Santa Barbara, California*

Re: *Preliminary Geologic Investigation*
13 apartment complex
915 E. Anapamu St
Santa Barbara, California

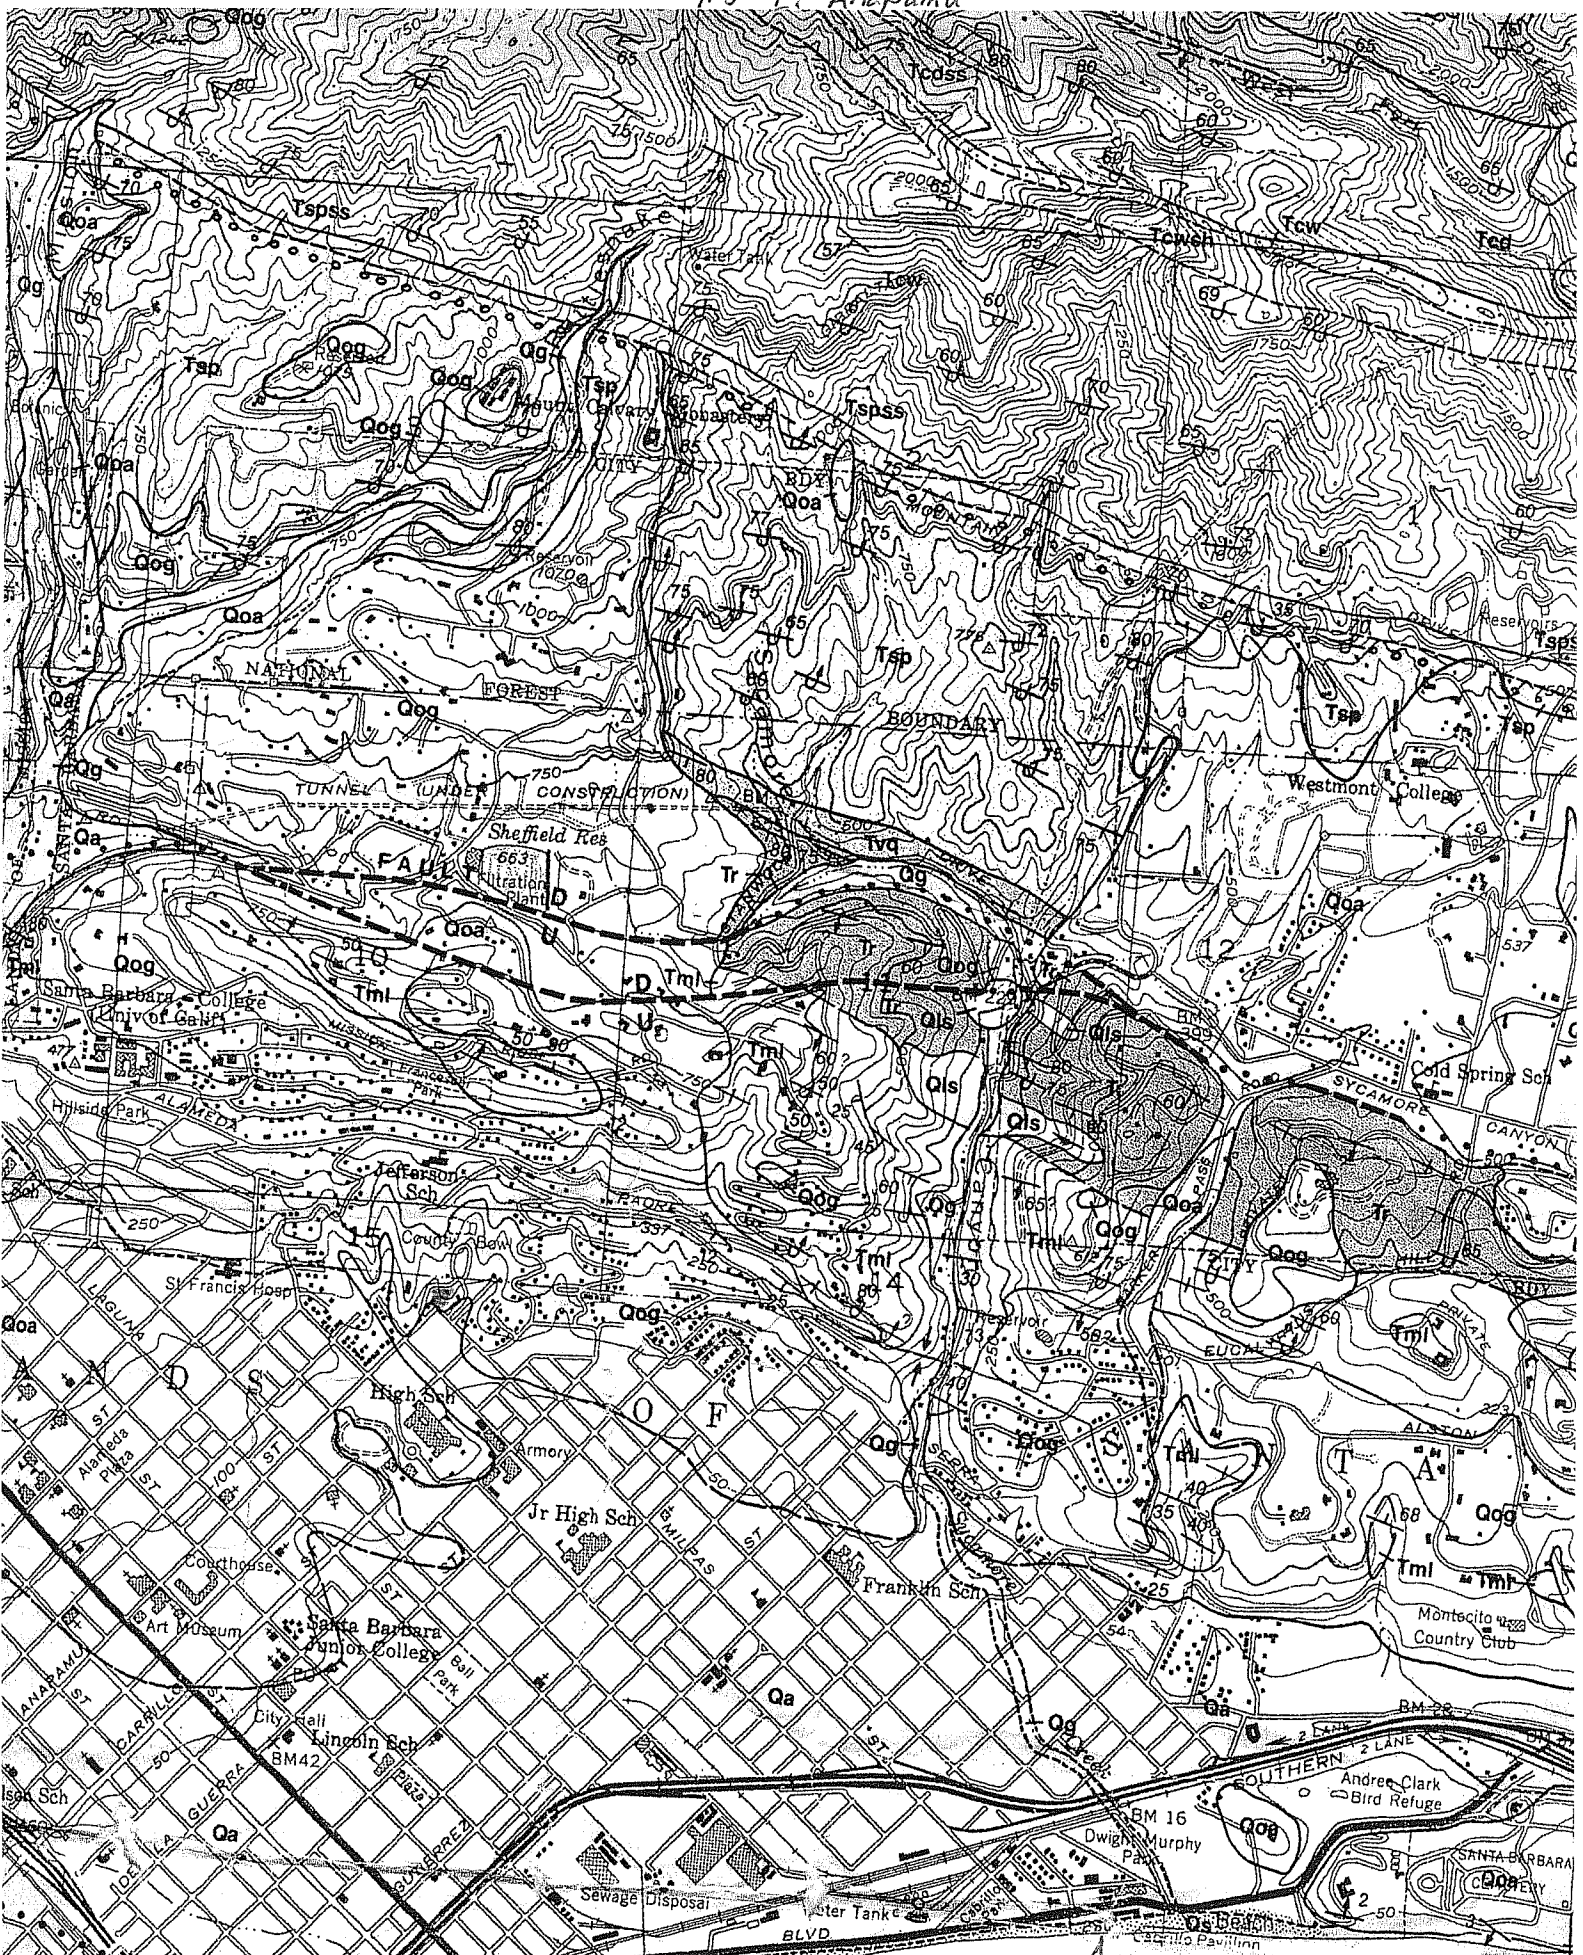
Regional Geologic Map

1" = 2,000' North
 Qa = Younger Alluvium
 Qog = Fonglomerate

Pursuant to your request, we present herewith the results of our preliminary geologic investigation of the above captioned property. It is our understanding that you propose to construct a 13 unit apartment complex on the above described address. The existing single family residence, located on the eastern portion of the property, is to be demolished. Eleven units are proposed on the east side of the drainage swale and 2 units on the west. The location of the subject property and the general geologic conditions of the surrounding area are graphically shown on the attached map entitled **REGIONAL GEOLOGIC MAP** (see Figure 1).

We have enclosed a geologic map for your review. Figure 1 is a **REGIONAL GEOLOGIC MAP** of the area prepared by Mr. Dibblee in 1986. This map indicates that the subject property is underlain by Older Alluvium (Fanglomerate) Deposits. The Fanglomerate Deposits (shown as "Qog" on Figure 1) is typically composed of unconsolidated to weakly consolidated boulders, gravels, sands, silts, and clays. The Alluvium material is normally considered suitable for construction of the multi unit dwellings, provided the site is properly graded and recompacted and other details of the development are appropriate for the area.
