August 2015 DRAFT

CITY OF SANTA BARBARA

HISTORIC RESOURCE DESIGN GUIDELINES

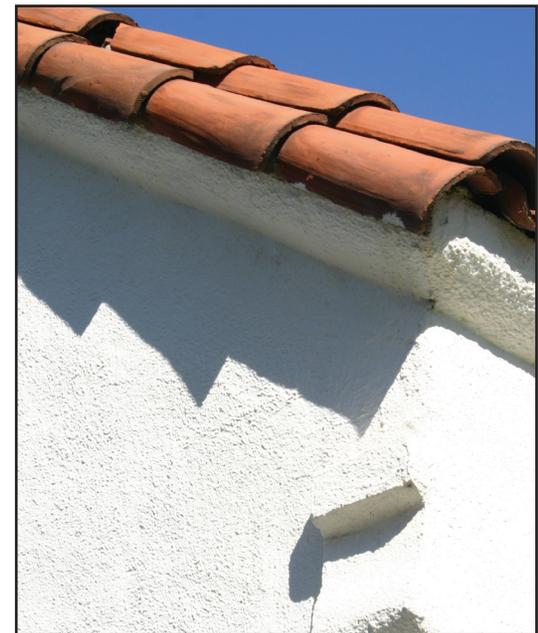
Repair of a red clay tile roof that re-uses or matches the original tiles is an example of a project that can be administratively approved.

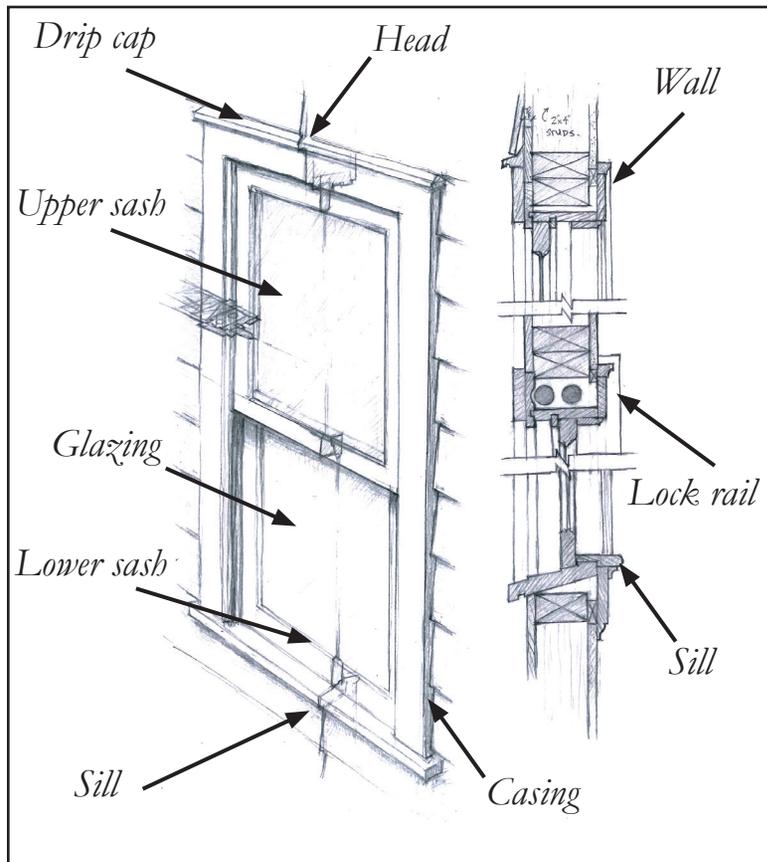
Components of a traditional wood window.

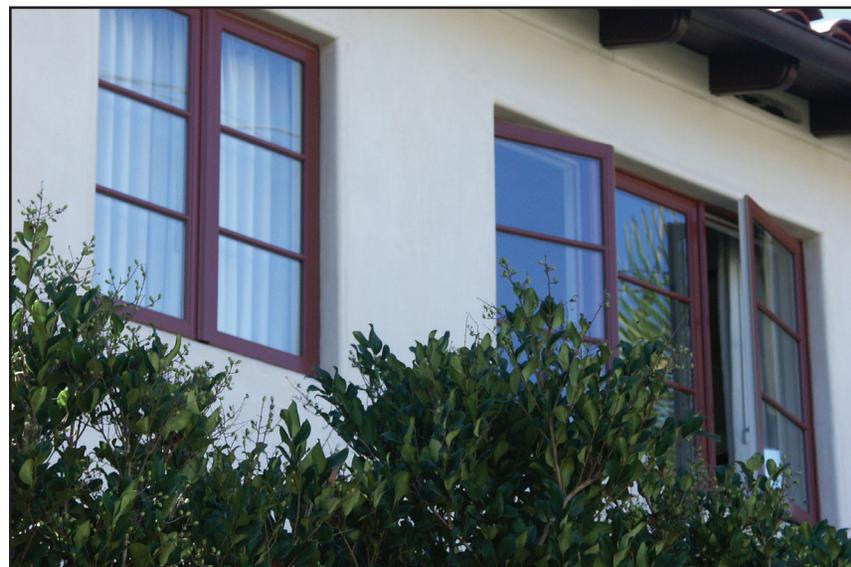
Casement windows with three horizontal true divided lights that are recessed into the stucco façade with no trim.

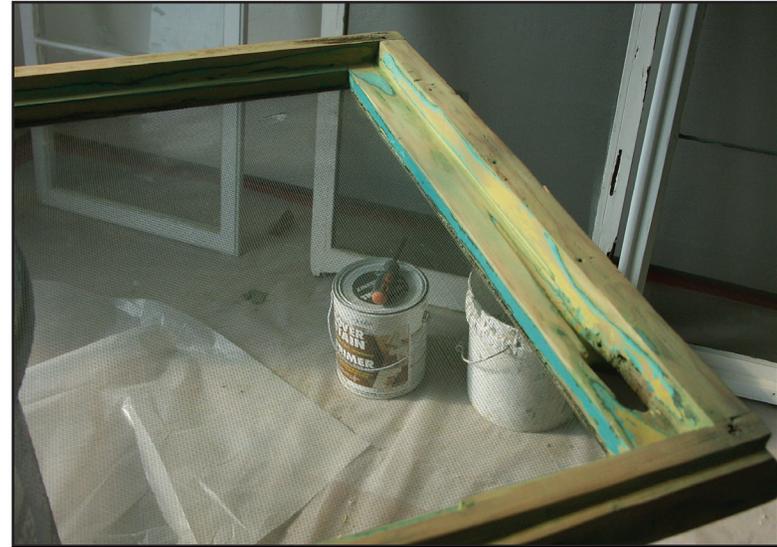
This original casement sash has been removed from the casing and is being restored before being repainted and installed.

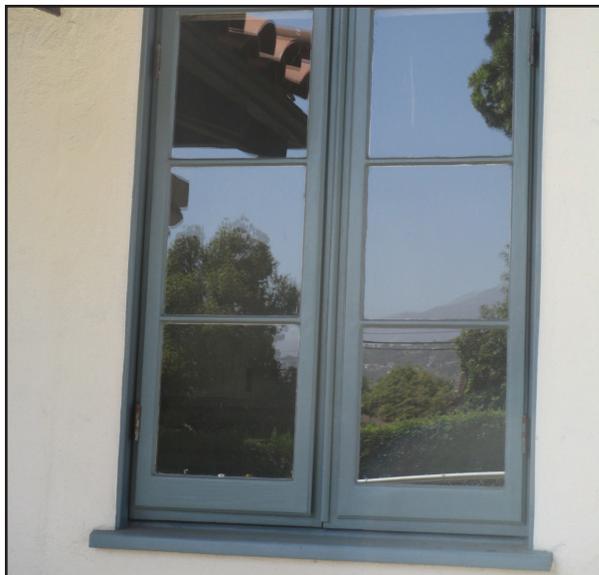
After: The same wood casement window after restoration.

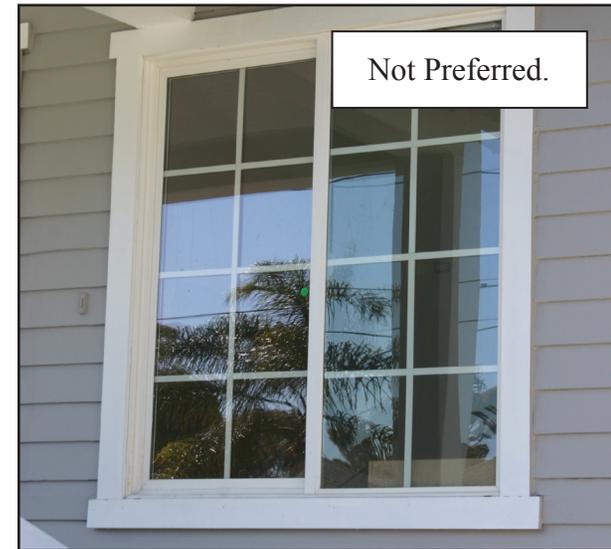
As many original windows are being removed and replaced with windows that do not match the original, Santa Barbara is losing unique architecture elements. The vinyl/aluminum slider windows that open horizontally in the above examples are inappropriate for historical resources because the configuration, material, and profile do not match the original windows, altering the unique character of the window.

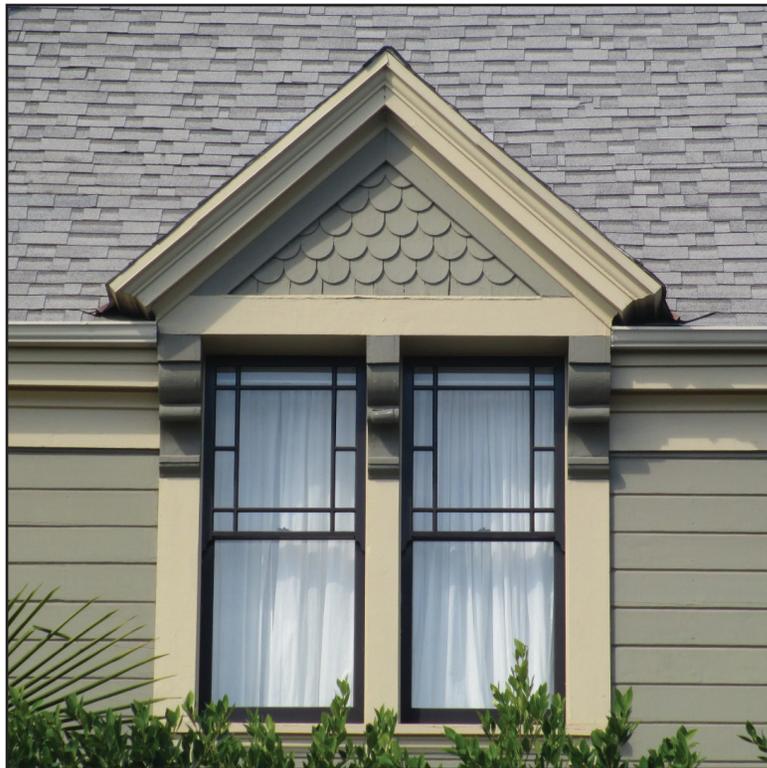
The two double hung windows have a geometric decorative design in their upper sashes.

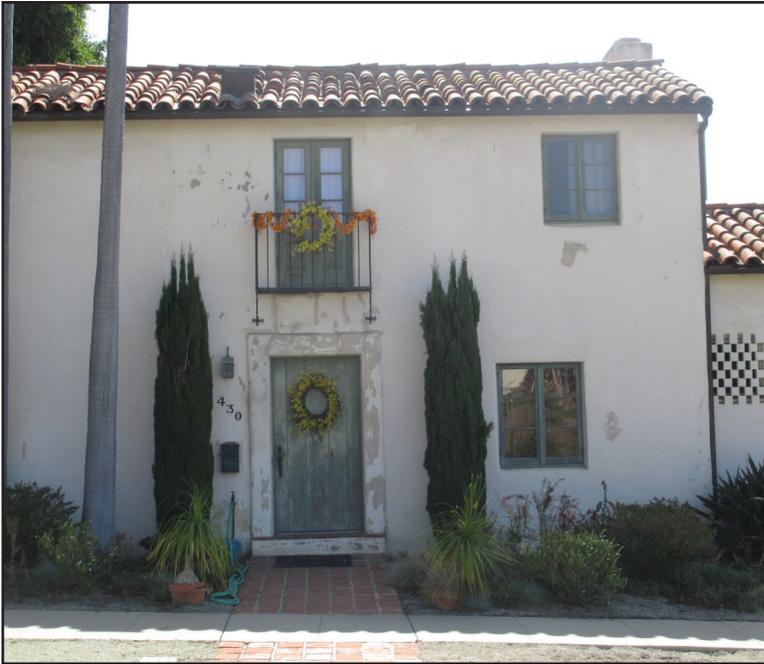
Using true stucco rather than a synthetic stucco is recommended for repairing stucco on Santa Barbara historic resources.

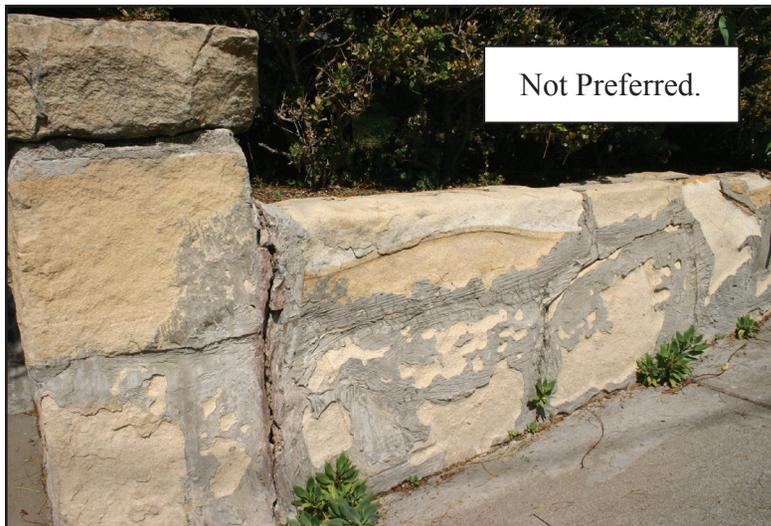
Poor maintenance and improper repointing can damage stone walls.

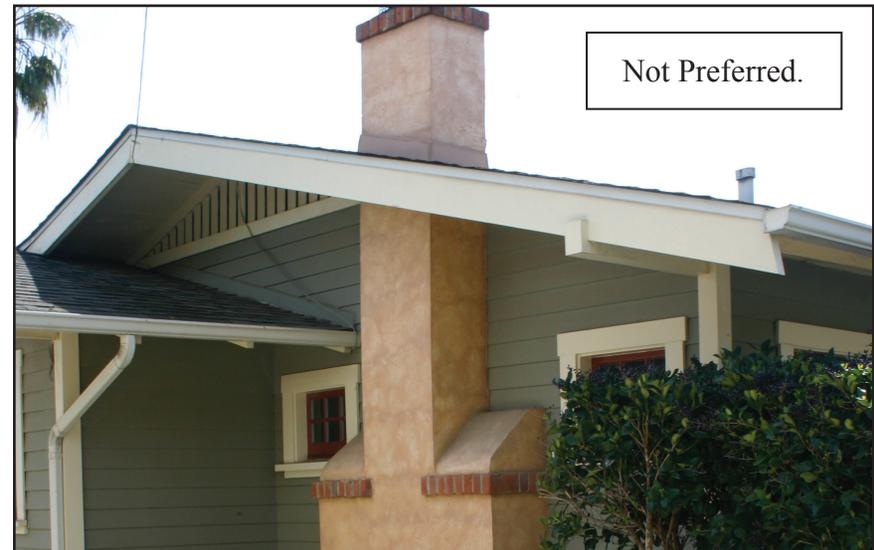
The chimney was covered in a stucco that is not compatible with the wood Craftsman style bungalow. The original chimney was either brick or stone.

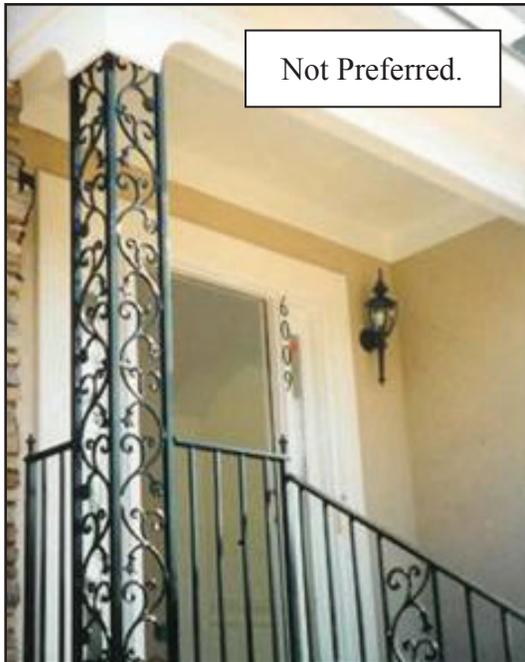
It is not appropriate to replace original columns, posts and railings with modern metal posts and columns that are different in material, shape, and configuration from the original.

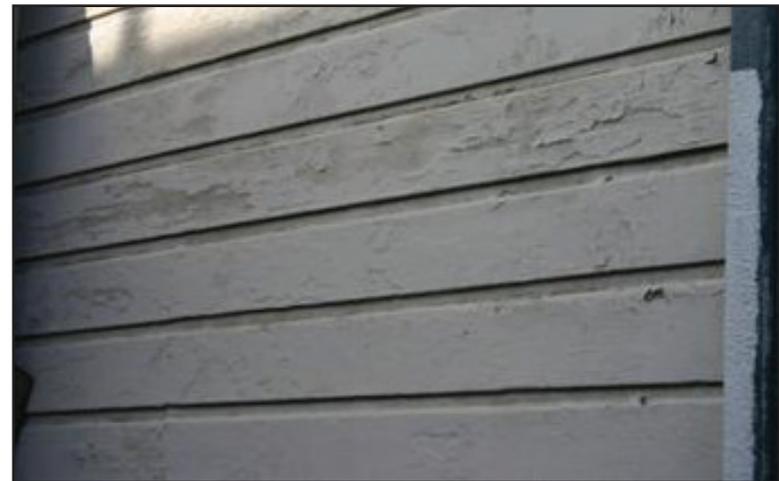
This wood siding is in need of gently scraping off the loose paint to the sound layers and repainting with high quality paint. If not repainted, the wood will become exposed to the sun and water and begin to deteriorate, which may cause expensive repairs in the future.

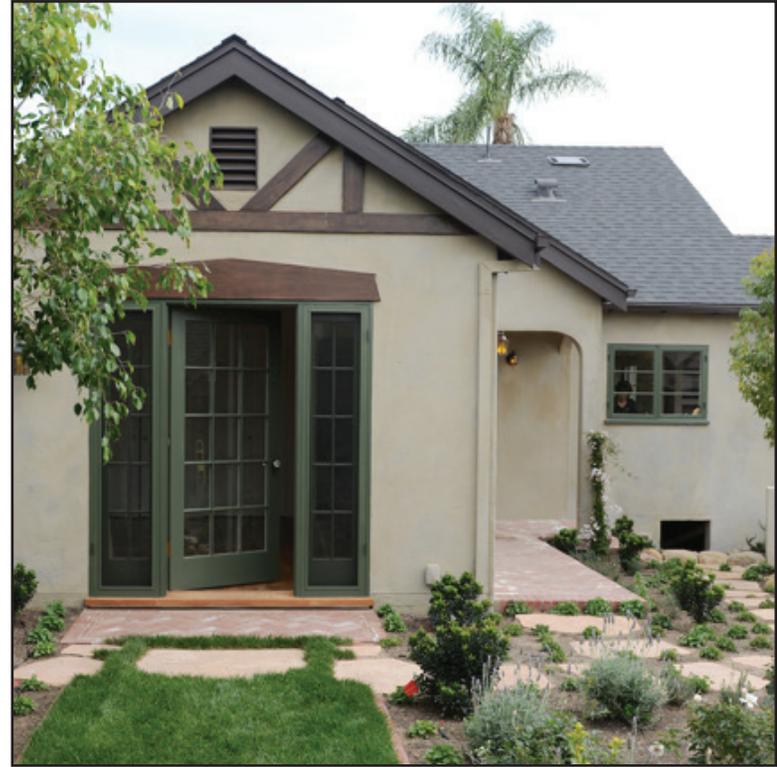
This one-story rear addition is not visible from the streetscape and uses similar finish materials so it relates to the main structure, rather than overwhelming it.

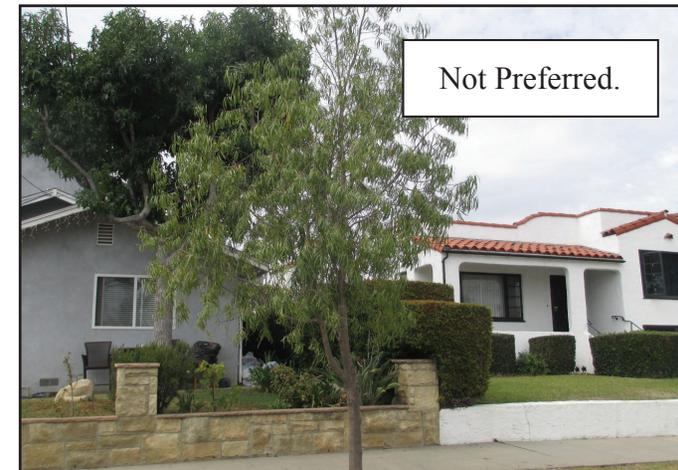
Example of new house (left) does not have appropriate mass, scale, roofline or fenestration and setback to match the 1920's Spanish Colonial house (right), which overwhelms the setting of the streetscape.

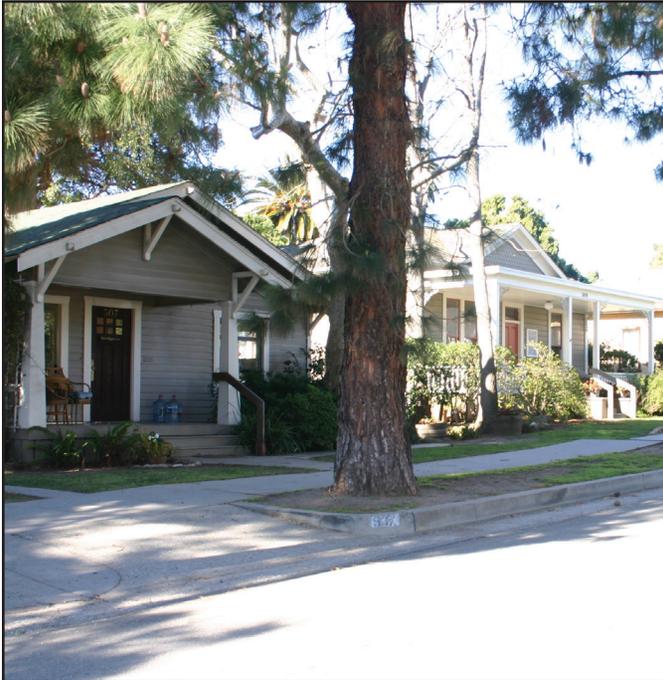
The foundation floor to ceiling heights and the eaves, cornices and ridge lines are aligned creating a sense of cohesiveness even though the street displays differing styles.
