8.1 DETERMINING CREEK TOP OF BANK

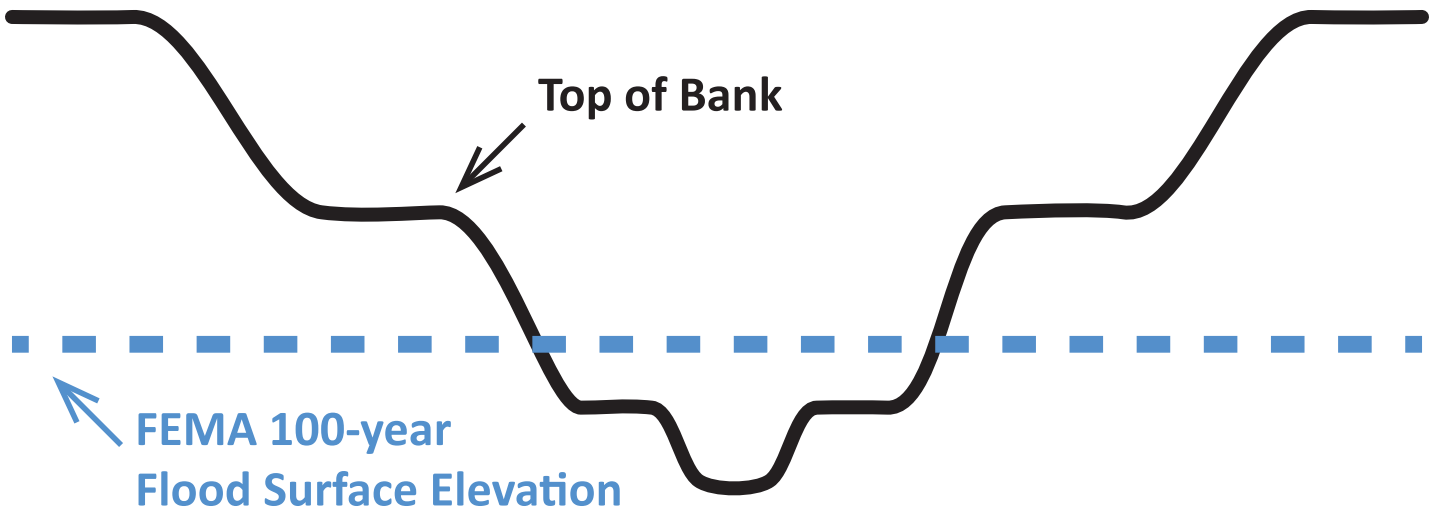
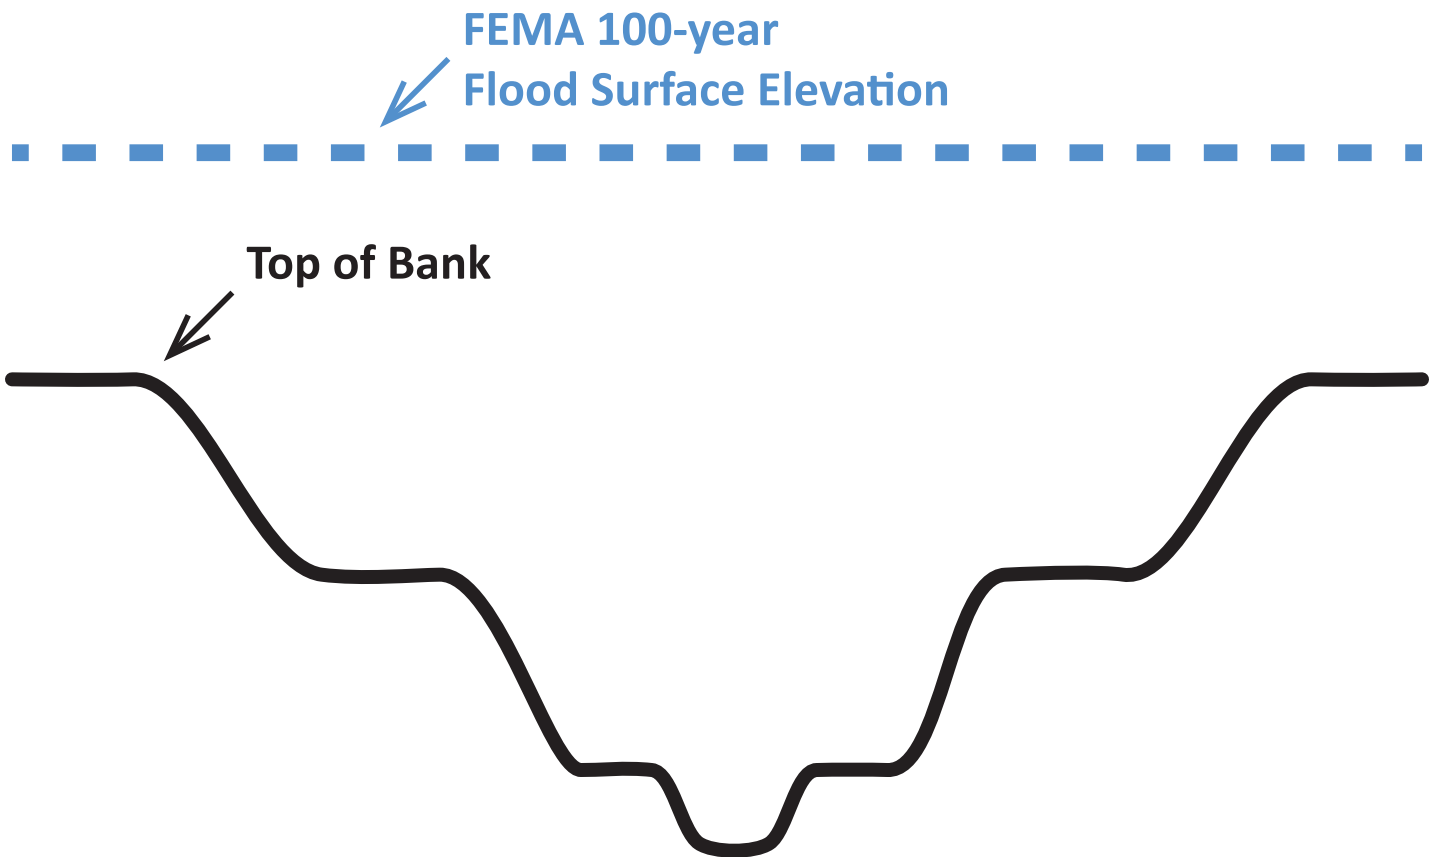
Case 2: Bank Slopes with Multiple Hinge Points

Case 2. *Bank Slopes with Multiple Hinge Points.* Case 2 occurs where the creek bank slope rises from the toe of the bank, levels off one or more times, then rises to a hinge point at the generally level upper ground. In this case, the hinge point at or directly above the FEMA 100-year flood surface elevation is the “top of bank.” If the FEMA 100-year flood surface elevation is above the highest hinge point, the location of the top of bank does not change and is the highest hinge point.
